(2013) - Seventh International Conference on
Case Histories in Geotechnical Engineering

Reconstruction of Road Embankment Failure Using Reinforced Geogrid: Revisiting the Site After 15 Years

RECONSTRUCTION OF ROAD EMBANKMENT FAILURE USING REINFORCED GEOGRID: REVISITING THE SITE AFTER 15 YEARS

A case history of repair works of road embankment failure at KM39, Route 68, Kuala Lumpur – Bentong Road in the state of Selangor, Malaysia and an observation on the condition of the site after 15 years and some tensile strength testing carried out on buried and exposed geogrid was presented in this paper. Due to heavy rainfall in 1995, about half of the road embankment which was located at the alluvial fan of an upslope stream valley was washout. For the reconstruction of the alignment, the existing half of the alignment was converted into a buffer zone with a row of gabion as a barrier to trap any fallen debris from the upslope stream valley. A geogrid reinforced embankment was constructed to provide an additional area for the new alignment of the road.

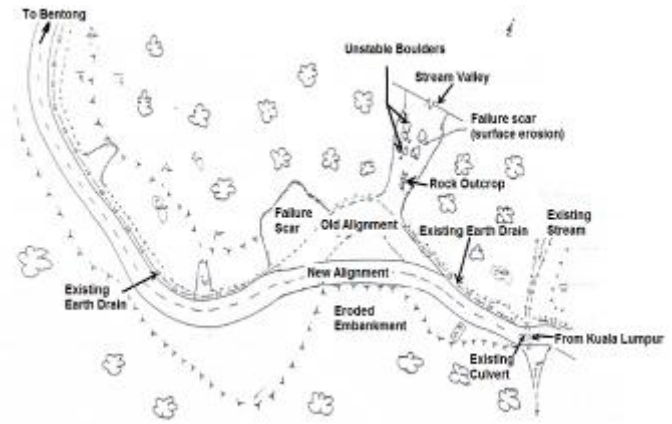
Fig. 3. Sketches of failure area

37°. Materials at the down slope consisted of spoils brought down from the upslope and previous fill materials, which were loosely tipped during the construction of the road. This resulted in erosion failure on the embankment face. Seepage water was also noticed on the surface of the embankment. The lateral extend of the scoured face was estimated to be about 40m and the affected height was approximately 15m below the road level.

Scouring of down slope embankment was due to seepage and surface flow from upslope. Seepage flow underneath the road embankment resulted blow out of piping of road embankment materials. This initiated the scouring of the embankment surface. Flow of surface runoff over the road downwards, causing further scouring of the down slope embankment surface (RAS, 1996).

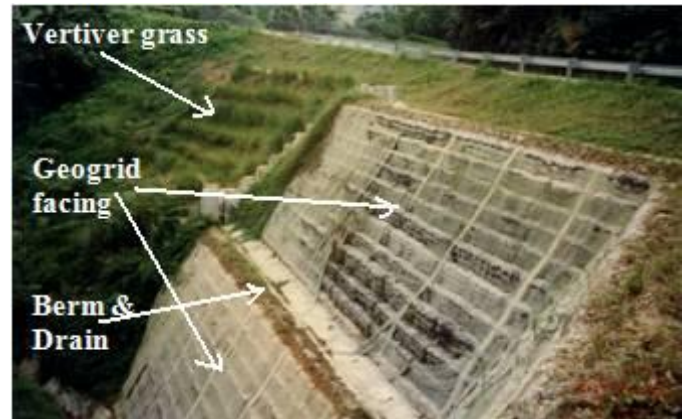
Fig. 13. Photo taken on May 25, 1998

Figure 13, 14 and 15 is a series of photo taken on various times shows progress of vegetation growth on the slope surface. Within four years construction completed, fast growing vegetation covers transformed the constructed slope surface into thick bushes as shown in Fig. 15.

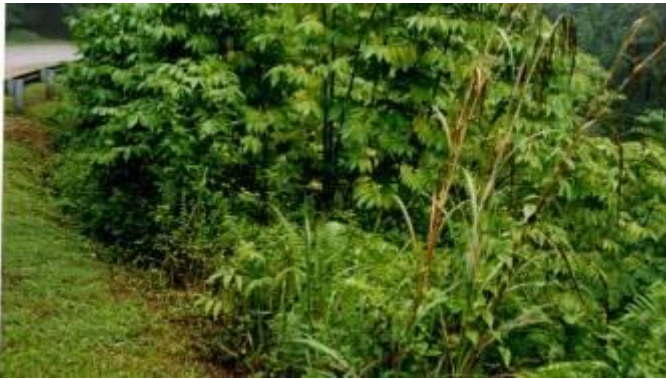
Fig. 15. Photo taken in 2001

There is no evidence of any crack or settlement on the road surface or at the top of the geogrid embankment on the last visit to the site in 2001.

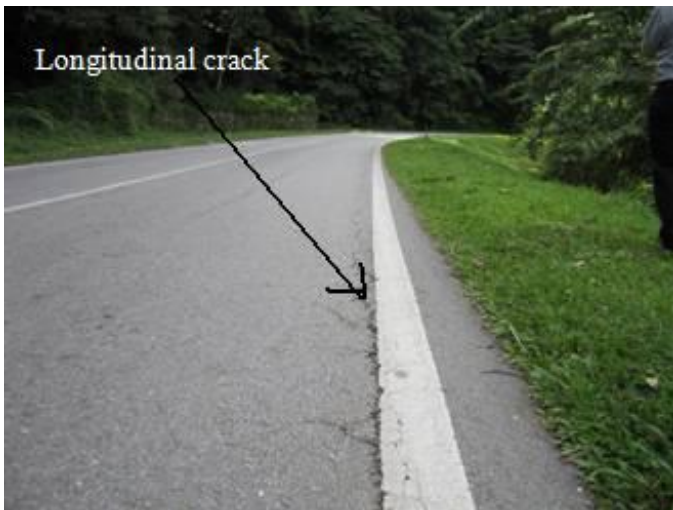
Fig. 16. Longitudinal crack was observed parallel to the edge line of the road

There is single longitudinal crack observed parallel to the edge line of the road on the reconstructed side of the embankment (Fig. 16). The crack is relatively small and if the time after construction was considered (15 years), it was acceptable. The crack is minor and maybe just shallow crack on the road pavement only.

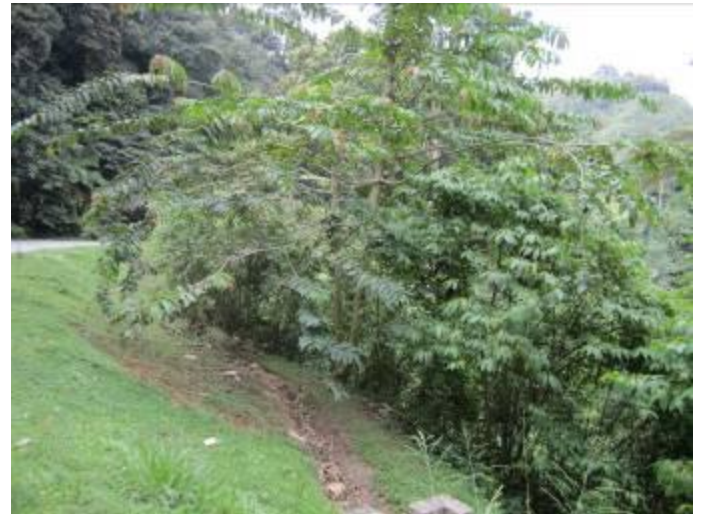
After 15 years, the vegetation or bushes covering the slope surface are more mature as shown in Fig. 17 compared to condition 11 years before as shown in the photo in Fig. 15

Fig. 17. Photo taken on September 11, 2012 shows the site was covered with thick vegetation

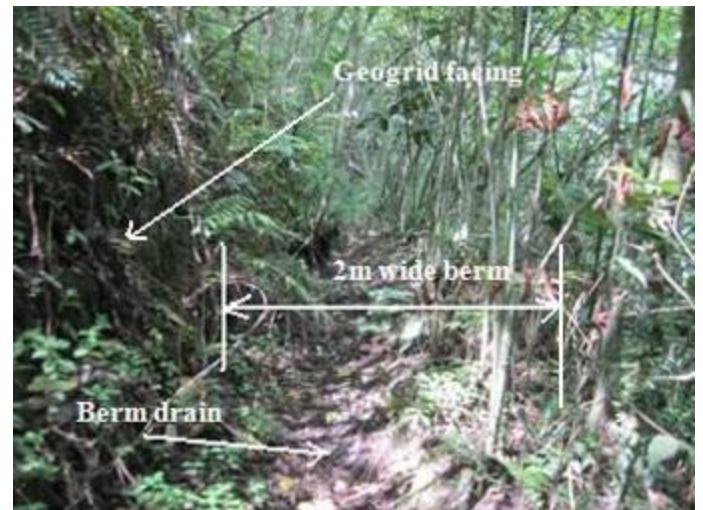
Fig.18. Photo at first berm taken on September 11, 2012 shows the site was covered with thick vegetation

Down to the first berm from top (Fig. 18), the slope surface was covered by 3 to 5m thick bushes. The berm drain was intact, still functioning with no sign of cracking along the berm. Layers of full layer thickness (500mm) of geogrid facing were intact, covered by thin layer of fern and shrubs (Fig. 19). The layers of sandbags used as geogrid facing or temporary formwork during construction were also intact, in the original form as shown in Fig. 20. As usual, due to wet or moist condition at the floor of most tropical forest, especially at hilly area, the geogrid lines were become a medium of algae growth.

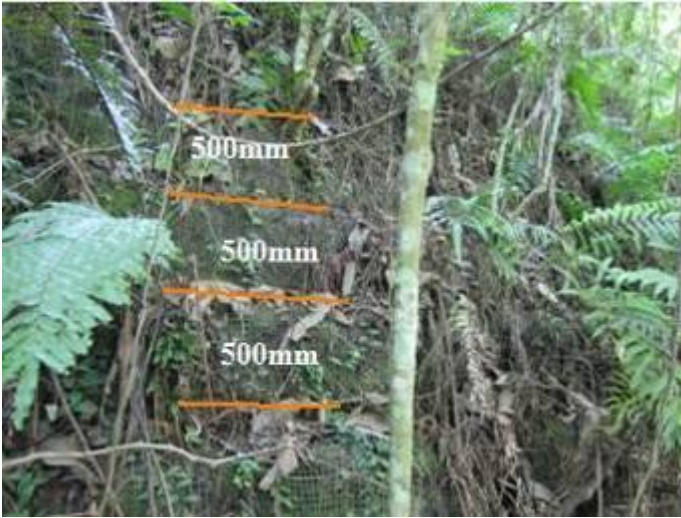
Fig.19. Photo taken on September 11, 2012 shows layers of full layer thickness (500mm) of geogrid facing

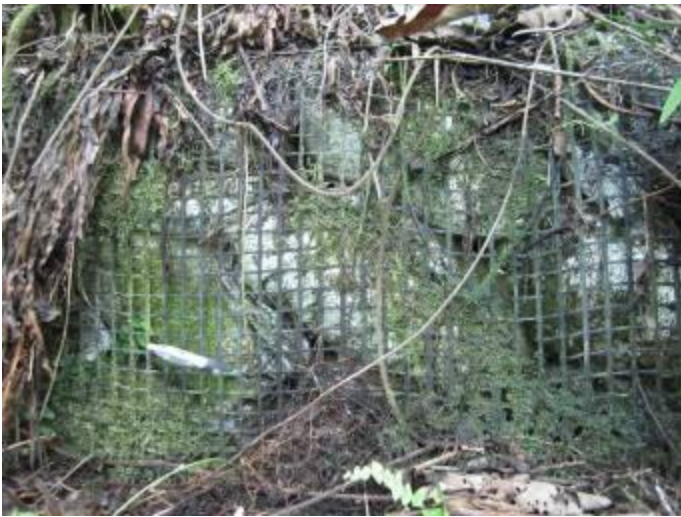
Fig. 20. Photo taken on September 11, 2012 shows geogrid facing clearly intact 15 years after it was constructed

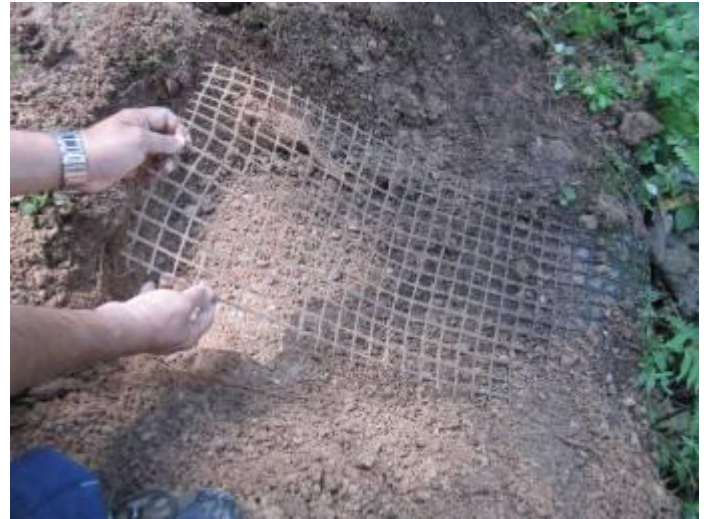
Fig.21. Sampling of buried geogrid from top layer of geogrid embankment

Figure 21 shows sampling of buried geogrid from top layer of geogrid embankment where the soil covering the geogrid was removed before a piece of 600mm (Wrap) by 200mm (Weft) was cut. Figure 22 shows sampling of exposed geogrid from the facing was in the process. The samples were then washed because it should be freed from soil, sand and algae before sending it to the laboratory. Figure 23 shows the cleaned samples of geogrid with minimum size of 600mm (Wrap) by 200mm (Weft) ready to be sending to an accredited laboratory for tensile testing.

Table 1 shows the results of Wide Width Tensile Test (based on ISO 10319-2008) carried out on all seven samples. For buried Fortrac 80/30-20, constant percentage reduction of strength between 0.5% and 5.9% with an average of 2.63%

was observed. For exposed Fortrac 110/30-20, the percentages reduction of strength is between 2.3% and 17.7% with an average of 10.2% and standard deviation of 7.68%. Glaring in difference of strength reductions is difficult to explain. Is it the contractor tries to cut cost by using lower grade of geogrid? Noted that the only available grades of Fortrac geogrid attached in the Design Report (RAS, 1996) are 110/30, 80/30, 55/30, 35/20 and 20/13.

If we ignore the last two samples (BR6 and BR7), an average percentage reduction of strength for both condition is not much difference. This means that Malaysian tropical environment effect of ultraviolet, temperature and humidity) didn't much effect on the strength of geogrid.
