(1998) - Fourth International Conference on
Case Histories in Geotechnical Engineering

An Investigation of an Embankment Failure in Soft Clay

AN INVESTIGATION OF AN EMBANKMENT FAILURE IN SOFT CLAY

Bujang B. K. Huat

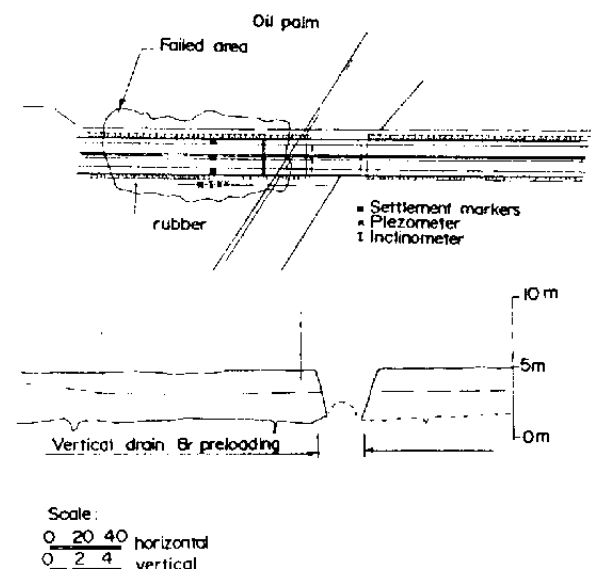
Fig. 1 Plan and profile of embankment

Figure 1 shows plan, profile and instrumentation of the embankment. The instruments installed include settlement markers, piezometers and inclinometers.

The embankment was to be built to about 3.2 m high above original ground level, inclusive of a 1.5 m surcharge. Site clearing was commenced in early January 1992 followed by placement of geotextile separator layer with 400 mm thick sand blanket. Earth filling was commenced in early March 1992 and was completed to final level by midst July 1992 (i.e. on Day 140). Five days later the embankment collapse without prior sighting of any tension crack.

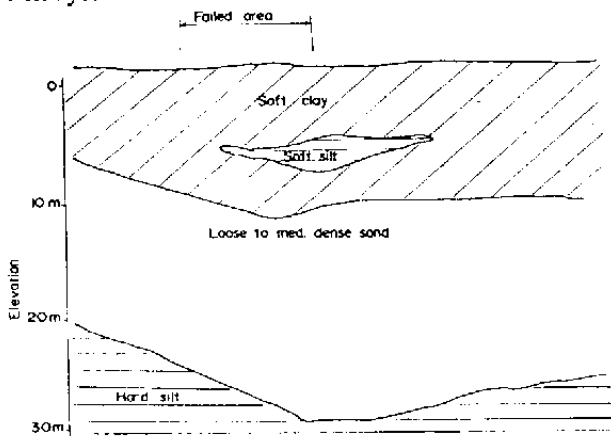
Fig. 2 Subsoil profile of the embankment

Figure 2 show subsoil profile of the embankment as obtained from the site investigation carried out during the design stage. The subsoil comprised of soft silty clay layer of about 10 m thick, underlain by layer of loose to medium dense sand. The liquid limits of the soft clay vary from 90 % - 100 % with natural water content close to the liquid limit, and plasticity indices in the range of 35 % - 70 %. Undrained strength obtained from the vane test showed a general trend of strength increase below a weathered upper crust, with S_u/σ_c ratio in the range of 0.3 - 0.4. The clays are shown to be moderately sensitive, with sensitivity ratios in the range of 3 - 9. Results obtained from the oedometer tests indicated that the clays are slightly over consolidated but highly compressible. The apparent over consolidation of the clay is believed to be due to that of the weathered crust. The values of C_v are typically low, ranging from 1 - 10 m^2/yr .

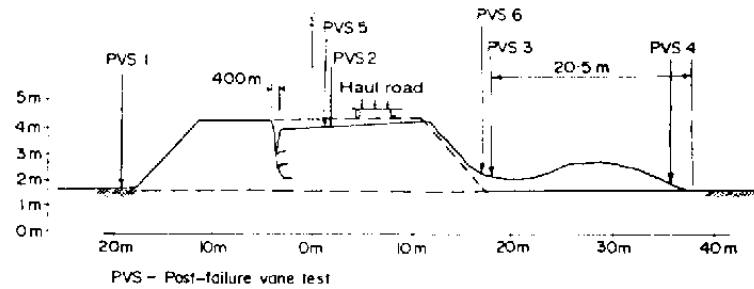
Fig. 3 Cross-section of the embankment

Figure 3 shows cross sections of the embankment surveyed soon after the failure. As shown the failure of the embankment was characterised by wide open crack through the embankment fill with a significant heave at the embankment toe. This indicated that the mode of the embankment failure has been that of a rotational slip.

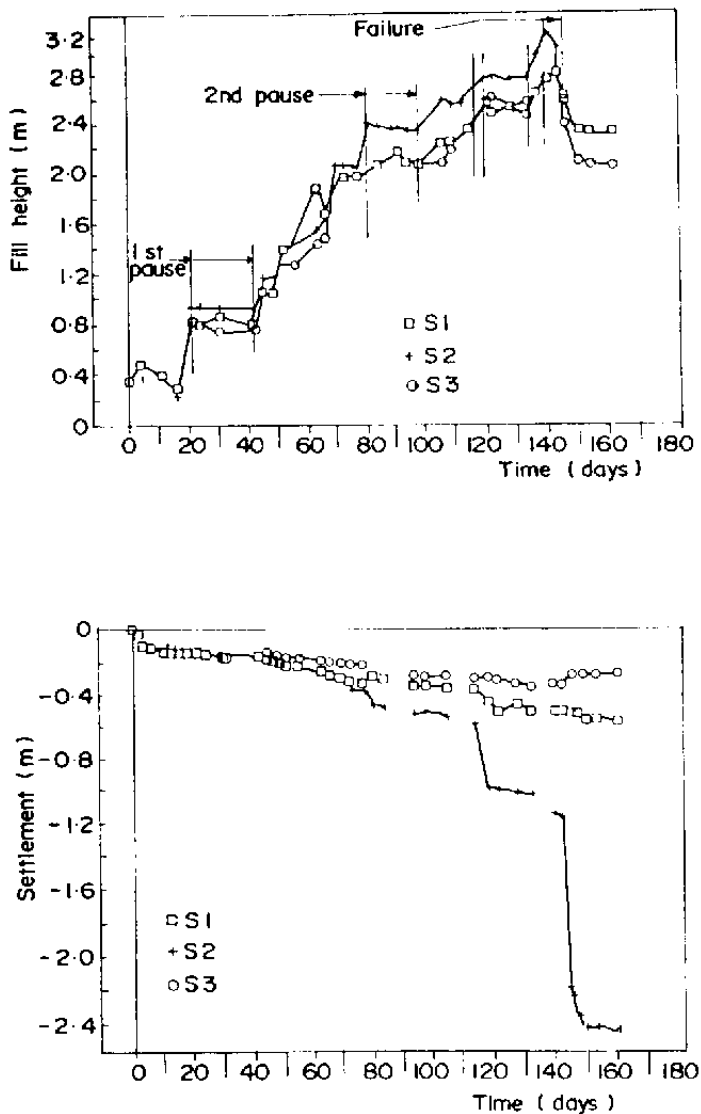
Fig. 4 Construction history and settlement of the embankment

Figure 4 shows construction history and settlement of the embankment. As shown there has been a dramatic increase in settlement rate just prior to the failure.

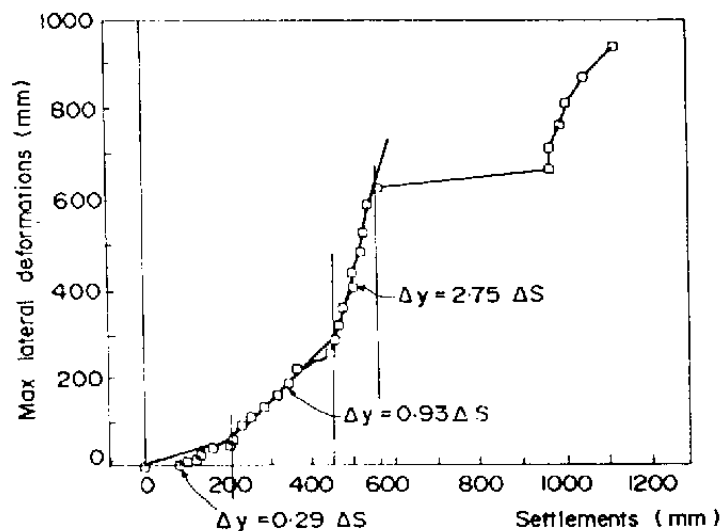
Fig. 5 Max lateral deformations - centreline settlements of the embankment

Figure 5 shows plot of maximum lateral displacement (Δy) versus centreline settlement (ΔS) of the embankment. It is of interest to note that when the fill was low, i.e. for fill thickness of less than 1 m, the $\Delta y / \Delta S$ relation is small with $\Delta y \cong 0.29 \Delta S$. But on the onset of the failure, Δy increases significantly; from approximately equal to ΔS to almost 3 times ΔS .

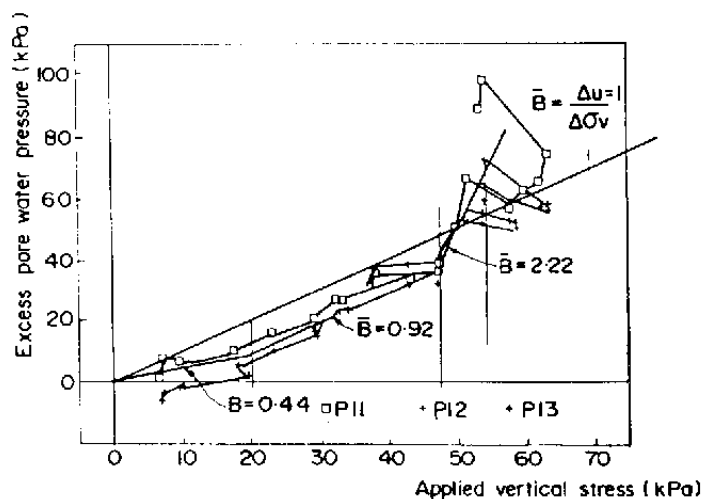
Fig. 6 Pore pressure ratio ($B = \Delta u / \Delta \sigma_v$) of the embankment

The variation of excess pore water pressure (Δu) with applied vertical stress, $\Delta \sigma_v$ is shown in Fig. 6

For low fill of less than 1 m, the piezometric response of the clay foundation is low; $\Delta u = 0.44 \Delta \sigma_v$. The increase in the pore water pressure then becomes approximately equals to the applied vertical stress. However on the onset of failure, the piezometric response is large; $\Delta u \gg \Delta \sigma_v$. This is probably due to the following scenario. Prior to collapse of the embankment, local failures may have been initiated in the subsoil beneath the embankment. This results in strain softening hence an increase in total horizontal stresses and pore water pressures. Therefore prior to the failure, one should expect $\Delta u > \Delta \sigma_v$, and this is shown in the pore pressure plot in Fig. 6.
