# Repair of a Reinforced Earth Wall

**SYNOPSIS** The facing of a Reinforced Earth retaining wall, built at an altitude of 1200 m, was damaged during the winter 1981. The repair was achieved quickly and under traffic. The instrumentation carried out on the repairs and the tests run on the backfill material have revealed the action of the frost and its increase in the fortuitous presence of water.

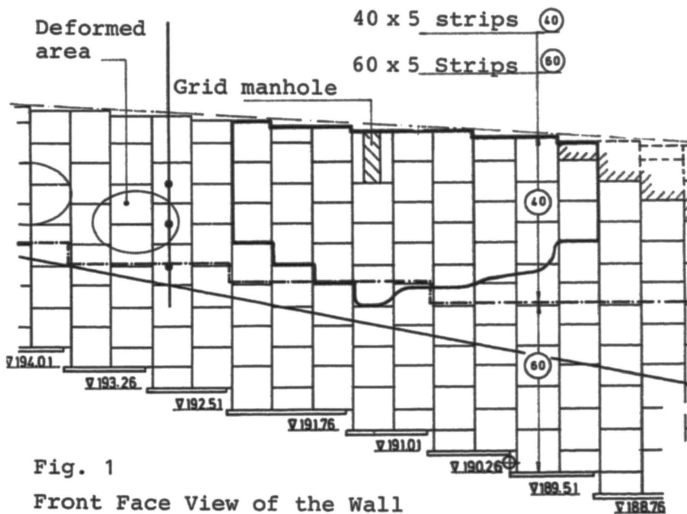
Fig. 1  
Front Face View of the Wall

1) The rupture concerned a surface of facing 9 to 10.5 m wide and 6 m high near the top of the wall and resulted from the breakage of the strips at the connection. There was no trace of corrosion on these strips (fig. 1).

2) The part of the facing that collapsed contained 40x5 strips. Right below, the 60x5 strips were not broken.

3) A portion of backfill (1 or 2 m thick), which can be considered as the "active zone" of the Reinforced Earth mass, failed with the facing. According to witnesses, this backfill was saturated.

4) Behind the collapsed area, the reinforced structure remained perfectly coherent.

5) In the centre and at the top of the collapsed area was a grid manhole about 2 m deep, conducting the running water towards the main sewer of the uphill bank of the road through a  $\varnothing$  300 mm transverse pipe. Although the manhole was displaced and broken, it could still be observed that no re-bar had been placed to tie its walls to the bottom slab.

6) Beside the collapsed area, bulges could be observed in several areas of the facing.

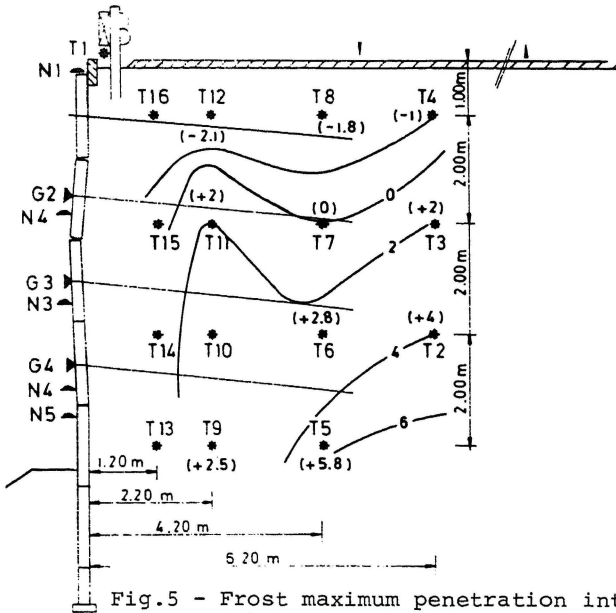
Fig. 5 - Frost maximum penetration into the structure

- . The outside lowest temperatures were reached on 12 February (-17,6°C).
- . The lowest temperatures inside the structure were recorded at the beginning of March (fig.5) i.e., three weeks later.
- . The frost deeply penetrated the top part of the structure (4.20m behind the facing). The part of the structure is in fact submitted

the frost coming from the road and the Reinforced Earth facing.

. On a lower part the frost penetrated as far as 1.5 m behind the facing.

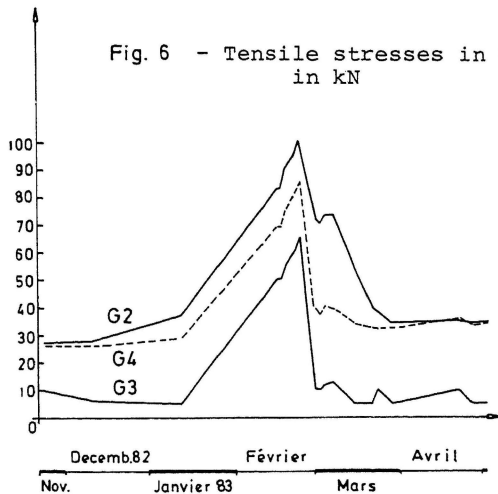
Fig. 6 - Tensile stresses in the rods in kN

The maximum tensile stress observed in the rods was noted on 23 February when the outside temperature had risen (maximum 5,7°C, minimum - 8,7°C) and when the frost went on penetrating

An increase in tensile stress was noted :

70 kN on G2 and 60 kN on G3 and G4. This increase in tensile stress applied to the four strips of a panel gives an increase of 15 kN per strip. Normally, the maximum working stress of the strip is 180 MPa, namely a force of  $180 \times 5 \times 40 \times 10^{-3} = 36 \text{ kN}$

When the test took place each strip could have then been submitted to a force of  $27+15=42 \text{ kN}$  i.e. a force inferior to the shearing stress of the tie-strip (51,5 kN). In this case the stress in the steel at the connection is :

$$42 / [(40-13) \times 5 \times 10^{-3}] = 311 \text{ MPa i.e. a stress superior to the elastic limit of } 240 \text{ MPa.}$$
