International Conference on Case Histories in
Geotechnical Engineering

Lessons Learned from the Disaster at Lippe Canal Bridge

LESSONS LEARNED FROM THE DISASTER AT LIPPE CANAL BRIDGE

Markus Herten

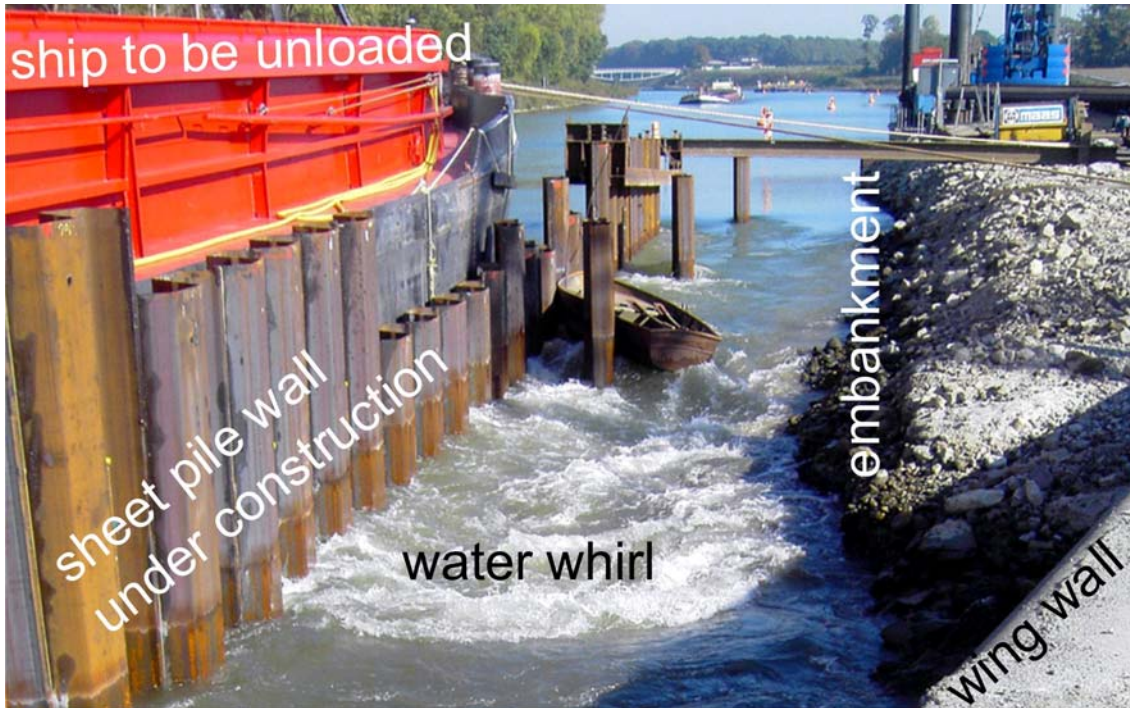
On the day of the accident large steel parts were delivered by ship and unloaded by a truck mounted telescope crane. Shortly before noon, a worker observed leakage between the northern abutments of the old and the new canal bridge. Members of the construction supervision were immediately informed. They found a water whirl in the canal in front of the wing wall of the old northern abutment (Fig. 3). The leakage increased substantially within a short time period. The water from the canal flew first into a small construction pit (Fig. 4), passing under a wing wall footed on piles (Fig. 5). This construction pit was supposed to be protected by a surcharge drain. Then the water flew through the two abutments into the Lippe River (Fig. 6).

Fig. 3: Water whirl in front of the wing wall of the northern abutment

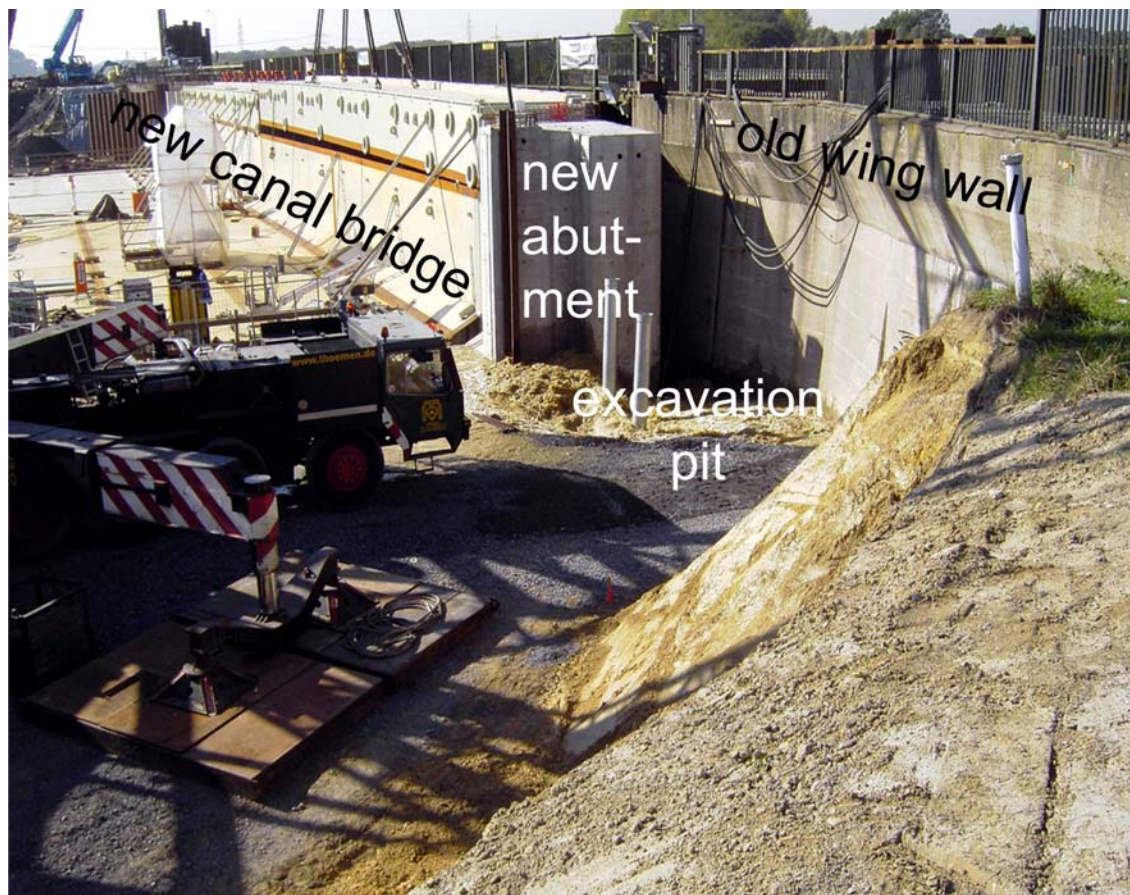
Fig. 4: View of the construction pit between the two abutments

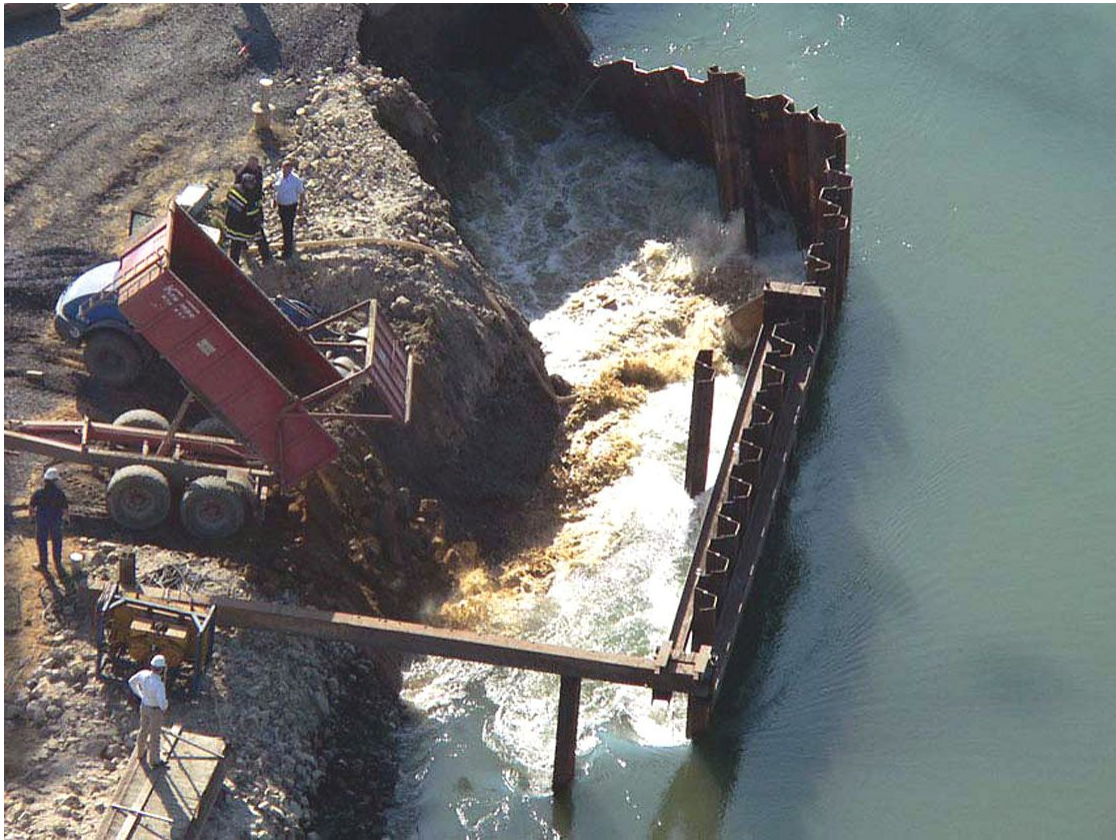
Disaster alarm was triggered and the safety gates Datteln and Schlieker were closed after all the ships had left the canal stretch (cf. Fig. 1). A downspout was moreover opened to empty the canal stretch. Several attempts to close the leak with soil material on the canal side failed (Fig. 7). Due to the high flow velocities, the embankment next to the wing wall eroded totally (Fig. 8). An 8 km long canal stretch was emptied completely. The water from the canal flew around the old and the new wing walls into the Lippe River.

Fig. 7: Attempt to close the leak by dumping soil material into the canal

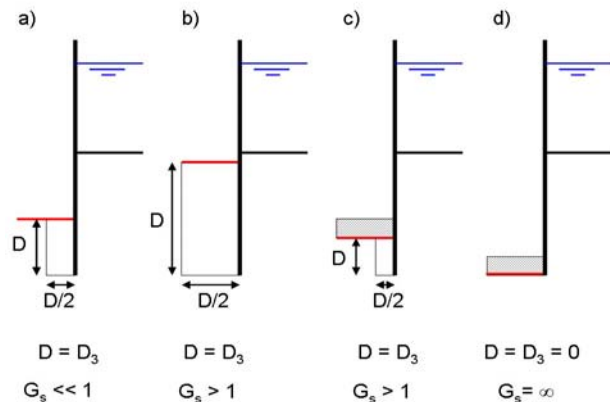
The columns examined are described in Figure 11. The water level on the landward side corresponds to the red line. Assuming that the ground is homogeneous and no surcharge drain is installed, the safety against hydraulic heave would be much smaller than unity in regard to the permitted excavation bottom (Fig. 11a). For sufficient safety, the surface should be much higher (Fig. 11b). However, this was not possible due to the construction progress. Instead, a deeper pit was dug and a surcharge drain applied (Fig. 11c). The surface had to be on the level shown in Figure 11a. The safety was verified with the failure body according to Terzaghi, including the weight on the drain (Fig. 11c). But with a surcharge drain at the bottom of the sheet pile, the calculated safety would be infinite since the excess hydrostatic pressure U_e is zero (Fig. 11d).

A more realistic result is obtained if, as described in Terzaghi (1947), the balance is considered not only at the wall base but also at other depths $D_3 \neq D$ (Fig. 9c). Terzaghi writes: "The investigation can be repeated for different horizontal sections through the sand, which are located at different depths D_3 below the bottom of the pit. The critical head is determined by the condition $h_p = \text{minimum}$, and the horizontal section to which this minimum refers is the critical section. It represents the lower boundary of the mass of sand subject to lifting in the initial state of the piping phenomenon." However, this was not considered when planning the excavation pit at the canal bridge Lippe and hence a false safety was calculated.

Fig. 11: Different columns reaching down to the lower edge of the sheet pile
