The Failure of a Cut Slope on the Tuen Mun Road in Hong Kong

S. R. Hencher and R. P. Martin

Engineering Development Department, Geotechnical Control Office, Hong Kong

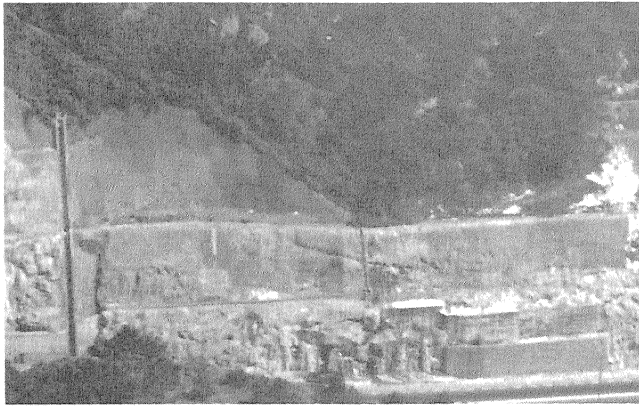
Figure 1 Oblique aerial photograph before failure

Figures 1 and 2 show the site before and after failure. The landslides occurred in decomposed granite and colluvium in the upper 10 m of the 20-25 m high cuttings. The original cut slope angle was $55^\circ - 60^\circ$, with the natural slope above rising steeply at $35^\circ - 40^\circ$. Both slides left an arcuate scar on the slope, with steep back walls. The bulk of the slide debris fell to the base of the cut slopes.

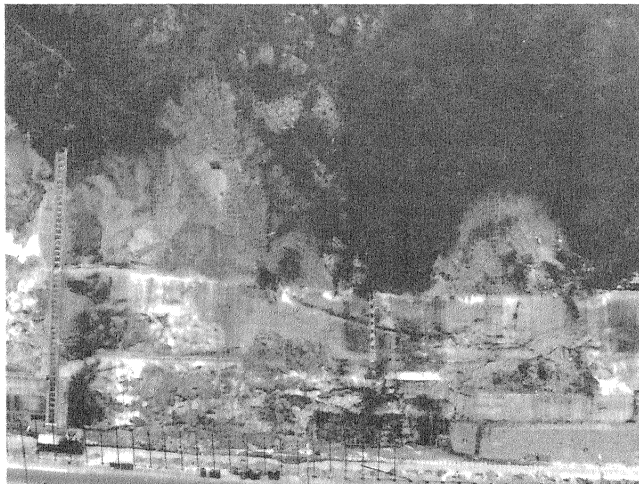
Figure 2 Oblique aerial photograph after failure (June 1982)

The principal geological features are illustrated schematically in Figure 4 and can be recognized in Figure 2.

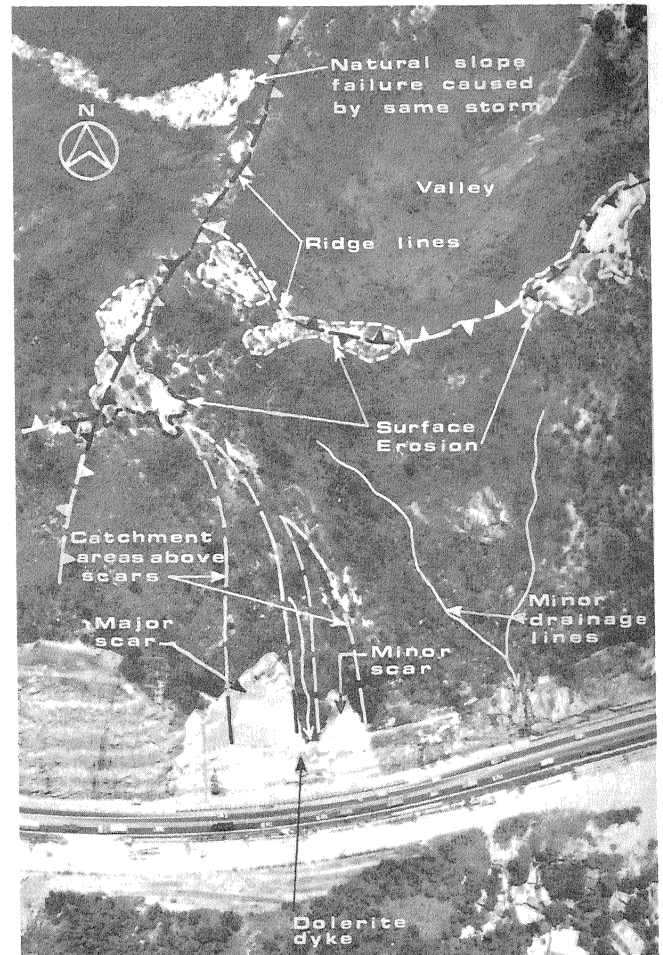
Figure 3 Vertical aerial photograph after completion of remedial works (July, 1982)

Figure 3 shows the site after remedial works had been completed (July 1982). The failures took place on the flank of a major north-south trending ridge line. The rock exposed in the base of the cut slopes was not affected by the landslides. Bare, unvegetated areas near the ridge crest above the failure scars on Figure 3 indicate the susceptibility of the decomposed granite to surface water erosion. No perennial streams occur above the head of the cut slopes but a minor valley falling towards the south separates the two scars. The natural catchment areas are approximately 2200 m^2 for the major (western) scar and 750 m^2 for the minor scar.

The Geotechnical Control Office (GCO) maintains a 24-hour emergency service during heavy rainfall, which provides advice to other government departments at landslide incidents. Following the Tuen Mun Road incident, a geotechnical engineer was present within 3 hours of the call for assistance and provided immediate advice to Highways Office engineers concerning road clearance and restricted land openings. Follow-up action involved site inspection, geotechnical and topographic mapping and recommendations for remedial works. These involved debris clearance, slope cutting to a flatter profile

and improved surface drainage and protection, and were completed within 9 weeks.

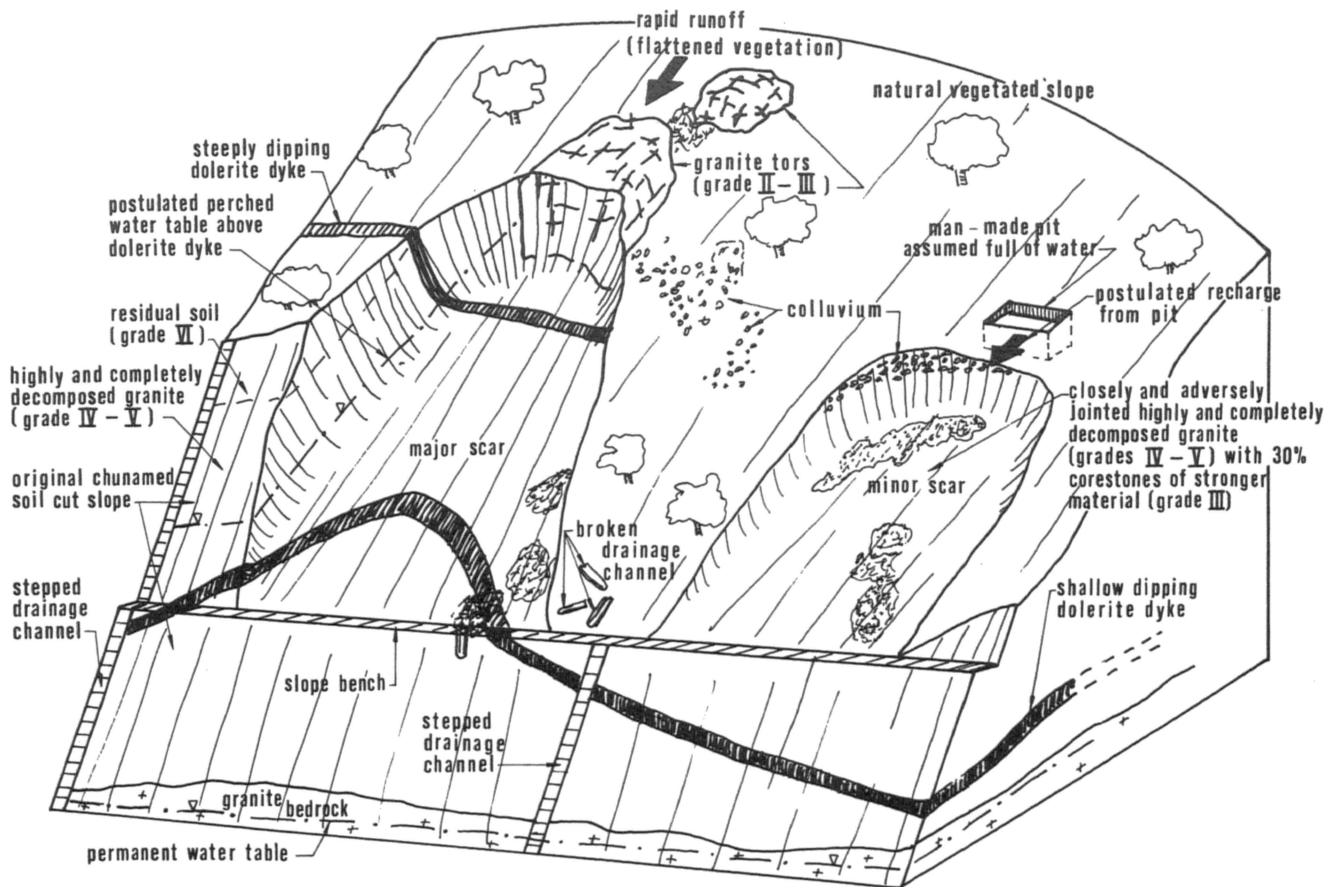
Figure 4 Schematic block diagram showing simplified geology and hydro-geological conditions

In simple terms, the two failures occurred in decomposed granite (grades IV and V). In detail, however, it was established that the local geology is far more complex, with the granite being intruded by persistent dolerite dykes and with local variations in material decomposition, resulting in heterogeneous engineering properties. The dolerite dykes in particular are considered to have played an important part in the failure by causing a perched water table to develop and this is discussed in more detail below.

As illustrated in Figure 4, two major dolerite dykes up to a metre in thickness intrude through the granite. Within the main failure scar the rock is decomposed to a dark red, uniform silt-sized soil. Similar material sampled from another nearby failure scar was shown to have a permeability approximately one order of magnitude lower than that of the decomposed granite. Therefore it is likely that these dykes restricted seepage through the granite.

A number of field observations, however, suggested the possibility of transient perched water tables which might have led to the failures. Firstly it was noted that above the major scar, vegetation had been flattened, apparently by intense surface run-off leading from the natural catchment towards the edge of the cut slope. Secondly, the continuous, low-permeability, decomposed dolerite dykes passing through and just beneath the major failure scar may have acted as aquicludes, leading to critical pore water pressures in the sections of slope that eventually failed.

In the case of the minor failure, a large man-made pit found just above the crest of the slope may have filled with water during the storm, providing a continual and delayed recharge to the already saturated slope. These features are illustrated schematically in Figure 4.

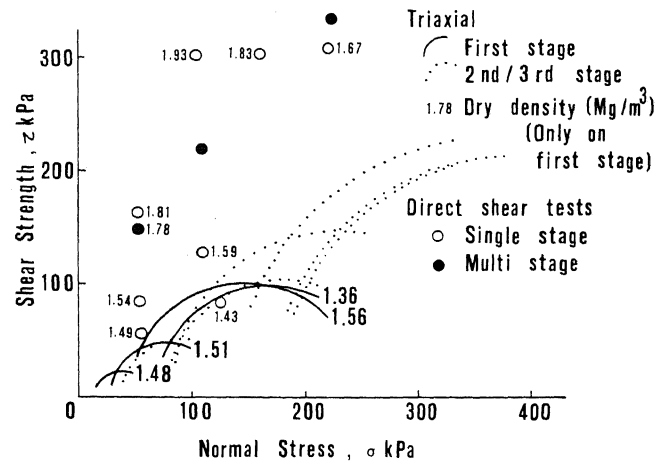
The results from these tests in terms of peak strength are given in Figure 5. The data show a great deal of scatter but on closer examination it is found that strength is clearly related to the dry density of the samples, which is indicated beside each data point in Figure 5.

Figure 5 Results of strength tests on decomposed granite (grades IV/V)

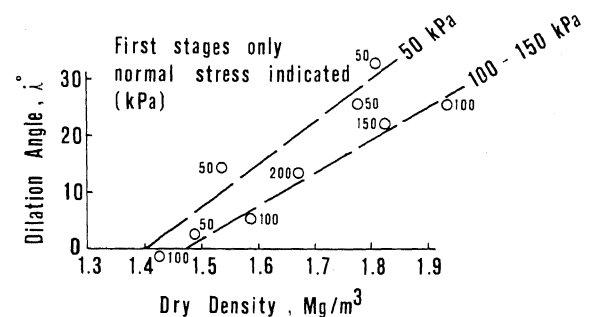
It was also noted that the stronger, high-density samples exhibited pronounced dilatant behaviour which was in turn related to the normal stress (Figure 6).

Figure 6 Effects of dry density and normal stress on dilatant behaviour of granite samples in direct shear tests.

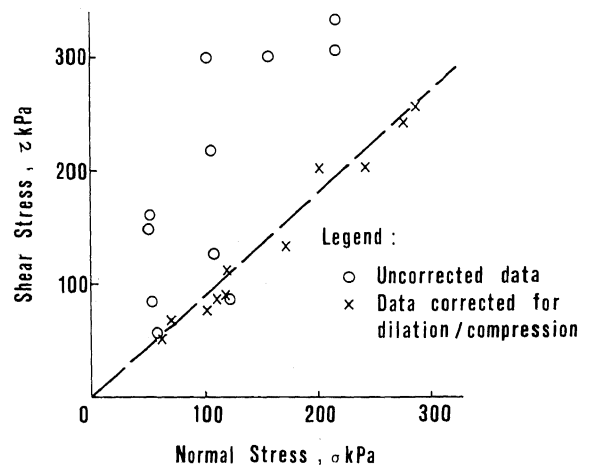
In order to investigate these results in more detail, stresses were resolved as in rock shear testing (Hencher & Richards, 1982) to account for dilatant or compressive behaviour at peak shear strength. These corrected data are presented together with the original data in Figure 7. This shows that the individual peak strengths can be explained as a basic friction angle, ($\phi' = 41^\circ$) together with a positive or negative component which is due solely to the geometrical deviation of the sample from horizontal during testing. This geometrical behaviour was governed by the original density of the material and the normal stress applied.

Figure 7 Direct shear test data corrected for geometrical deviation at peak shear strength.

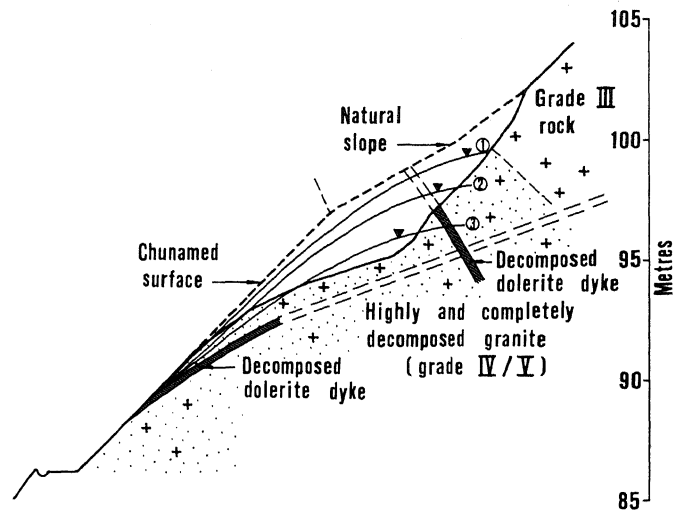
Figure 8 Section through major failure.

Cross-sections of the failure scars are given in Figures 8 and 10. Both sections were analysed using various trial piezometric surfaces as well as for dry conditions. All calculations were carried out using both the Janbu Rigorous and Simplified Methods (Janbu, 1973) programmed for an ICL 2900 computer.

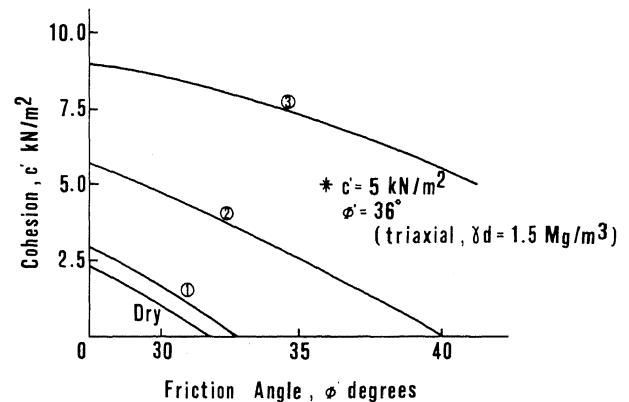
Figure 9 Results of analysis for major failure.

Strength parameters are given in Figure 9 for which a factor of safety of 1.0 is calculated for the various trial piezometric levels. The representative strength of the decomposed granite, as discussed above, is indicated by an

asterisk in Figure 9. Using this strength, it can be seen that the factor of safety would only be reduced to unity for water conditions between those indicated by lines 2 and 3 and it is concluded that these were the probable failure conditions.

For failure to have occurred with no positive pore water pressures, it was calculated that the shear strength of the decomposed granite would have had to be much lower than measured or expected for such material. It is therefore concluded that a perched water table formed above the dolerite dyke and that this led to the failure.

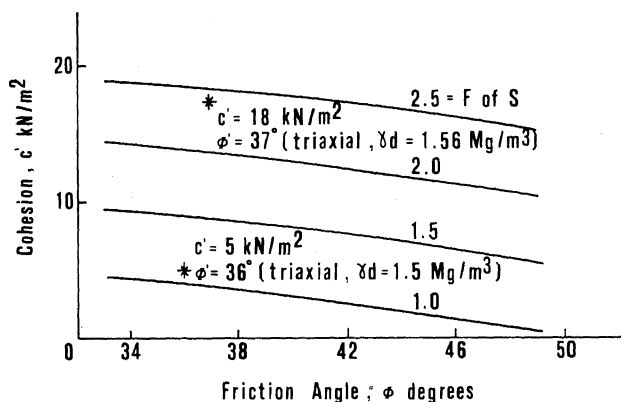
Figure 11 Results for minor failure.

In Figure 11, factors of safety are plotted for various strength parameters on the assumption that the piezometric surface was at ground level.

It can be seen that for this extreme condition, the factor of safety would be greater than one even when using the low strength parameters adopted for the major failure scar. The strength parameters obtained from samples taken from the minor failure scar were much higher than this. Triaxial tests on the weaker material (70%) gave values of $c' = 18 \text{ kN/m}^2$,

$\phi^* = 37^\circ$ and the factor of safety using these parameters is 2.5 even for the worst conceivable ground water conditions. Also the presence of 30% of stronger materials could have only improved the stability. There are two possible conclusions. First, the measured shear strengths were unrepresentative of the intact materials that actually failed. This is not considered likely as the materials were carefully described and the sampling points chosen to be representative. Second, the failure occurred along the complex series of adversely orientated, impersistent joints noted in the failure scar and which are assumed to have lower strengths than the intact granite. This hypothesis appears to be the more feasible of the two.
