Investigation of Collapse of an Apartment Building Due to Differential Filling

SYNOPSIS Investigation of collapse of a five storey residential building in Calcutta is described. The failure occurred soon after construction but, fortunately, before occupation. Detailed soil investigation revealed that a bowl-shaped depression, 5.5 m deep, existed in the collapsed building area which was subsequently filled up. The foundation raft was placed 5.325 m below ground level and the subsequent filling put an overburden pressure of varying magnitude resulting in non-uniform pressure on the subsoil. This was apparently not considered in design. Factor of safety was found to be low against bearing capacity failure and the building tilted towards the heavier load concentration. This caused over-stressing, in structural elements which gradually failed and ultimately led to the collapse of the building.

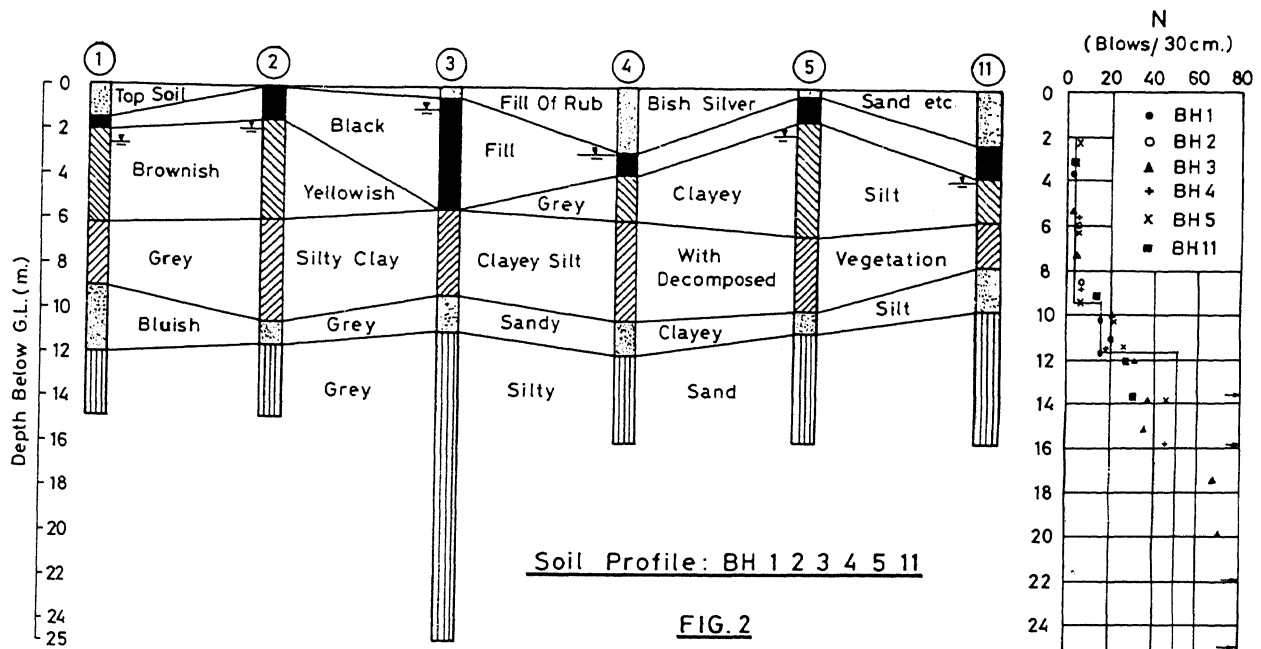
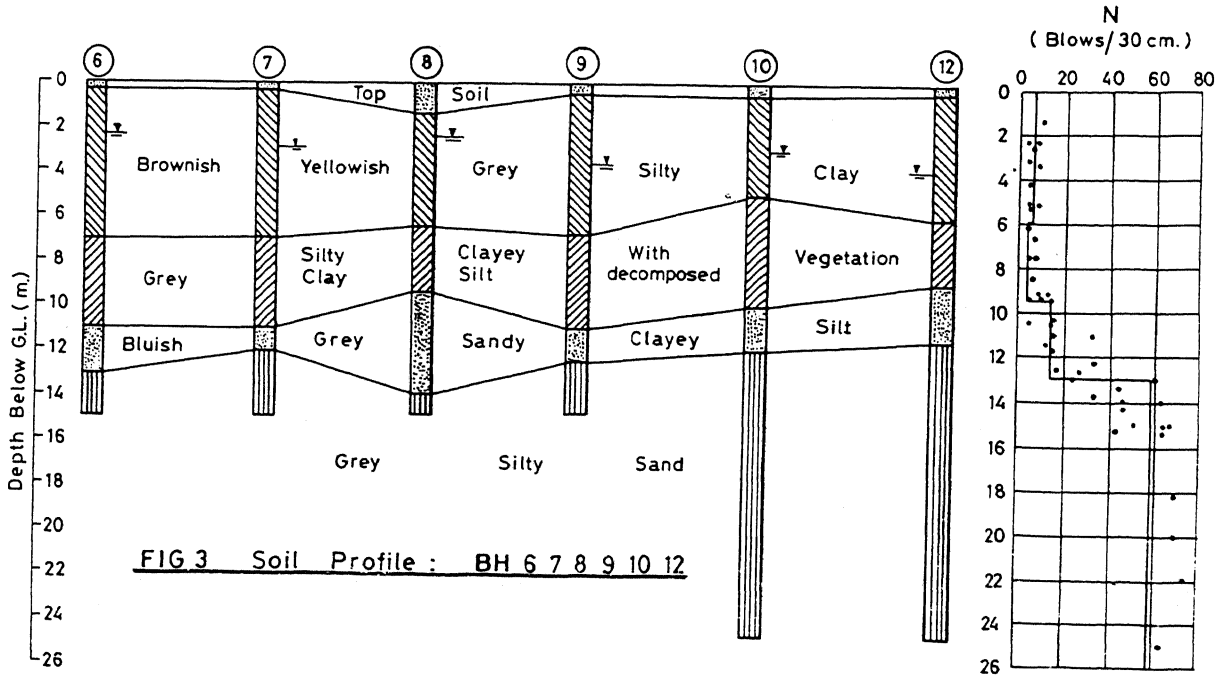
The soil profiles as revealed by the boreholes are shown in Figs. 2 and 3. Fig. 2 gives the soil profile in the area surrounding the collapsed building, while Fig. 3 gives the soil profile in the rest of the area. There appears to be some distinct difference in the soil profile in the vicinity of the collapsed building and in the rest of the area.

The subsoil in the collapsed building area, consisted of a heterogenous fill of brickbats, rubbish, fine sand and a black/dark grey peat-like substance with high organic content. This was followed by successive layers of silty clay/clayey silt overlying medium to dense sand approx. 12 m below ground surface. The depth of fill at various locations near the collapsed building is shown in Table II. The fill was maximum near Borehole 3 (5.5 m) and gradually decreased on all sides.

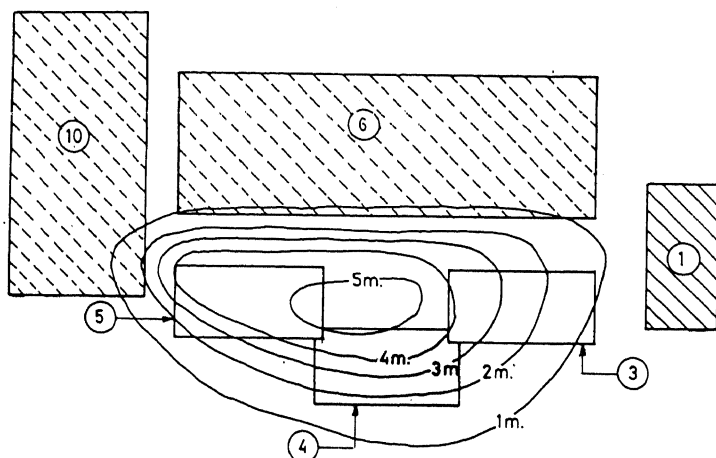
FIG.4 Contour Plan Of Bottom Of Filled Up Soil

An attempt has been made to draw an approximate contour plan of the bottom of the fill in the collapsed building area - based on the field observations. The plan, thus obtained, is shown in Fig. 4. Although some interpolation had to be made to draw the contour plan it gives a fair representation of the depth of fill at different locations. It is apparent that the fill extended over most of the area covered by the three buildings in the collapsed zone. The maximum depth of fill, 5.5 m, was, however, found just west of the collapsed building. The depth of fill varied from 5 m to 2 m from west to east under the collapsed building.

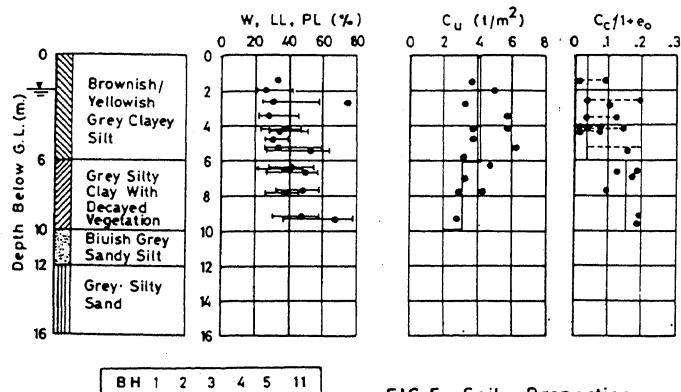
FIG.5 Soil Properties

Fig. 5 shows the soil properties in the collapsed building area as obtained from laboratory tests.

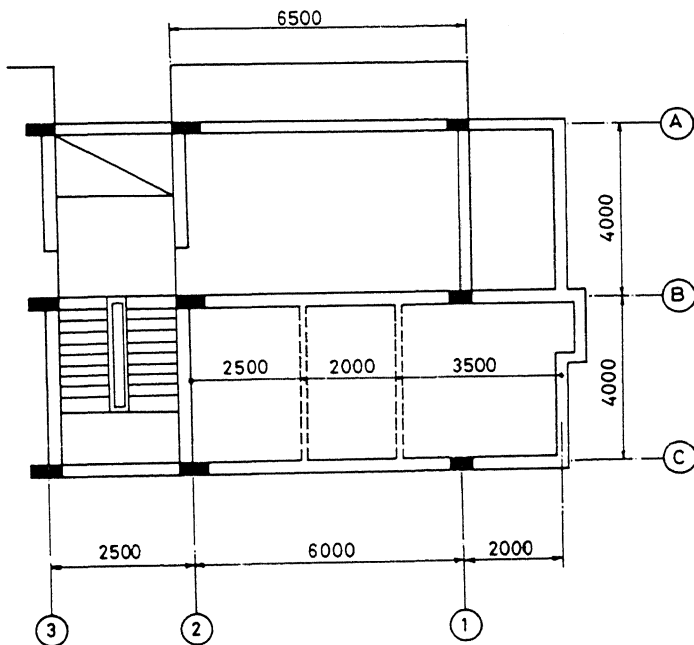
FIG. 6 Structural Plan: Building 4

The plan of the collapsed building is shown in Fig. 6. The building covered an area of 8 m x 18.5 m having symmetry about the staircase block. There

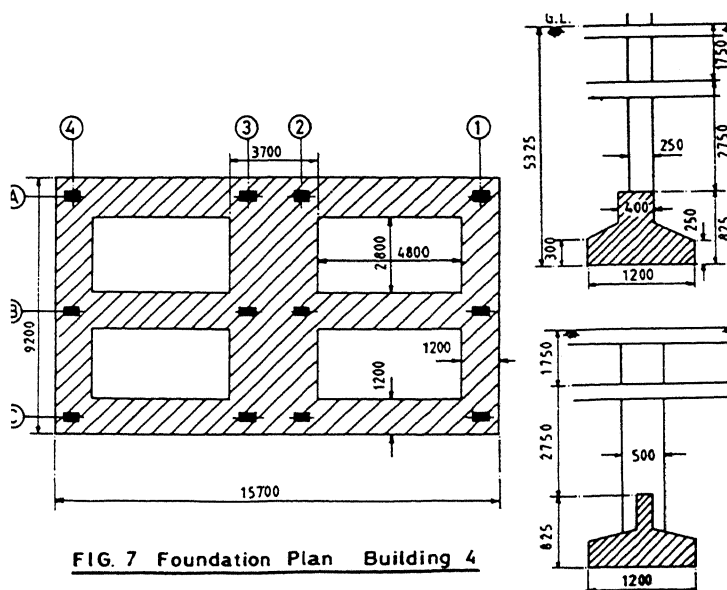
FIG. 7 Foundation Plan Building 4

were 12 columns in the building frame. The foundation details were obtained from excavation done at the site after the collapse, Fig. 7. The columns were supported on 1.2 m wide R.C.C. strips running east-west with interconnection in the N-S axis. The columns on either side of the staircase block were placed on a 6 m x 4 m grid (approx.) with a 2 m wide cantilever in the northern and southern faces. The vertical loads on the columns of the building frame as calculated from structural details are shown in Table IV.

It will be evident from the foundation details shown in Fig. 7, that - although the columns of the building frame were supported on two-way interconnected strips - the foundation as a whole would behave almost as a raft foundation placed 5.325 m below existing G.L. The equivalent raft covered a plan area of 9.2 m x 15.7 m with four

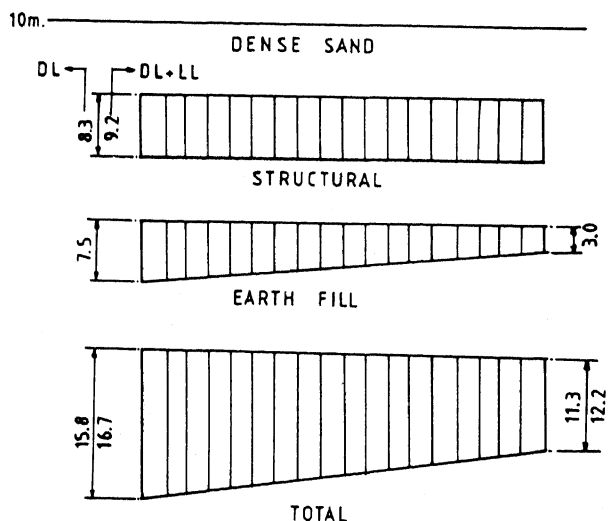
FIG. 8 Foundation Pressure Building 4 (t/m^2)

building area, Fig. 8. It would appear that the depth of the fill varied from 5 m on the western face to 2 m on the eastern face. The foundation raft was placed at 0.325 m below original G.L. at the western face of the building and excavation of varying depth - upto a maximum of 2 m at the eastern side - was made to build the foundation. The area was subsequently filled up with the factory waste to arrive at the finished ground level. With regard to the net foundation loading, therefore, a fill of varying depth - 5 m on the western side to 2 m on the eastern side - is to be considered on the foundation raft. This would give additional foundation pressure of 7.5 t/m² to 3 t/m² due to the overburden. The backfill upto the original ground profile was actually a replacement of the excavated soil and need not be considered as an additional load on the subsoil. The net foundation pressure below the raft may thus be obtained by considering the superstructure load and the backfill load separately. The data are shown diagrammatically in Fig. 8.

excavation was made across the building (E-W) from the then existing ground profile to locate the foundation at a depth of 5.325 m and the area was subsequently filled up. This resulted in differential filling on the foundation raft giving a non-uniform pressure of 16 t/m^2 on the western side and 11 t/m^2 on the eastern side of the foundation. The effect of differential filling was, perhaps, not taken into consideration in the foundation design.
