Geotechnical Problems and Treatments of Weathered Rock Seams Occurring in the Foundation of Karjan Dam, Western India

GEOTECHNICAL PROBLEMS AND TREATMENT OF WEATHERED ROCK SEAMS OCCURRING IN THE FOUNDATION OF KARJAN DAM, WESTERN INDIA

Paper No. 2.07

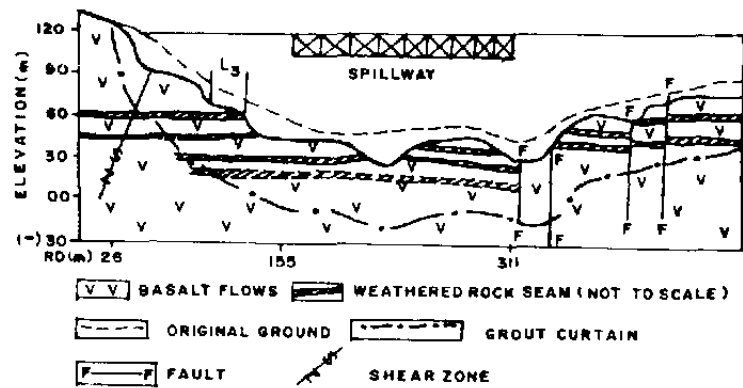
Fig. 2 Longitudinal geological section of part of the dam showing disposition of weathered rock seams.

A characteristic feature in this area is the presence of weathered rock seams at 4 to 10m intervals, developed along interfaces of flows and sub-horizontal joints (Fig. 2).

The weathered rock seams consist of a zone of highly to completely weathered basalt varying in thickness from 1cm to 2m, developed along flow contacts and also along sub-horizontal open joints due to percolation of seepage water. The presence of slickensided surface and gougey material, and displacement of the vertical shear zones along seams clearly indicated shearing and lateral movement resulting in the formation of potential weak planes for sliding.

In-situ shear tests conducted on the seams indicated the value of angle of internal friction " ϕ " = 22° to 26° and the value of cohesion "C" = 0.

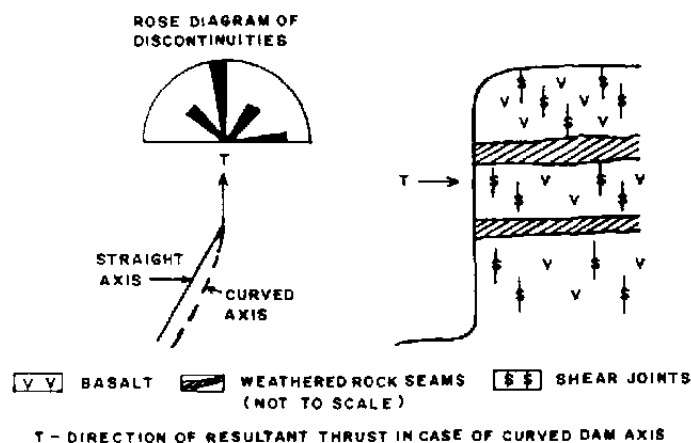
Fig. 3 Critical geological abutment conditions.

Curvature in the alignment of the dam. A mild upstream curvature in the alignment of the dam was initially considered for mobilising greater resistance against sliding. On the basis of geological analyses abutment rocks were not found suitable for arch action as they are dissected by steeply dipping shears, joints and faults aligned almost parallel to the probable direction of thrust in case of curved axis. These abutment rocks are also traversed by sub-horizontal weathered rock seams (Fig. 3).

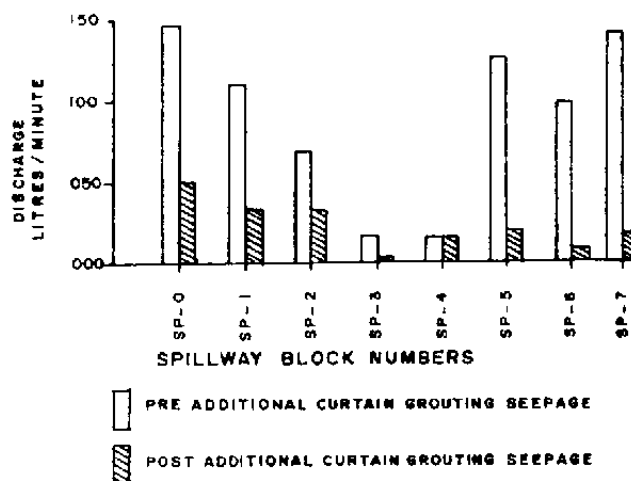
Fig. 5 Pre- and post-additional curtain grouting seepage observed through foundation drainage holes in spillway blocks.

Conspicuous seepage was observed through weathered rock seams during the excavation of shafts and drifts in the foundations of spillway blocks (Mehta and Prakash, 1990). Nearly all the drill holes during pre-construction stage investigations recorded high permeability (upto 75 Lugeons). To reduce the permeability of rock foundation initial curtain grouting was done in four stages with 5, 10, 15 and 20 kg/cm² pressures, gradually increasing with depth when the reservoir level was at minimum. Depth of curtain grouting in spillway section varies from 42 to 60m. It was observed in five spillway blocks that post grouting seepage was more than 100 litres/minute. It clearly indicated ineffectiveness of initial curtain grouting. Therefore, to reduce the seepage additional curtain grouting was done with uniform high pressure of 20 kg/cm², after filling of the reservoir upto El.78m, to seal remaining gaps/permeable windows in the grout curtain. Seepage has reduced in general by about 70 to 90% after providing additional curtain grouting (Fig. 5).

Conspicuous seepage was observed through weathered rock seams during excavation of the foundation and even after initial curtain grouting as such type of features are pathways for ground water movement. Therefore, additional curtain grouting with uniform high pressure has been done to effectively grout the seams and to seal remaining permeable windows in the grout curtain. Now, seepage has reduced appreciably.
