International Conference on Case Histories in Geotechnical Engineering (1984) - First International Conference on Case Histories in Geotechnical Engineering

## Slip Failure of Embankment on Soft Marine Clay

K. Y. Yong  
*National University of Singapore, Singapore*

S. T. Ting  
*Soil Investigation (Pte) Ltd, Singapore*

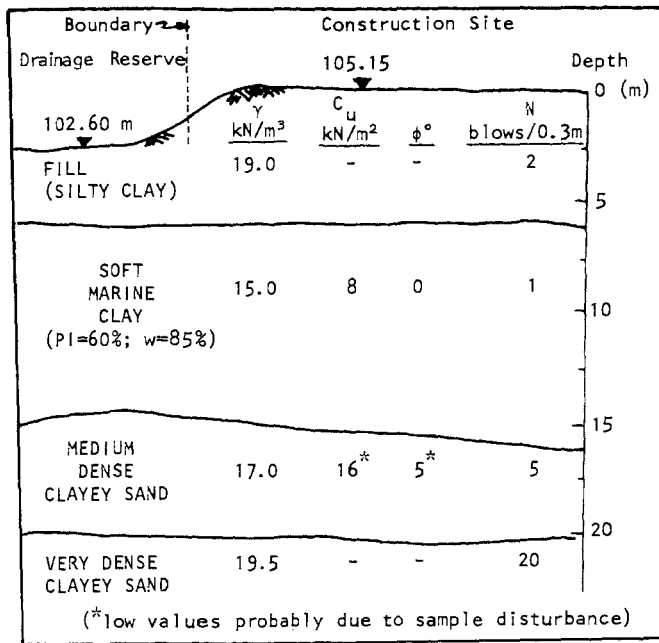
Fig. 2. Typical Soil Profile

Based on earlier site investigation, a typical section of the soil profile at the site is shown in Fig. 2. The subsoil consists generally of a top layer of fill deposits of medium stiff silty clay. Below this top layer is soft marine clay overlying medium dense to very dense clayey sand. Ground water-table observed from the boreholes was about 1.5 m to 2.5 m below the existing ground level at the site.

From the soil information, it appears that the vehicle depot development is founded on soft ground where the thickness of soft clay is typically about 10 m. The shear strength of this layer is so low that large settlement and low stability can be expected.

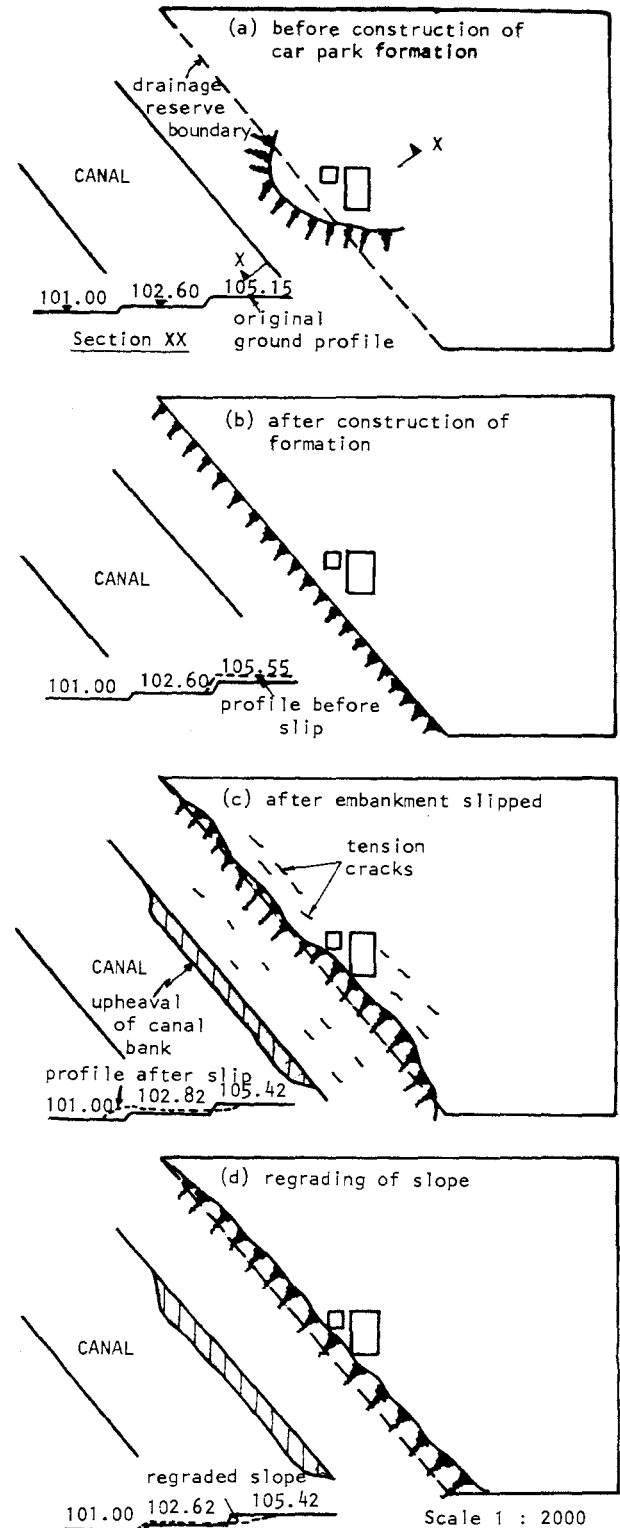
Fig. 3. Sequence in Slip Failure of Embankment

The plan and typical sections of the site at various stages of events, before construction of the car park formation to the removal of collapsed earth and regrading of slope, are illustrated in sequence in Fig. 3. Ground levels for various stages were measured by surveying techniques.

To construct the parking area for vehicles, additional placement of fill was required for the whole site. It can be seen from Fig. 3(a) and (b) that an additional layer of fill of about 0.3 to 0.5 m was placed at the site. In addition, fill of about 2.85 m high was placed at the boundary of the site and drainage reserve, extending about 2 m from the toe of the original slope. Unfortunately, there was no available records to indicate the actual quantity and the rate of placement of fill except the fact that the fill placement and compaction began about two weeks prior to the day of failure.

Eye-witnesses at the site indicated that tension cracks were observed on the fill on the morning of the day in which failure occurred. Moments after this observation, the pipeline burst resulting in water overflowing into the fill at the drainage reserve. This was followed subsequently by the slip failure and upheaval of the banks of the canal as shown in Fig. 3(c). Failure encompassed a length of about 100 m along the canal and extended across the drainage reserve to about 15 m into the construction site. The eye-witnesses further noted that failure took place suddenly with out any perceptible vibration. At the end of failure, settlement of the fill at the

boundary had reached over a metre, while the floor of the canal heaved close to a metre. The bin centre and vehicle washing shed, which are supported by tanalised timber piles showed no structural damage apart from some minor cracks in the floor slabs. The rest of the buildings, which are supported on precast concrete piles, appeared to be unaffected by the slip failure.

To prevent further movement of the slip and additional damage to the canal, construction activities ceased in the vicinity of the drainage reserve boundary and the collapsed soil was removed by the site contractor. The removal of the collapsed soil and the regrading of the slope shown in Fig. 3(d) was completed in five days. Although no records were available on the amount of earth removed, the site contractor estimated that about 480-lorry loads were involved.

The use of counter-berm to stabilise the movement was not possible because of its proximity to the canal. As an expedient measure, the slope was regraded gently to 1:8

as shown in Fig. 3(d) and excess soil removed to relieve some of the stresses on soft marine clay. Inclinometers were recommended to be installed at the drainage re: to monitor any ground movements during regrading and the subsequent repair of canal.

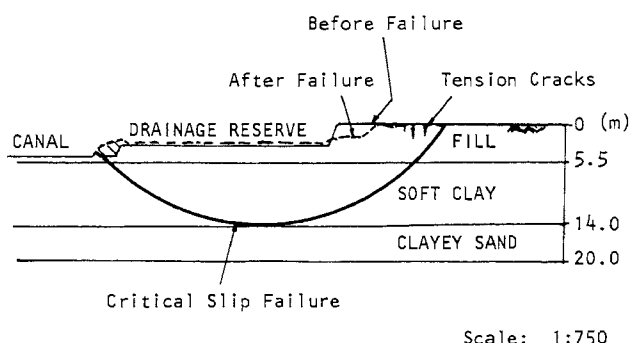
Fig. 4. Results of Slope Stability Analyses

Stability analysis have been carried out considering critical circles using total stress analysis. The approach to stability analyses are by the method of slices and the design charts given in Navfac DM-7 (1982). Results of the analyses are summarised in Fig. 4. The standard slip circle analysis, using undrained shear strength calculated from results of triaxial test and vane tests, is adequate for the prevailing site conditions. In the analyses, the following conditions and assumptions were made:

It can be seen from the results that the critical slip failure passes through the soft clay stratum giving factors of safety ranging from 0.91 to 1.21. This circle is in good agreement with the exterior signs of failure.

Method of Analysis	Shear Strength (kN/m <sup>2</sup> )	Factor of Safety
Method of slices	8 (Undrained Triaxial)	0.91
Method of slices	10 (Vane Shear Test)	1.21
Navfac DM-7 (1971)	8 (Undrained Triaxial)	1.02
