Case Histories of Foundations on Top of a Rupturing Normal Fault During the Kocaeli 1999 Earthquake

G. Gazetas

I. Anastasopoulos

CASE HISTORIES OF FOUNDATIONS ON TOP OF A RUPTURING NORMAL FAULT DURING THE KOCAELI 1999 EARTHQUAKE

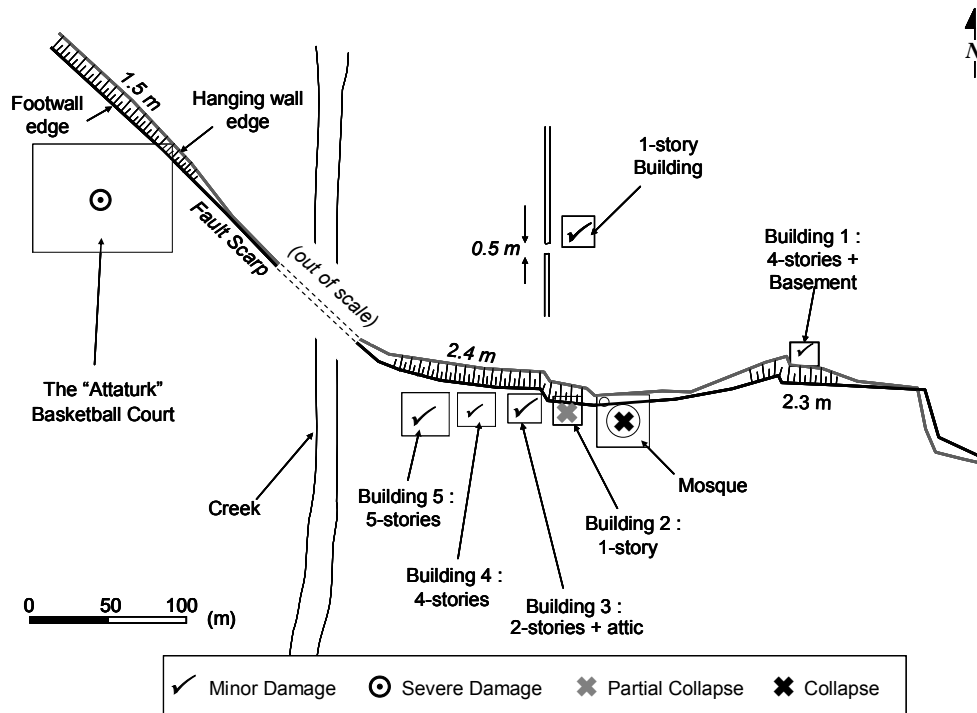
Figure 1 illustrates a plan sketch of the investigated area along with the surface trace of the dislocation. As depicted in the figure, the rupture emerged at the surface creating fault scarps of up to 2.4 m. In contrast, in some cases the dislocation could not be easily identified seeming to disappear, converted to widespread differential settlement of the ground surface rather than a distinct scarp. From east to west, a first impressive (even though perhaps merely fortuitous) success was that of a high-voltage electricity pylon : crossed by the fault rupture, the pylon did not collapse, sustaining only minor damage despite the “loss” of two of its four supports.

Figure 1. Plan sketch of Denizevler (east of Gölcük). The fault trace crossed a number of buildings, a mosque, and a basketball court. The extent of damage ranged from minor to full collapse. Values indicate the vertical component of the fault offset at the ground surface.

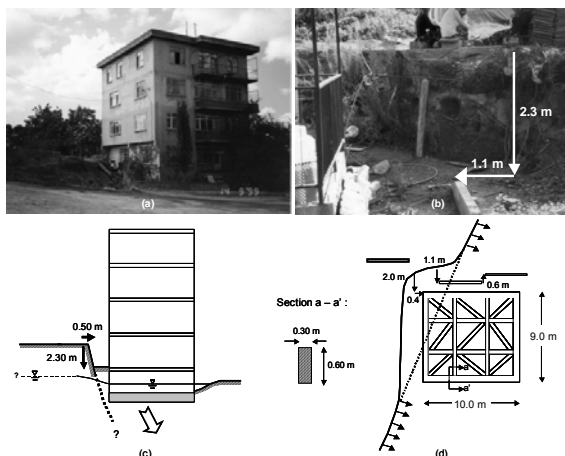
Figure 2. Building 1, four stories plus basement : Minor Damage

As depicted in **Figure 2** the surface rupture diverted and just avoided the 4-story reinforced-concrete structure, leaving it totally un-harmed. The downward settlement reached 2.3 m, accompanied by a strike component of 1.1 m. The only apparent damage was the flooding of the basement, due to the local modification of the water table. The owners were inside the house during the earthquake and felt no vertical falling. Evidently, the vertical displacement was of a quasi-static nature. The foundation of the 9 x 10 m building consists of strip footings ~0.6 x ~0.3 m (height x width) transversely connected through tie beams of similar dimensions.

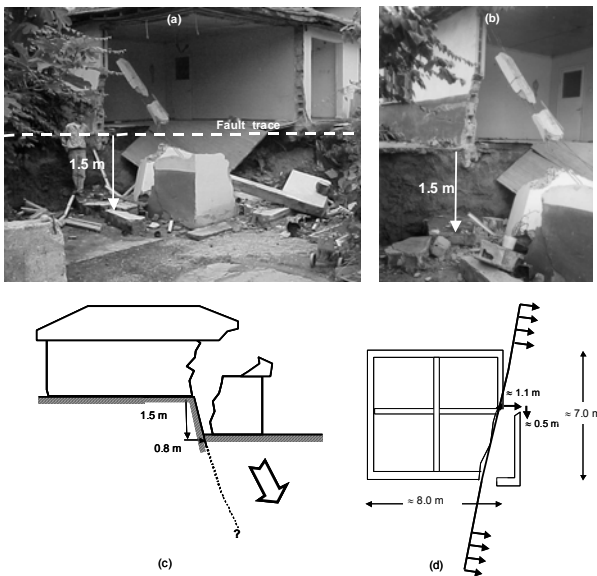
Building 2 was a simple 1-story structure. Its wooden tile-roof was supported on cinder block walls. The walls were practically founded directly on the soil, without any foundation. This poor building could not have been expected to perform well subjected to a differential displacement of 1.5 m, and indeed it was torn apart by the rupture (**Figure 3**). However, it did not collapse completely, not causing fatalities. The rupture crossed its north-east corner tearing it apart from the rest.

Figure 3. Building 2, one story cinder-block structure : Collapse

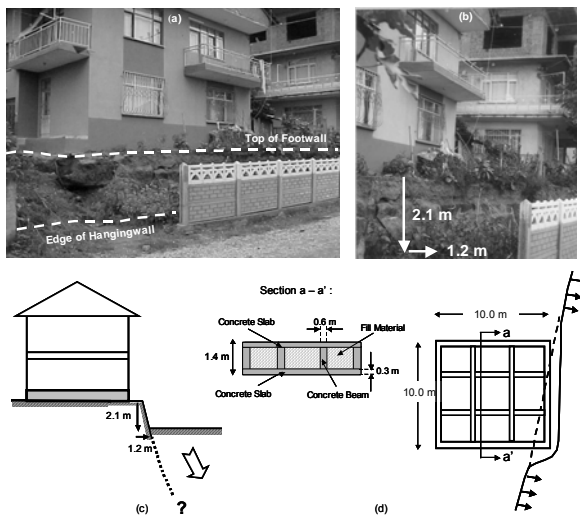
Building 3 managed to survive without any visible damage. Most importantly, the rupture was diverted, as in the case of Bldg. 1, but since Bldg. 3 is founded on the footwall, the rupture was diverted to the North, towards the hanging-wall (**Figure 4**). The vertical

displacement was 2.1 m. The 2-story (+attic) reinforced concrete building is founded on a rigid box-type foundation, comprising stiff concrete beams, ~0.5 m x ~0.8 m (width x height) sandwiched between a mat and a top slab, both ~0.3 m thick. The thickness of the whole box reaches 1.4 m, and the voids are filled with soil. It appears that this box foundation is quite common in the provincial regions of Turkey with poor soils. In Adapazari, where most of the failures were of the bearing capacity type, although many buildings toppled, foundation and superstructure remained un-harmed, confirming the ability of such foundations to safeguard vulnerable superstructures.

Figure 4. Building 3, two stories plus attic : No Damage

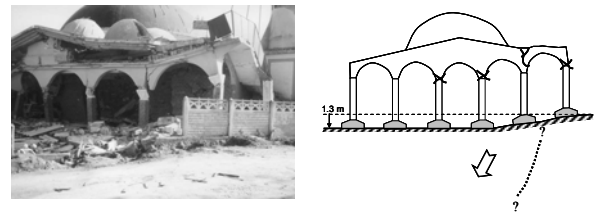
As shown in **Figure 5**, in the area of the Mosque (less than 150 m west of Building 1) the rupture did not create a visible fault scarp. On the contrary, the dislocation appeared at the surface as a widespread differential settlement, not easily observable. Despite this seemingly “favorable” situation, the Mosque partially collapsed, and was fully demolished later. The

superstructure of the mosque was also of reinforced concrete, but its foundation comprised several isolated footings, apparently without any connection between them. No shear walls or stiff tie beams existed between the columns. In conjunction with its rather “heavy” arched roof, its structural system was less stiff than that of Building 1. Its foundation is, obviously, discontinuous and thus quite flexible. Hence, the differential settlements were transmitted to the superstructure practically unaltered. We have to exclude the intensity of ground shaking from being a principal cause of the collapse, since the observed damage and cracking did not indicate horizontal shear failure. The minaret of the mosque confirms this hypothesis: in most of the regions where ground shaking was the main cause of damage, the minarets of the Mosques were quite susceptible to collapse. In this case, the minaret did not collapse.

Figure 5. Mosque : Collapse

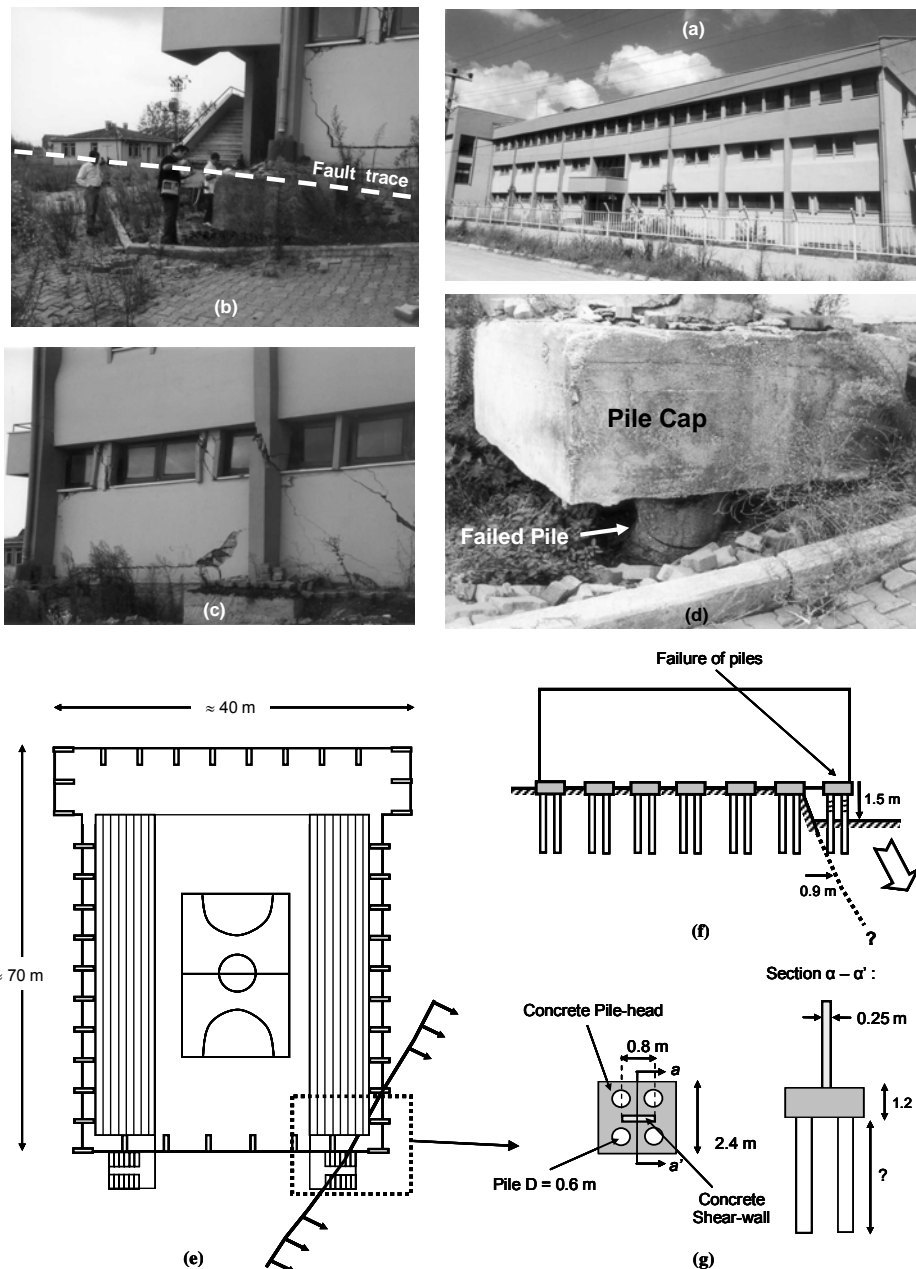
This Basketball Court, had just been constructed when the 1999 earthquake struck. As shown in **Figure 6a** the rupture crossed its northeastern corner causing significant local damage to its reinforced concrete superstructure. **Figure 6b** shows the southern part of the building, which sustained practically no damage. Again, the damage can be attributed solely to differential tectonic displacement and not strong seismic shaking. **Figure 6c** depicts the extent of damage suffered by the northeastern part of the building, near the corner struck by the dislocation. Several of its concrete shear walls failed, while its non-bearing brick walls were diagonally cracked, indicating tensile failure at 45° due to differential settlement. **Figure 6d** depicts the damage to the piled foundation. The pile at the photo had been pulled downward and outward, and tensile cracking was easily observable. Its adjacent pile (not seen in the photo) had failed in tension completely, and was totally detached from the pile cap.

Figure 6. Basketball Court : Severe Local Damage

The plan view of the Basketball Court is sketched in **Figure 6e**. Its structural system comprised shear-wall type columns 0.25 m x 0.80 m in plan, positioned along the perimeter. As depicted in **Figure 6f**, each column is founded through a 2 x 2 pile group. The piles are 0.6 m in diameter, connected together through a 2.4 m-square pile cap, 1.2 m in thickness. Although the building survived the induced differential displacement, the extent of damage was quite significant; the structure was deemed as “beyond the limit of repair”. It can be argued that this constitutes a case where the piled foundation possibly contributed to the damage, by forcing the superstructure to follow the imposed displacement. In fact, if the piles had not failed (in tension), the situation might have been even worse!

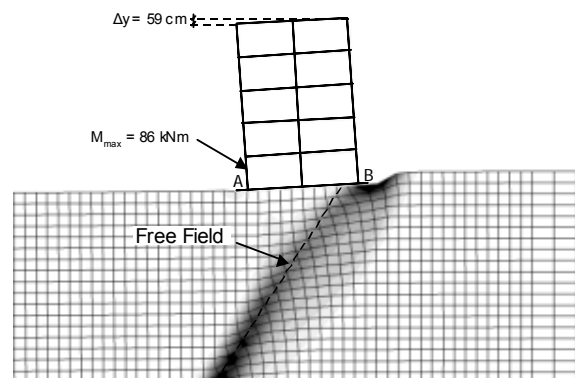
As clearly seen in **Figure 8**, the rupture path is diverted away from the building (towards the footwall), as it approaches the ground surface (topmost 10 m of the propagation path). As it deviates to the right of the building, the plastic strain does not remain as concentrated as along the free-field rupture path, but is diffused over a wider area. The building tilts towards the hanging wall and the differential settlement reaches 59 cm. Despite this significant differential settlement the maximum bending moment M_{max} in the superstructure does not exceed 86 kNm.

Figure 8. FE analysis of Building 1 : Deformed mesh and plastic strain

The rigid foundation not only diverted the rupture, but also allowed the building to rotate essentially as a rigid body, without stressing its superstructure. Although the differential settlement is significant (6 % is much higher than the usually accepted maximum of 1/300), the analysis does not indicate significant distress of the building’s superstructure. This agrees fairly well with the observed performance: the building sustained no structural damage. However, in reality, the tilting of the building was not as large as the predicted. We identify two possible explanations: (i) post-seismic consolidation near-the-edge of the building due to the increased contact stresses under that part, (ii) the rupture did not cross the structure perpendicularly as assumed in our analysis: it intersected

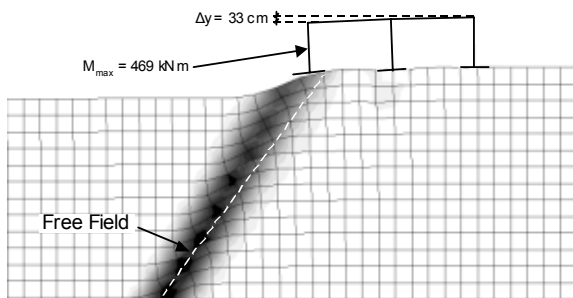
The model is only an approximation of the actual cinder-wall superstructure. The rupture is only locally diverted towards the hanging wall to avoid the far-left “footing” of the building (**Figure 9**). The dislocation follows the same propagation path as in the free field, with the exception of the top 4 m. The building tilts towards the hanging wall, with the differential settlement reaching 33 cm. Part of the edge footing loses its support from the ground. Despite the smaller differential settlement, M_{max} reaches 469 kNm. Evidently, such a distress could not be accommodated by the cinder walls of this structure. Again, FR-SFSI does not affect either the path of dislocation, or the deformations along the surface. We can safely argue that the analysis agrees quite well with the observed performance, despite the crude modeling of the superstructure.

Figure 9. FE analysis of Building 2 : Deformed mesh and plastic strain

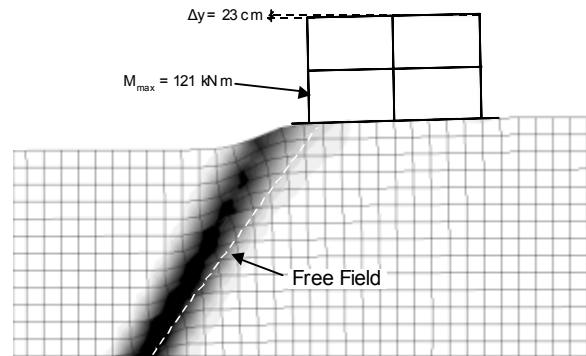
Until the rupture reaches a depth of about 12 m it follows the same propagation path as in the free field (**Figure 10**). Then it is diverted to the left of the building, towards the hanging wall. The plastic strain seems to be quite localized and a distinct fault scarp is predicted numerically. The building tilts slightly towards the hanging wall and the differential settlement does not exceed 23 cm. Despite the considerable differential settlement the maximum M_{max} only reaches 121 kNm. Again, as in the case of Bldg. 1, the rigid box-type foundation not only succeeds in diverting the dislocation, but it also “converts” the differential displacement to a rigid body rotation. Although the differential settlement is an appreciable 2 %, no sign of distress is predicted for the building. One must realize that despite the commonly accepted 1/300 rule of desired maximum tilting, a 2% tilting is not easily observable and as seen in the article of Charles & Skinner (2004) would not cause any structural distress in buildings on stiff rafts. Of interest are some additional examples from the Kocaeli (Turkey) earthquake. For instance, there were many buildings in Adapazari with post-seismic tilting of about 3° (tilting ≈ 5%), or more, that exhibited absolutely no structural damage. This is always the case when the

foundation is rigid enough to keep the differential settlement only in the form of rigid-body rotation. As a conclusion, our FR-SFSI analysis agrees well (at least qualitatively) with the observed performance of Building 3.

Figure 10. FE analysis of Building 3 : Deformed mesh and plastic strain

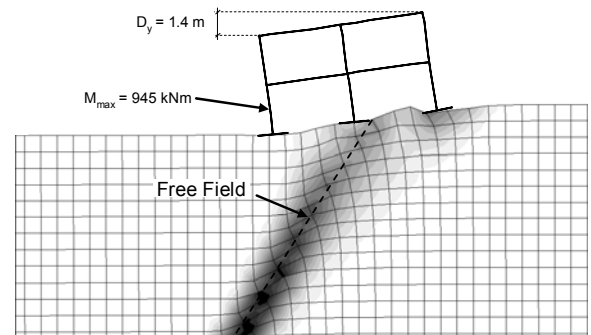
Our analysis results for the Mosque are presented in **Figure 11**. Admittedly, this is not a faithful representation of the structure, but one that roughly captures the stiffness characteristics of the superstructure and its foundation. The deformed mesh reveals that the rupture follows its original (free-field) path, almost unaltered by the presence of the structure. In contrast to Building 1, where a fault scarp can be clearly identified to the right of the structure, one can now see most of the deformation taking place between the isolated footings of the Mosque, with a diffuse failure zone.

Figure 11. FE analysis of the Mosque : Deformed mesh and plastic strain

The footings only barely divert the rupture from emerging directly beneath them, but not beyond the limits of the structure. The Mosque is tilting towards the hanging wall with the differential settlement D_y reaching 1.4 m. Unlike the previous case, D_y is not “absorbed” by the rigidity of the foundation. The Mosque not only rotates as a rigid body, but is also substantially distressed (tilting with significant distortion). The maximum bending moment M_{max} in its structural elements reaches 945 kNm. Such stressing would certainly cause collapse, given the dimensions and reinforcement of its structural members. The vertical displacement Δy , the distortion β , and the hori-

zontal strain ε_x , all clearly indicate that very little interaction takes place between the rupturing plane and the structure. In other words, FR-SFSI is hardly affecting the emergence of the rupture on the ground surface. Compared to the free field, the maximum distortion β remains almost unaltered, and occurs at about the same location. The horizontal tensile strain is spread over a wider area, but its peak is almost half of the free-field. In conclusion, the FR-SFSI analysis agrees quite well with the actual performance of the Mosque.

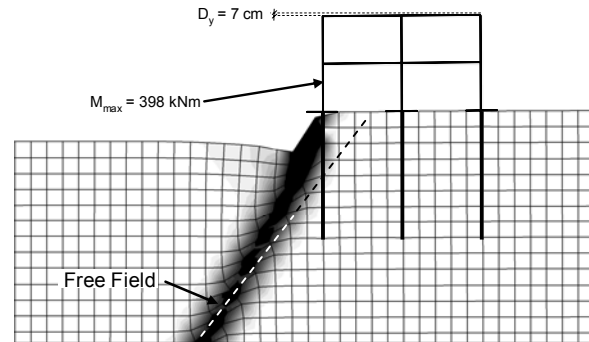
Our FR-SFSI analysis results for a small part of the Basketball Court are summarized in **Figure 12**. Note that the dislocation follows its free-field propagation path up to the vicinity of the corner pile, at a depth of about 10 m. It is then strongly diverted towards the hanging wall (to the left of the building). Plastic strain is localized in a very narrow band and a distinct fault scarp develops right next to the pile. The building tilts slightly towards the hanging wall with the differential settlement D_y not exceeding 7 cm, while at the same time the left pile cap loses contact with the ground — in accord with our field observations. Surprisingly, despite the relatively minor D_y , the distress of the superstructure is quite substantial: M_{max} reaches almost 400 kNm. Although the piles divert the dislocation, some differential settlement and, especially, differential extension takes place between the columns of the structure. This small but non-negligible deformation is imposed on the superstructure by the piles. The latter are being pulled down and out (even if slightly) by the downward moving hanging wall, thereby forcing the superstructure to follow. In contrast to the *continuous and rigid* box foundation of Buildings 1 and 3, the *discontinuous* piled foundation does not allow the superstructure to rotate as a rigid body without being distorted.

In conclusion, our analysis predicts significant distress at the corner of the Basketball Court, agreeing well with its actual performance. However, the limitations of our model for the piled foundation must be clearly spelled out. The plane strain assumption implies that our “piles” are in (the computational) reality continuous “walls” (diaphragm type). Such walls are subjected to higher normal actions (per unit length) from the downward and outward moving soil than individual piles. This is because : (i) soil can “flow” around the piles, but not around the plane “wall” ; (ii) the frictional capacity of the pile-soil interface is not unlimited, as implicitly assumed in our “bonded” model, thus making the downward “flow” of the soil even easier ; and (iii) in reality the corner piles failed in tension, thus reducing their pull-down of the superstructure (allowing it not to follow ground deformation completely). Nevertheless, in a qualitative sense the results of our (admittedly imperfect) analysis reveal the trends that were observed in the field.

Figure 12. FE analysis of the Basketball Court : Deformed mesh and plastic strain
