## Ground Heave Due to Jet Grouting Near an Existing Structure

## GROUND HEAVE DUE TO JET GROUTING NEAR AN EXISTING STRUCTURE

Renovations of the MBTA Copley Station in Boston included construction of a new elevator shaft to improve disabled access to the existing Green Line station. The site is immediately adjacent to the Eastern façade of the historic Old South Church. The construction work required excavation support including a perimeter secant pile wall and a jet-grouted base plug. Significant ground and structural movements were observed during jet grouting, mainly associated with soil displacements during grout injection. A three dimensional numerical model was developed, using the Plaxis 3D Foundation™ program, in order to test the hypothesis that the observed movements of the structure could be associated with the installation of the jet grout piles. The amount of volume expansion associated with installation of jet grout piles is estimated based by calibrating the model to measured ground movements. The finite element model results give a consistent explanation for the observed pattern of movements, including the heave of the church wall and lateral displacements at incl

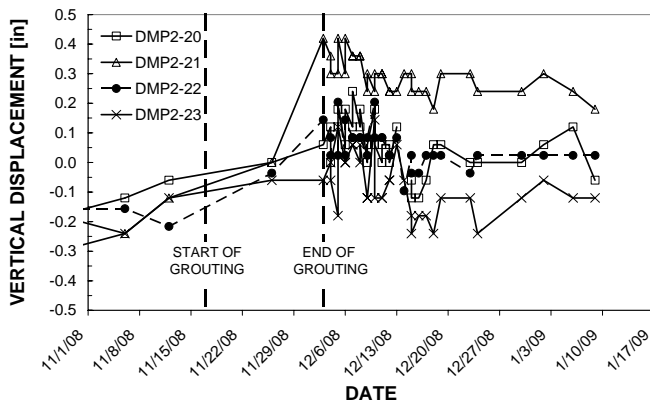
Fig. 2. Observed displacements at East Wall

Work on the project was suspended in December 2008 due to observations of damage to the East façade of the Old South Church including the widening and extension of cracks that extended up from the foundation level, through the stone walls above the main stained glass windows up to the roof level (and height of more than 60ft), causing significant damage to the interior plaster wall. Fig. 2 shows vertical displacements

measured at several displacement measuring points (DMP, Fig. 1). The ground and structural movements were attributed to jet grouting activities for the new elevator shaft that were on-going at the time. Subsequent investigations focused on possible mechanisms causing the movements including detailed inspections of the OSC foundations (involving load testing of several timber piles), an extensive geotechnical site investigation, and implementation of a sophisticated instrumentation program to monitor for any further ground or structural movements. After establishing that movements had stabilized, the below grade works resumed in November 2009 using a revised construction sequence. With careful planning and execution, the elevator shaft was completed in April 2010, with no further movement or damage to the Old South Church. This paper summarizes the development and validation of a 3-D model of the soil-structure interactions that was carried out to test the hypothesis that the observed movements of the OSC could be associated with the installation of the jet grout piles.

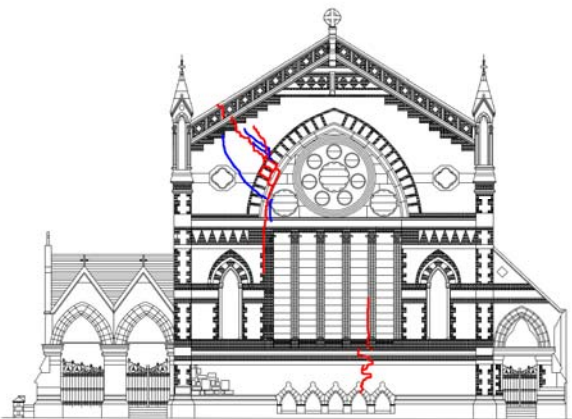
Fig. 4. East Wall – Observed cracks

Figure 4 shows an elevation of the East Wall of the Old South Church, together with the observed cracking pattern. The observed cracks start at the fourth bottom window from the South (left in Fig. 4), coincident with the location of a pre-existing crack, and continue towards the top of the wall, initially following an almost vertical path.

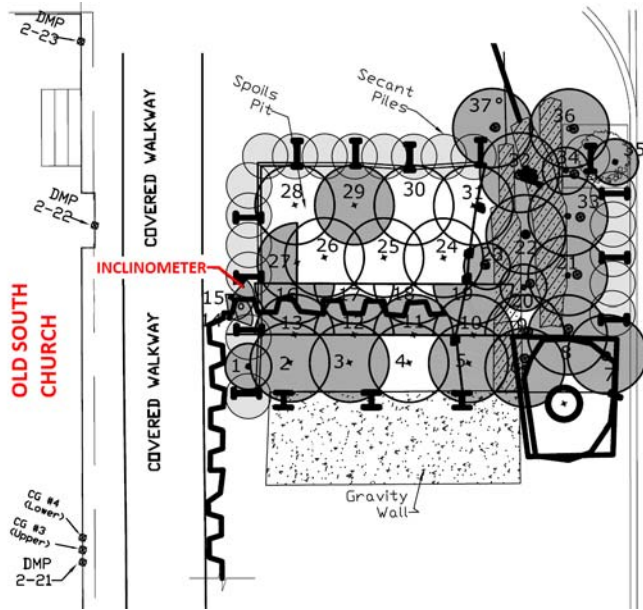
Fig. 8. Partially completed jet grout piles as of Dec. 3, 2008

A single inclinometer (located adjacent to jet grout pile #27, Fig. 8 with toe at El. +64ft in the upper BBC) was used to monitor ground movements during the initial construction phases for the elevator access shaft. Figure 11 compares the predicted and measured ground movements (direction A is orthogonal to the eastern walls of the access shaft and OSC) caused by access shaft construction at the time when damaged was observed (Dec. 3, 2008). The results show a maximum lateral deformation of 1.75 in towards the OSC (at El. +92ft).

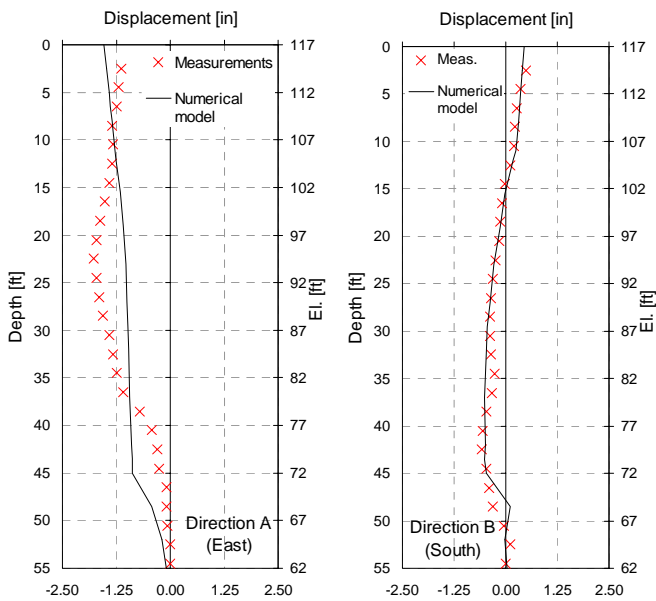
Fig. 11. Comparison of computed and measured lateral ground displacements due to elevator access shaft construction (measurements on 3-Dec-08)

The computed results are in reasonable agreement between with the measured ground deformations in the A axis (and in excellent agreement in the B-axis, parallel to the eastern façade), for a target volumetric strain of 15% in the jet grout piles.

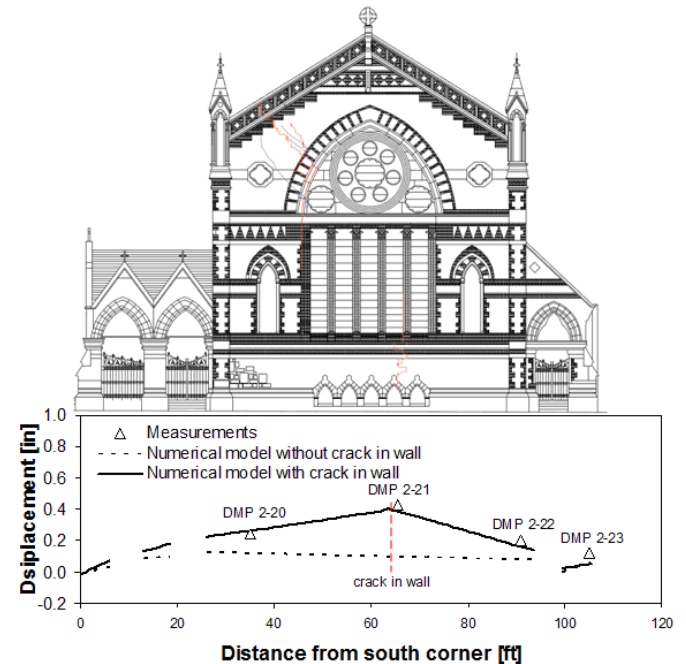
Fig. 12. Vertical displacements along East Wall predicted by numerical model

Figure 12 shows further comparisons of the computations with vertical displacements measured at a series of Displacement Measuring Points (DMP) along the Eastern Wall of the OSC in early December 2008. The figure shows results of two finite element models, one case assumes that the Eastern façade of the Old South Church is intact (no cracks) and the second assumes the full height vertical through-crack described above (Figs. 4 and 5). The results for the intact wall show relative uniform vertical deformations along the wall with a maximum heave on the order of 0.1 in. In contrast, the vertical through-crack model predicts much larger deformations (0.4 in) hinging at the assumed crack location. These results are in very good agreement with the magnitude and distribution of DMP measurements (with maximum 0.43 in). Hence, the FE model appears to confirm that volume strains associated with jet grout pile installation are the source of damage to the Old South Church.
