Construction of Hydel Power House in Weak Rocks

SYNOPSIS : Geological uncertainties have always played an important role in planning of a hydel power house. This paper presents case study of a power house which was subjected to major revisions in its planning due to inherent instabilities in rock slopes. Initially the power house was planned with service bay and other facilities on its left hand side, but the weak and instable slopes and sliding of large rock masses necessitated its thorough revision by bringing service bay and other facilities to its right hand side alongwith addition of many new features and flattening of slopes. There were many alternatives under consideration and final selection was based on techno-economic balance of the project.

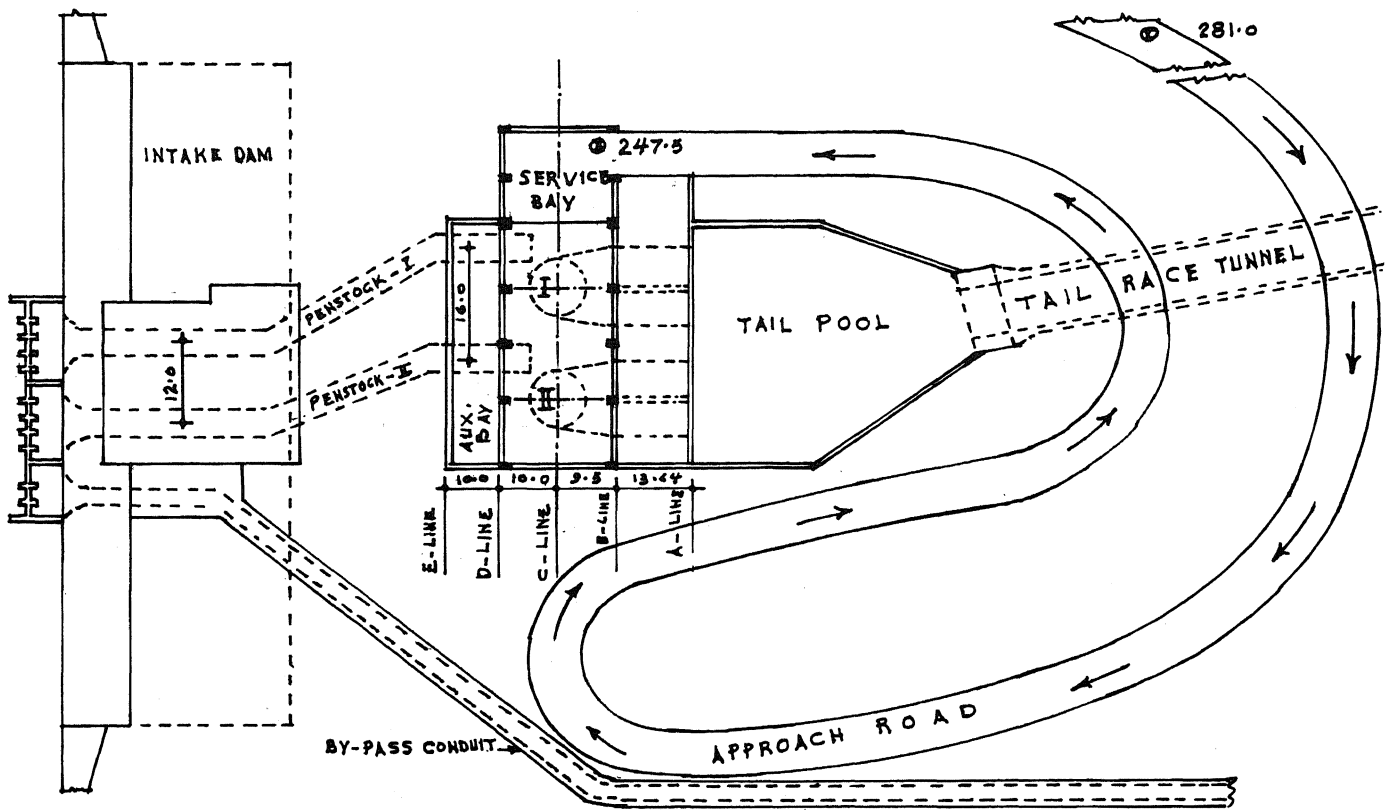
Fig. 1 Original layout plan of power house complex.

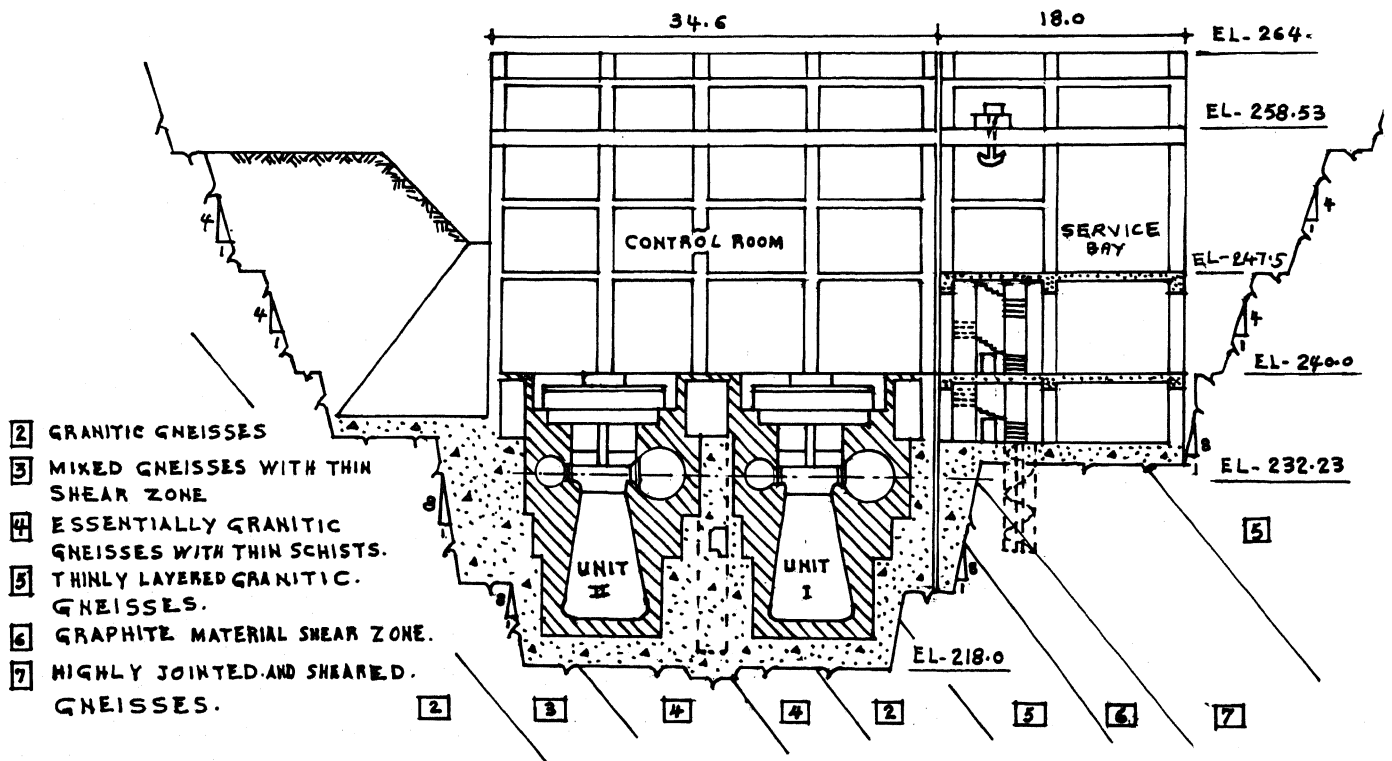
Fig. 2 Section of power house as per original plan.

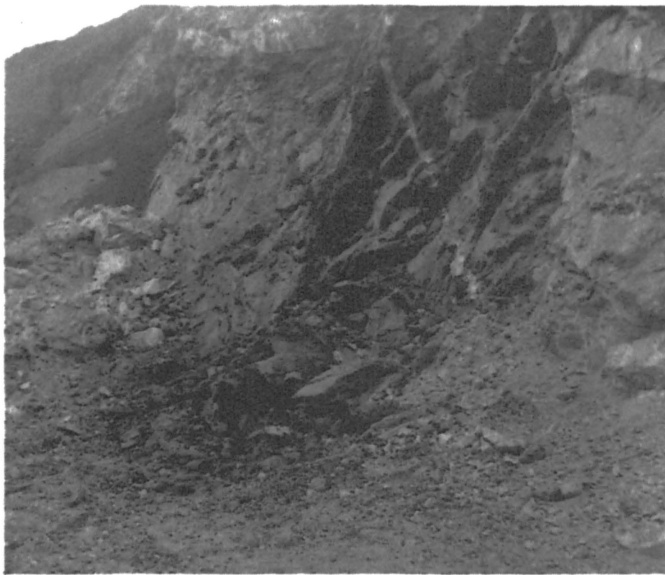
Finally in the month of May, 1980, when the pit had been excavated upto El-235.0m, the northern slopes failed and there was a major rock slide on the right hand side of pit between 'C' line and 'A' line.

Fig. 3 Photo showing rock slide

Excavation as per initial planning had been started but in May, 1980 there was a major rock slide and this failure of rock slopes raised many doubts about the future of this power house and its safety. Further, in this rock slide, a large portion of approach road collapsed indicating unsafe approach to the power house. Due to this mishap, an attempt was made to again examine the whole area geologically. It was revealed that country rocks are deeply weathered and decomposed upto a considerable depth. Rocks above El-250.0 m were found to be highly weathered and upto El-235.0 m slightly to moderately weathered. The fresh rock configuration was found to be highly irregular between El-225.0 m to El-240.0 m due to structural peculiarities which controlled the extent of weathering.

(a) First and foremost necessity was to stabilise the rock slopes. For this purpose several alternatives were available such as deep anchoring of slopes, grouting of rock masses, adequate flattening of pit slopes etc. It was opined that unstable and weak rocks of power house pit should not be taken care by short term measures such as anchoring or grouting etc. Only flattening of pit slopes was considered useful & effective. Accordingly pit slopes were reshaped in 1:1 gradient from top upto El-240.0 m and in 1/2:1 gradient below El-240.0 m. This reshaping of slopes was more essential for right hand side face. The left hand side slopes were comparatively more stable due to their favourable dip inside the rocks.

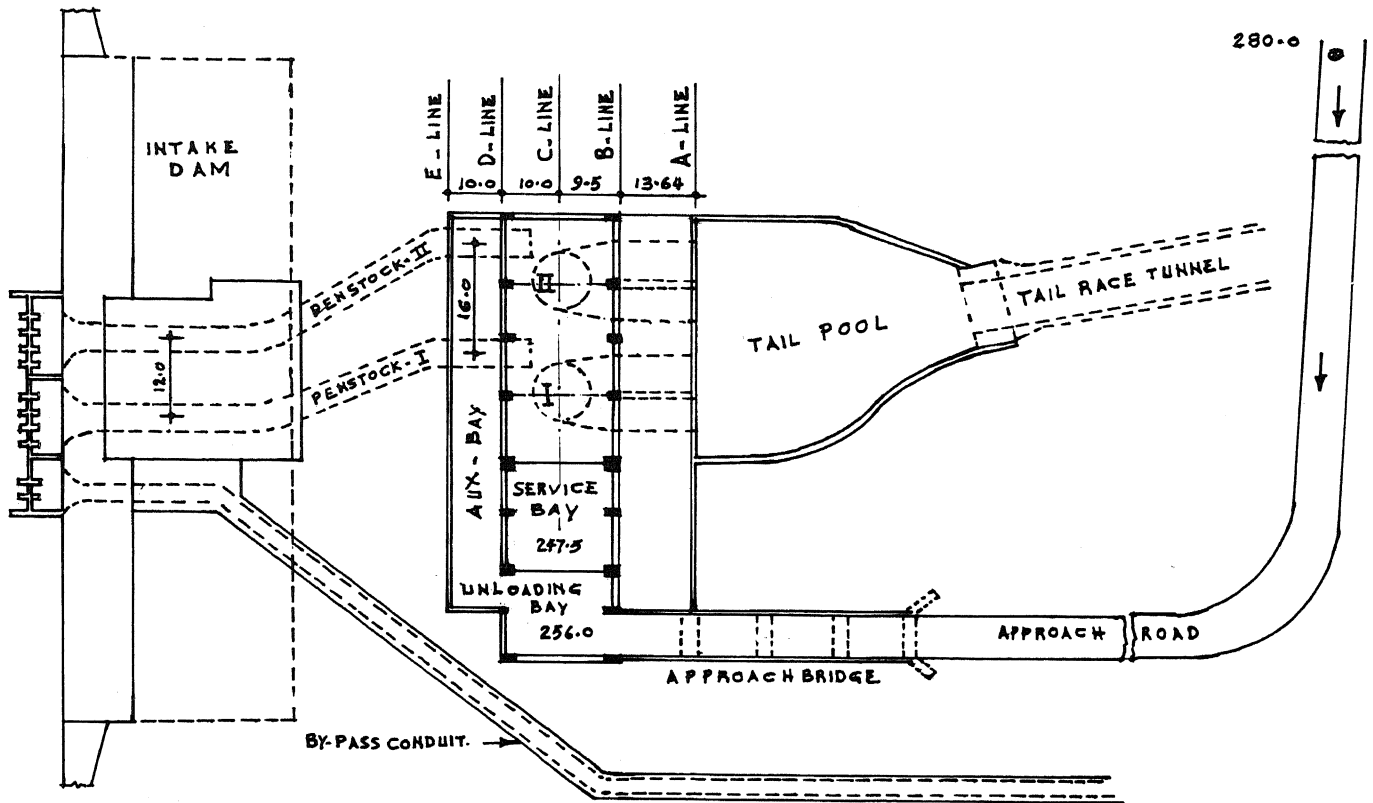
Fig. 5 Revised layout plan of power house complex.

Since direct access upto this level was practically not possible, idea of two level service bay was conceived and one additional floor 10 m wide at El-256.0 m was proposed to work as unloading bay. Service road from main highway was arranged upto this unloading bay at El-256.0 m by locating it along by-pass channel. Earlier only one E.O.T. crane was sufficient for this power house but now due to addition of unloading bay at higher level, it became necessary to provide one more E.O.T. crane to operate between unloading bay and service bay. The roof of the power house had also to be arranged in two levels.

(d) Approach portion of service road to unloading bay at El-256.0 m was earlier located on a gravity retaining wall curved in plan and having its foundation at El-240.0 m. The approach portion was to be provided on its back fill. But the geological advice restrained from adding so much load of gravity retaining wall and its back fill on the right hand side rocks. Then the idea of approach bridge with 4 spans of 8.8 m each was adopted and the service road was connected with unloading bay through this approach bridge. Foundations of this approach bridge piers were placed on El-240.0 m. Later on again on geological grounds the position of approach bridge was further shifted to right hand side by 5.0 m so that the rocks on which its foundations rested do not get daylighted in tail pool. This resulted in increase in the width of unloading bay by 5.0 m, thus making it total 15.0 m.

(e) Earlier provision was kept of counterfort retaining wall on the right hand side between 'B' line and 'D' line, but to expedite the construction work of service bay and unloading bay, it was replaced with mass concrete filling. Thus the right hand side slopes were supported with mass concrete filling for the main power house building portion.

(f) The shape of the tail pool was revised to semi circular mainly to minimise the rock cutting work in this area. This was done without affecting the total capacity of the tail pool.

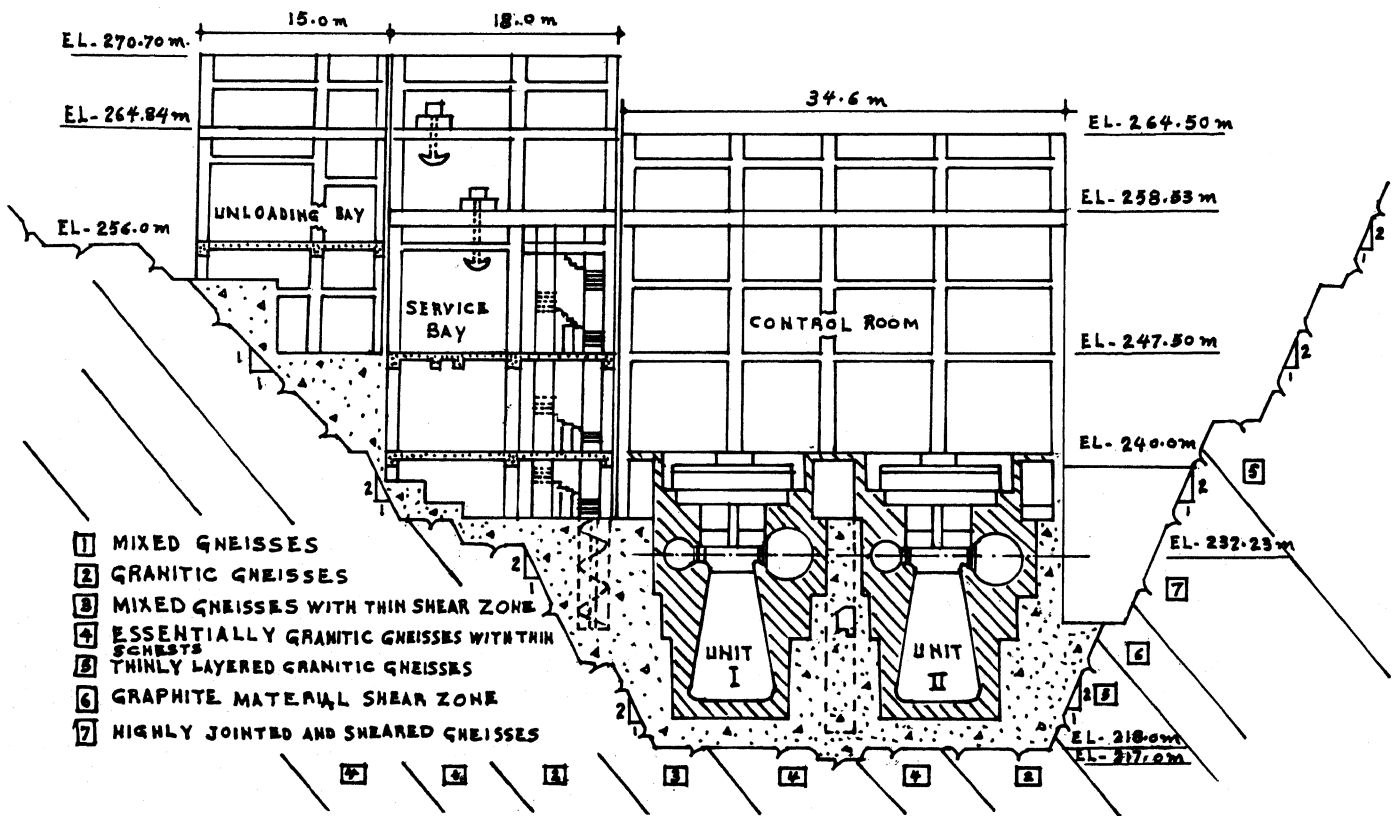
Fig. 6 Section of power house as per revised plan.
