Powerhouse Slope Behavior, Fort Peck Dam, Montana

J. V. Hamel

G. S. Spencer

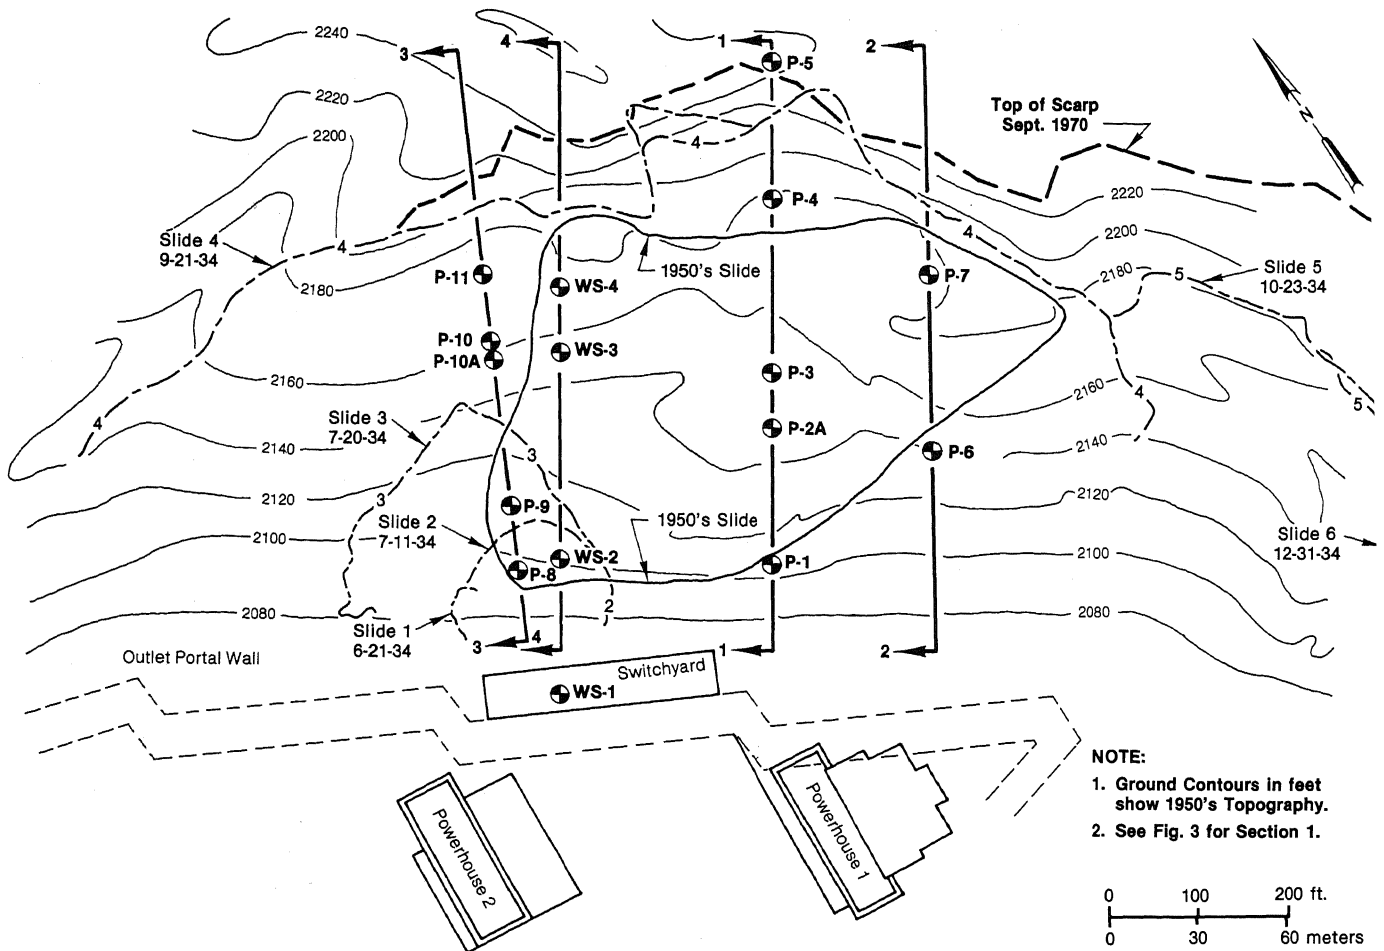
Figure 2 - Plan - Fort Peck Powerhouse Slope

The limit of the 1950's slide area is shown in Fig. 2. This slide continued to move, at least intermittently, through July 1970 (Hamel, 1973). The slide movements caused no distress to the powerhouses or related facilities. Slide debris was simply removed as necessary from the road and ditch along the slope toe.

The scarp retreat was scaled from 1 in. = 50 ft drawings of the slope at ten stations about 100 ft apart. Scarp retreat ranged from zero halfway between Sections 1 and 2 to 200 ft at the upstream edge of Slide 4 (Fig. 2). The average scarp retreat at the 10 stations was

tening the slope to an overall inclination of about 1 on 6 in the active slide area (Fig. 2) with somewhat steeper inclinations for distances several hundred feet upstream and downstream from the active slide area. Grading plans indicated this would involve some $1.6 - 1.8 \times 10^6$ cu. yd. of excavation.

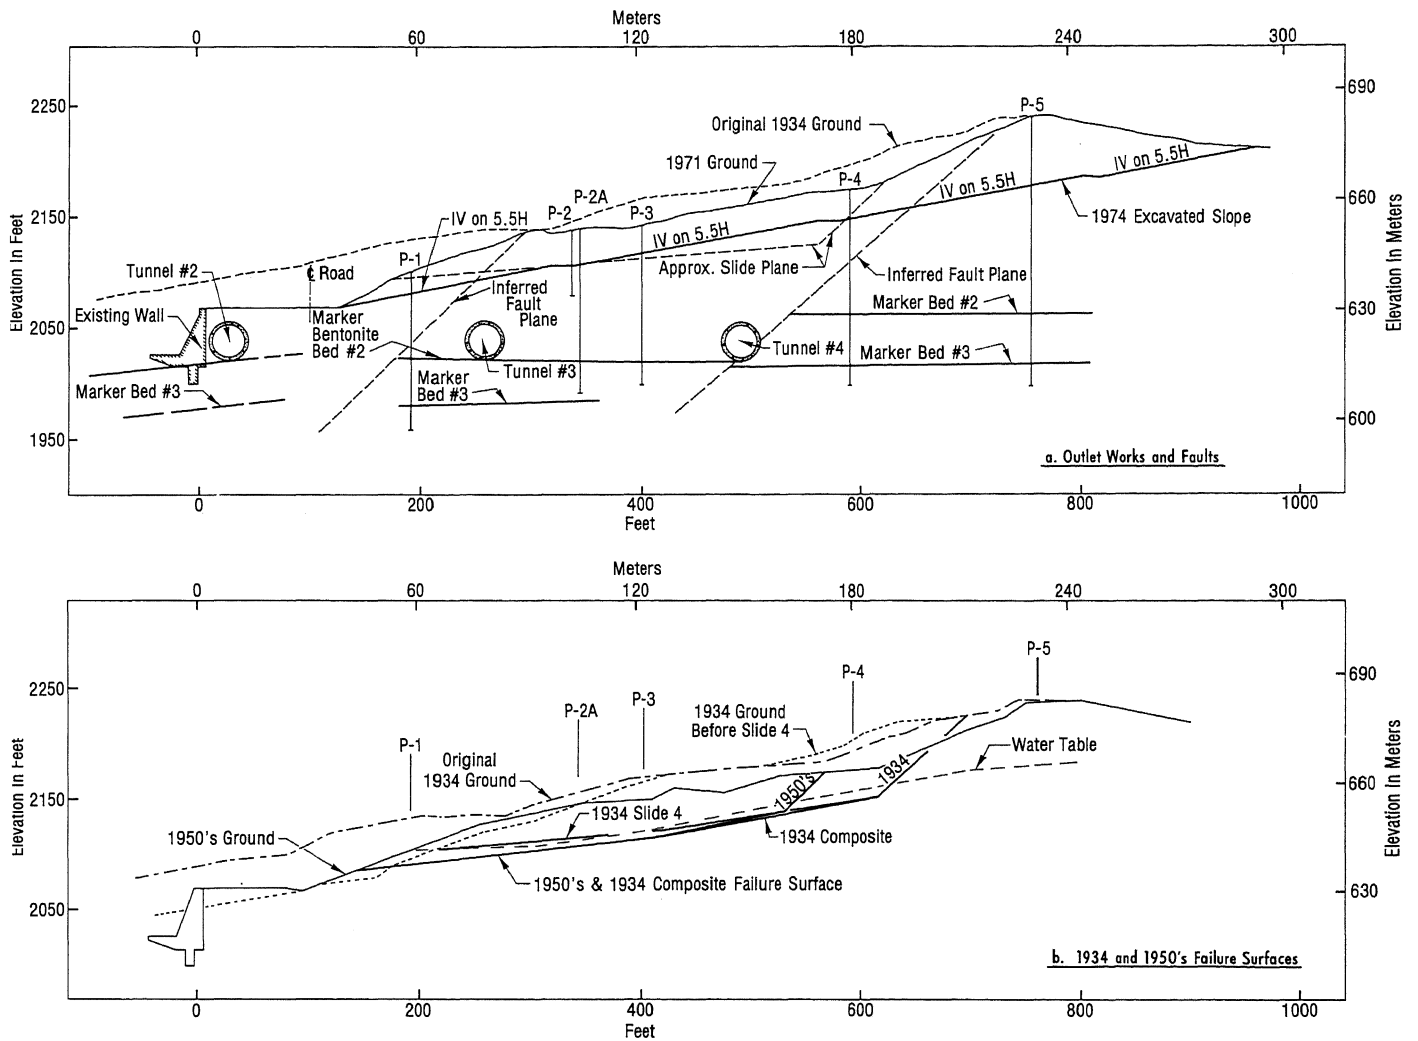
Figure 3 - Cross-Section 1
 a. Outlet Works and Faults
 b. 1934 and 1950's Failure Surfaces

sections in Fig. 2. Failure surfaces analyzed for Section 1 are shown in Fig. 3b. Hamel (1973) gives failure surfaces for the other cross-sections, data on failure mass geometry and groundwater conditions, and strength parameters calculated for equilibrium.

Strength values were calculated for limiting equilibrium of 1934 Slide 4 at Sections 1, 3, and 4 (Fig. 2). Slide 4 was not analyzed at Section 2 where its toe location was not reliably known. A composite 1934 failure surface was also analyzed for Sections 1-4. These composite failure surfaces were believed to be those along which much of the 1934 (and earlier) slide movement occurred. Composite 1934 failure surfaces were generally close to the 1950's failure surfaces (Fig. 3b; Hamel, 1973).

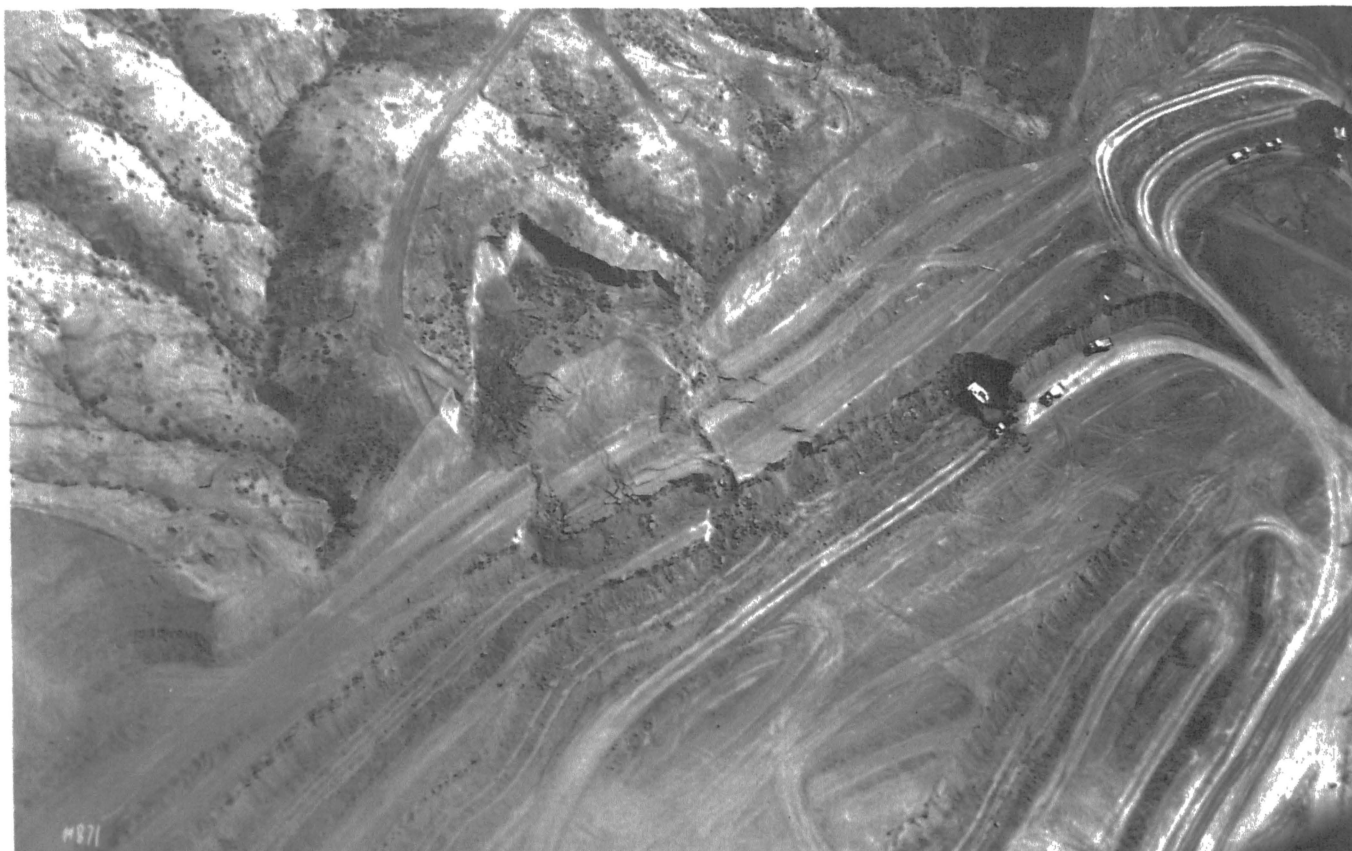
Two small slides occurred during this initial excavation. The second of these was probably Slide 1 dated 21 June 1934 on available drawings (Fig. 2). Then it was decided to flatten the excavated slope to 1 on 3. Shortly thereafter, a major slide occurred. This was probably Slide 2 dated 11 July 1934 on available drawing and photo (Figs. 2 & 4). Slide 3 dated 20 July 1934 (Fig. 2) was an upslope and downstream extension of Slide 2.

Figure 4 - Aerial View of Slide 2, 10 July 1934
(Photo 34/706)

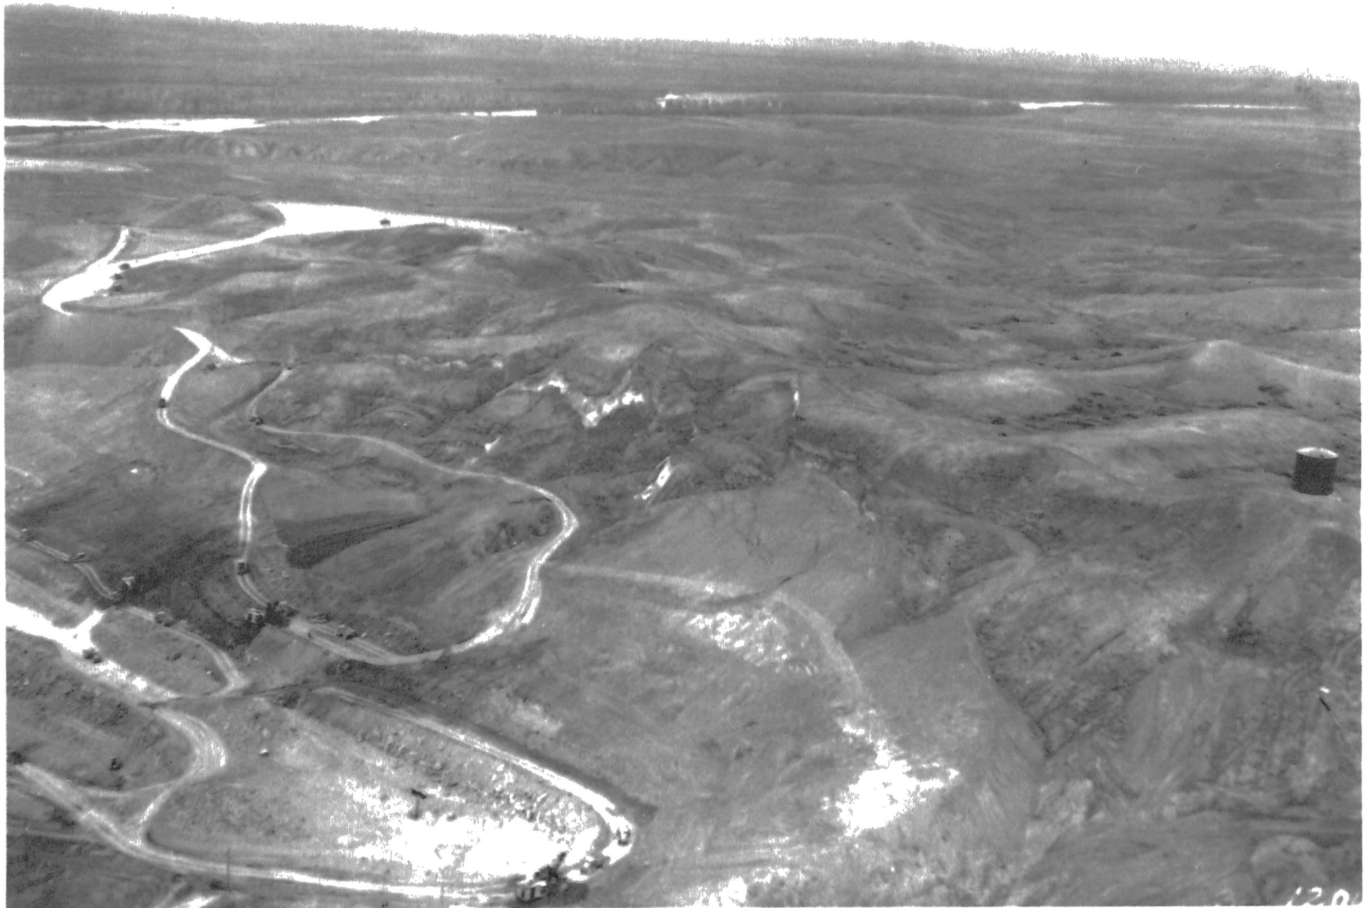
Additional slides occurred as excavation for the outlet works continued. Slide 4 dated 21 September 1934 involved much of the area upslope from the powerhouses (Figs. 2, 5, 6, & 7). Slides 5 and 6 dated 23 October and 31 December 1934, respectively, were upstream extensions of Slide 4 (Fig. 2).

Figure 5 - Aerial View of Slide 4, 2 Oct 1934
(Photo 34/1204)

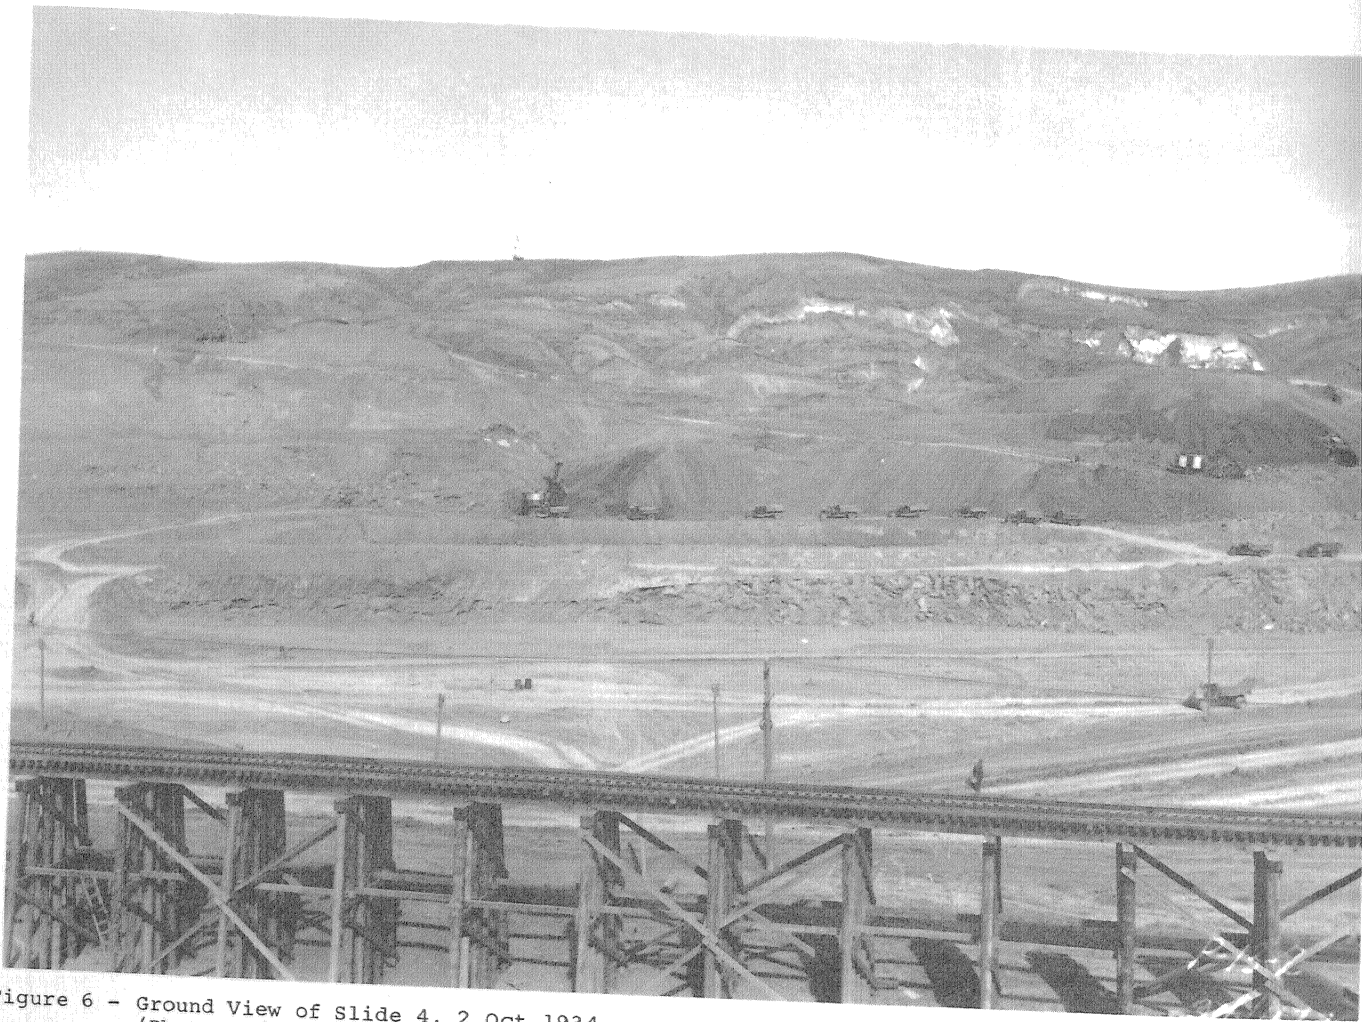
Figure 6 - Ground View of Slide 4, 2 Oct 1934
(Photo 34/1177)

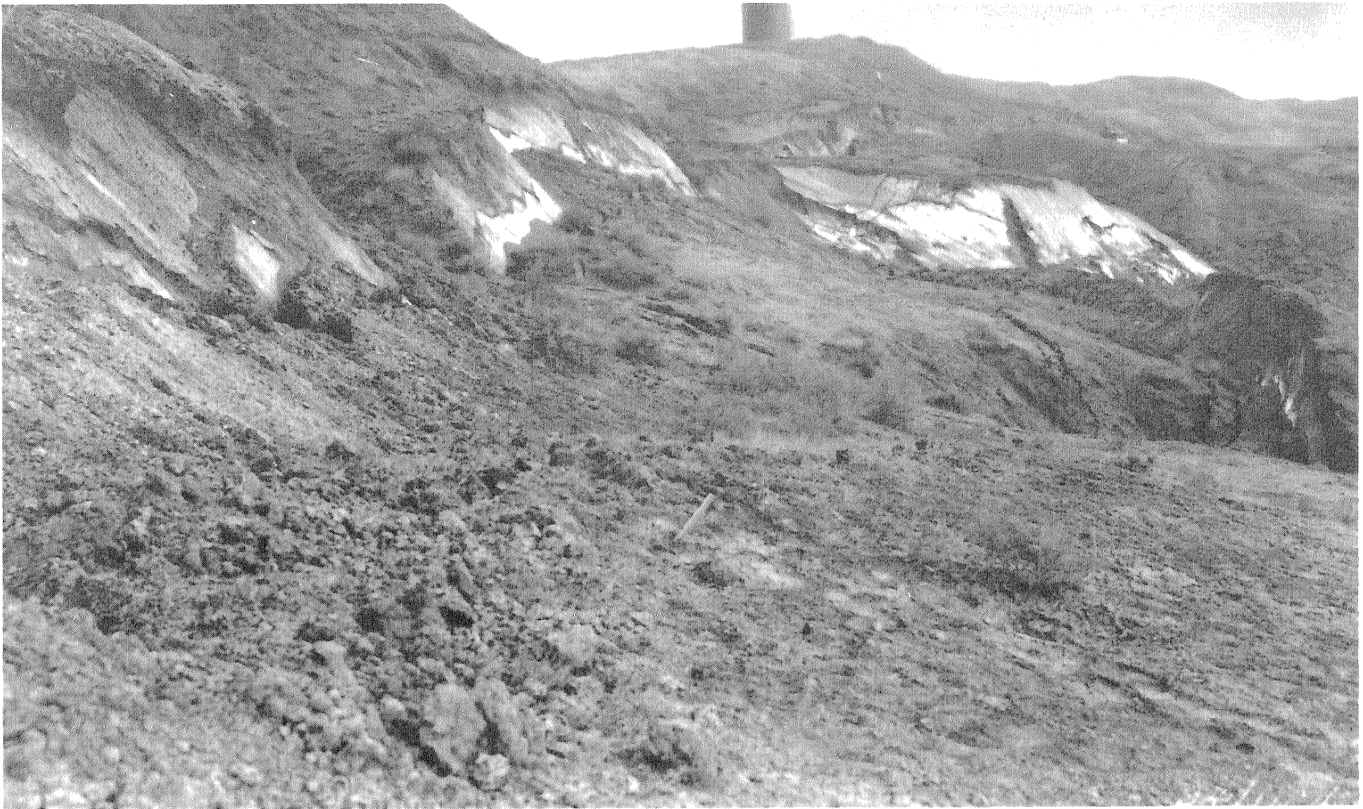
All of the slides during slope excavation in 1934 were translational block slides. In each case, the basal failure surface was along a bentonite bed and the rear of the failure mass was defined by a fault. It is probable that 1934 Slides 1-6 all involved re-activation of ancient landslide masses.

Figure 7 - Slickensided Scarp of Slide 4,
2 Oct 1934 (Photo 34/1184)

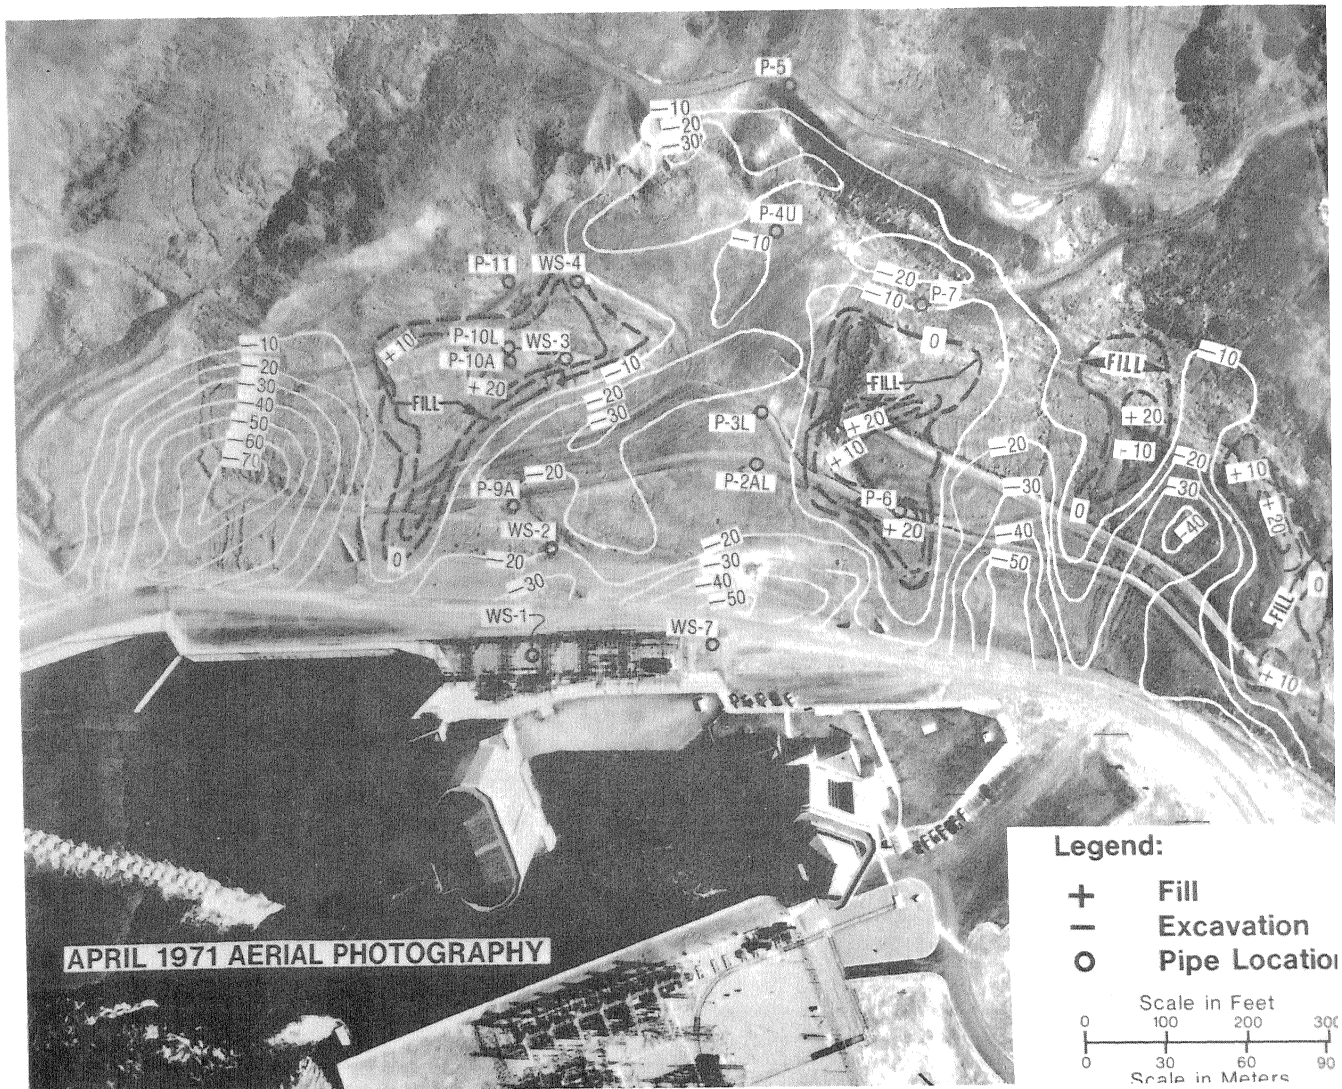
Figure 8 - Cut and Fill Contour Map (Pl. 16, DM MFP-116) Contours in Feet

Cut and fill contours in Fig. 8 show the difference between pre-construction 1934 topography and April 1971 topography. These contours include topographic changes due to slide movements and slope grading from 1934 to 1971 as well as topographic changes due to 1934 construction activity. Despite this limitation, it seems likely that most of the topographic change indicated in Fig. 8 resulted from 1934 construction activity.

Comparison of Figs. 8 and 9 indicates that areas of maximum slope movement correlate with zones of maximum excavation at the toe of original slope. This comparison also suggests that fill placement may have increased stability of portions of the powerhouse slope, e.g. by buttressing unstable colluvial masses reducing surface water infiltration.

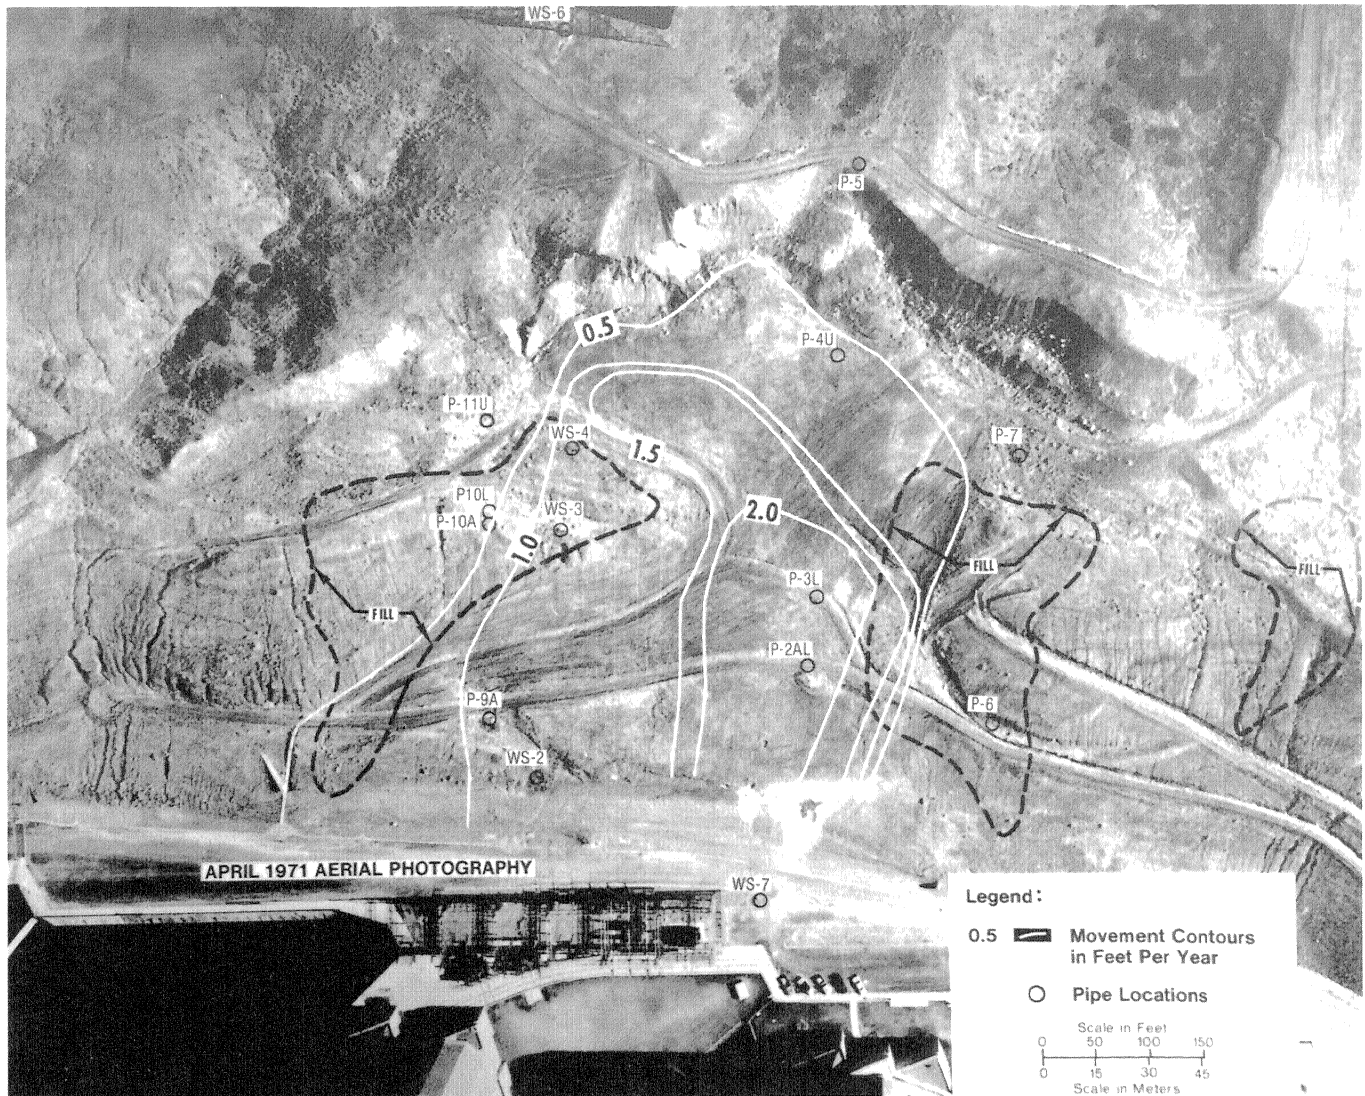
Figure 9 - Movement Contour Map (Pl. 17, DM MFP-116)

Contours of average annual downslope movement rates of tops of pipes in the powerhouse slope are shown in Fig. 9. For piezometers, rates were computed for the 18.7 yr. period from February 1953 to December 1971. For inclinometer casings, rates were computed for the 14.7 yr. period from February 1957 to December 1971. Average annual movement rates from pipe installation to December 1971 were virtually identical to those from installation to September 1970.

The contours in Fig. 9 show the general movement pattern of slide debris on the powerhouse slope over nearly two decades. Maximum movement rates of about 2 ft/yr. occurred in the active toe portion of the slide at and near Section 1 (Figs. 2 & 3). Further downstream, movement rates of 1.0-1.5 ft/yr. occurred at and near the downslope portions of Sections 3 and 4 (Fig. 2). Section 2 at the upstream edge of the active slide (Fig. 2) was relatively stable with movement rates of 0.1 - 0.2 ft/yr.

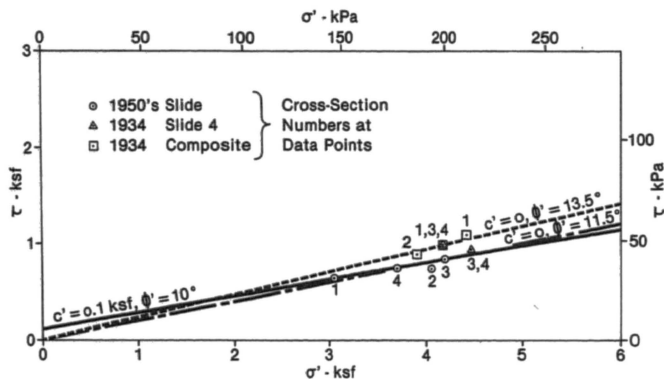
Figure 10 - Mohr-Coulomb Shear Strength Envelopes from 1934 and 1950's Slides

Shear strengths calculated from the 1934 slides are slightly higher than those calculated from the 1950's slides (Fig. 10). Failure surfaces of the 1934 slides must have existed in the slope and experienced late movements prior to 1934.* It is possible that the failure surfaces "healed" somewhat during a period of geologic time prior to 1934, e.g. by consolidation and/or formation of mineral precipitates. It is also possible that 1934 slides involved movement directions slightly different from those in the ancient landslides and that 1934 and later movements further reduced shear strengths in the sliding directions. Alternatively, the difference between shear strengths calculated from the 1934 and 1950's slides may simply have resulted from inaccuracies in the topography and groundwater levels which were not as reliably known as those for the 1950's slides.
