Excavation Shoring Failure Threatens a Historic Church: Exploration of Causes and Remedial Measures

EXCAVATION SHORING FAILURE THREATENS A HISTORIC CHURCH: EXPLORATION OF CAUSES AND REMEDIAL MEASURES

Recently, excavation works adjacent to the Lady of Annunciation Church resulted in severe cracking and deformations within the walls and floors of the stone and brick structure. The shoring provisions which were executed within the excavated lot consisted of contiguous bored piles with pre-stressed anchors. The failure occurred when the excavation works had progressed to a level of about 12m below original grade. Faced with the imminent catastrophic collapse of the church, the Municipality of Beirut ordered the immediate backfilling of the site in order to limit further movements. The case study presented in this paper includes the details and results of the geotechnical forensic investigation which included an array of measures and efforts, all implemented in an environment of urgency, given the need to find the cause of the failure, and propose and implement remedial measures which would spare the church. The analyses, monitoring measures and actual remedial works adopted and succe

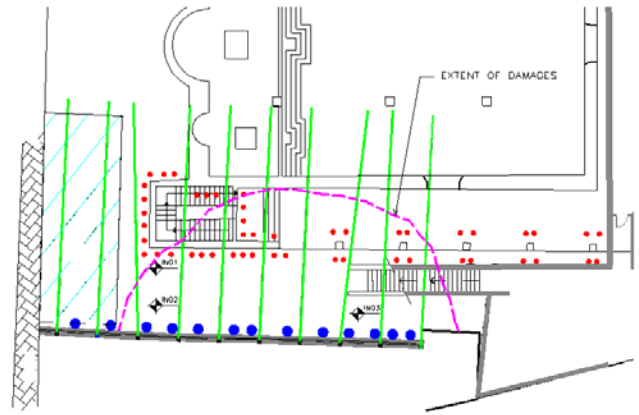
Fig. 3. Extent of 'failed zone' and micropile layout

Based on the comprehensive damage survey prepared for the structure, the areas of extensive damage appeared to be concentrated in the zone identified in Fig. 3. The damage patterns and the established subsurface conditions strongly suggest that the distress to the structure is due to a loss of soil and bearing support beneath the church foundations. The foundation system in this case consisted simply of shallow (1-2m) “piers” built with sandstone blocks and bearing on the sand layer for some and the underlying marl for others. As such, the remedial solution adopted for the church itself was to consolidate/strengthen the bearing soil and then strengthen the church walls.

As a result, the underpinning system was modified to include low capacity vertical and inclined micropiles installed in a dense array to act as root piles for the church. The micropiles are designed to both absorb the vertical loads and to consolidate the subsoil. Pre-jacking was not considered since it tended to increase the rigidity of the system and possible cause upward movement of the structure, which could have compounded the damage. The layout of the micropiles and typical details are shown on Figures 3 and 4.

The layout of the micropiles is shown on Fig. 3 and incorporates

two general schemes. Around the external 30-t columns, four inclined micropiles are installed in an “X” pattern as shown in Fig. 4. For the staircase walls, inside space was extremely tight and the micropiles were positioned outside the walls. A capping beam ties the top of the micropiles and connects through “finger” beams (openings made through the external walls) to an internal mat constructed inside the staircase. The micropiles were distributed in such a way to minimize interference with the future prestressed anchors of Lot 235.

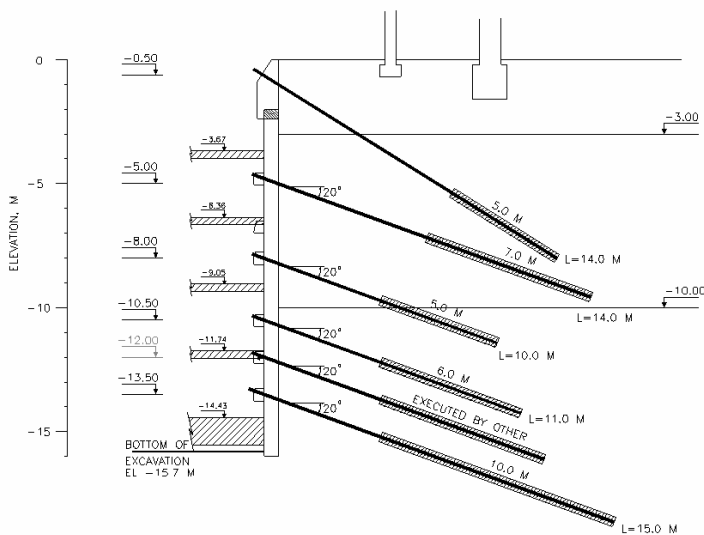
Fig. 6. Layout of the re-designed shoring system along lot-235

Five rows of anchors were used at the project as shown in Fig. 6. The moment capacity of the piles was verified but large deformations remained at the pile toe despite increasing the number of anchors and lowering the last row of anchors. The reason for these large deformations was attributed to the inadequate pile embedment. Nevertheless, these deformations were tolerated in the design with the assumption that the toe

The first row of anchor was installed on a new concrete wall constructed above the existing piles. This row was considered a key element in controlling top deformations.

The temporary prestressed anchors were designed in accordance with "Recommendations TA95". For a borehole size of 120 mm, the working shaft resistance used to determine the bond length of the anchors was 0.23 MPa and 0.35 MPa for the weathered marl and limestone formations respectively. Anchor capacities varied between 300 kN and 640 kN. A quality assurance plan was implemented for the anchors in the form of two destructive pull-out tests and conformity checks for each anchor to 20% above working load.

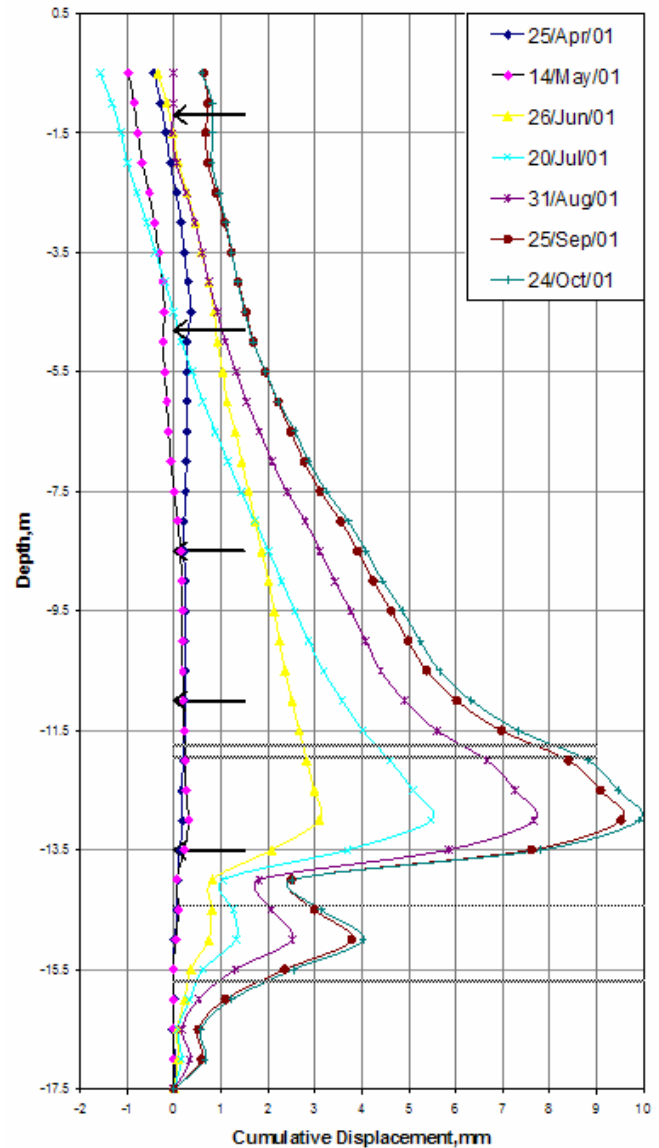
Fig. 7. Cumulative displacements at IN02

- ❑ Deformations at the top remained small and less than 1 mm.
- ❑ Deformations at the bottom of the pile are relatively large, reaching a maximum of 10 mm.
- ❑ Deformations usually increase during excavations and either regress or stabilize after anchor installation.
- ❑ Deformations at top anchors are not affected by subsequent excavation stages.
- ❑ Once the final excavation depth was reached, deformations continued to evolve but at a slightly slower rate than during excavation.
- ❑ Once construction of the building foundations and slab started, the rate of deformations decreased significantly to become almost nil.

The above findings were generally expected by design. However, it is interesting to note that deformations continued when reaching a stable level of excavation. Although the observed values were still smaller than anticipated, the observed behavior is unusual and may be associated with one or a combination of the following:

- ❑ Lack of pile embedment, which gives rise to an unstable toe; or
- ❑ Delayed reaction of the shoring system due to a natural long-term relaxation of the cohesion.
