The Observed Seismic Behavior of the Matahina Dam

M. D. Gillon

Ministry of Works and Development, Wellington, New Zealand

SYNOPSIS: On 2 March 1987 the 86 m high Matahina earth dam in the Eastern Bay of Plenty region of New Zealand was shaken by a nearby magnitude 6.3 earthquake. The dam response was recorded by five strong motion accelerometers and a maximum crest level acceleration of 0.42 g was measured. The crest level rockfill settled about 100 mm and moved downstream 250 mm during the earthquake. No major leakage has resulted from the earthquake.

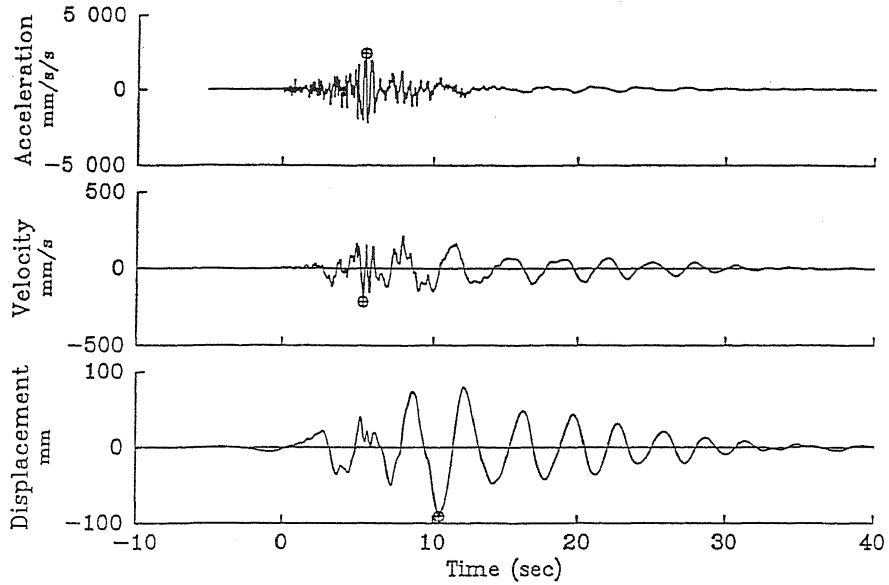
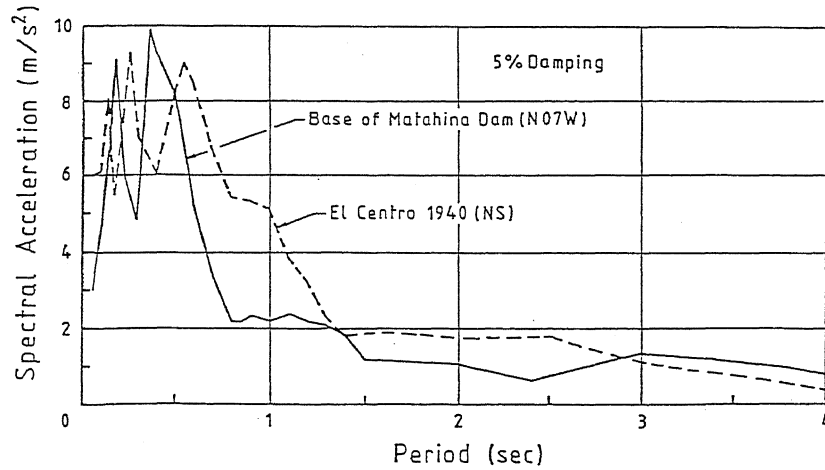
Figure 3. Acceleration, velocity and displacement at the base of the Matahina Dam and comparison of the 5% damped acceleration response spectra there with El Centro 1940 (NS).

The accelerometer at the base of the dam recorded the M_L 5.2 foreshock, the M_L 6.3 main shock and the largest aftershock, the M_L 5.5 event 8½ minutes after the main shock. The transverse (upstream-downstream) acceleration, velocity and displacement record from the base of the dam and the 5% damped acceleration response spectra are shown in Figure 3. The El Centro 1940 (N-S) response spectra is shown for comparison.

⊕ Peak values: acceleration 2381 mm/s/s, velocity -218.5 mm/s, displacement -90.56 mm

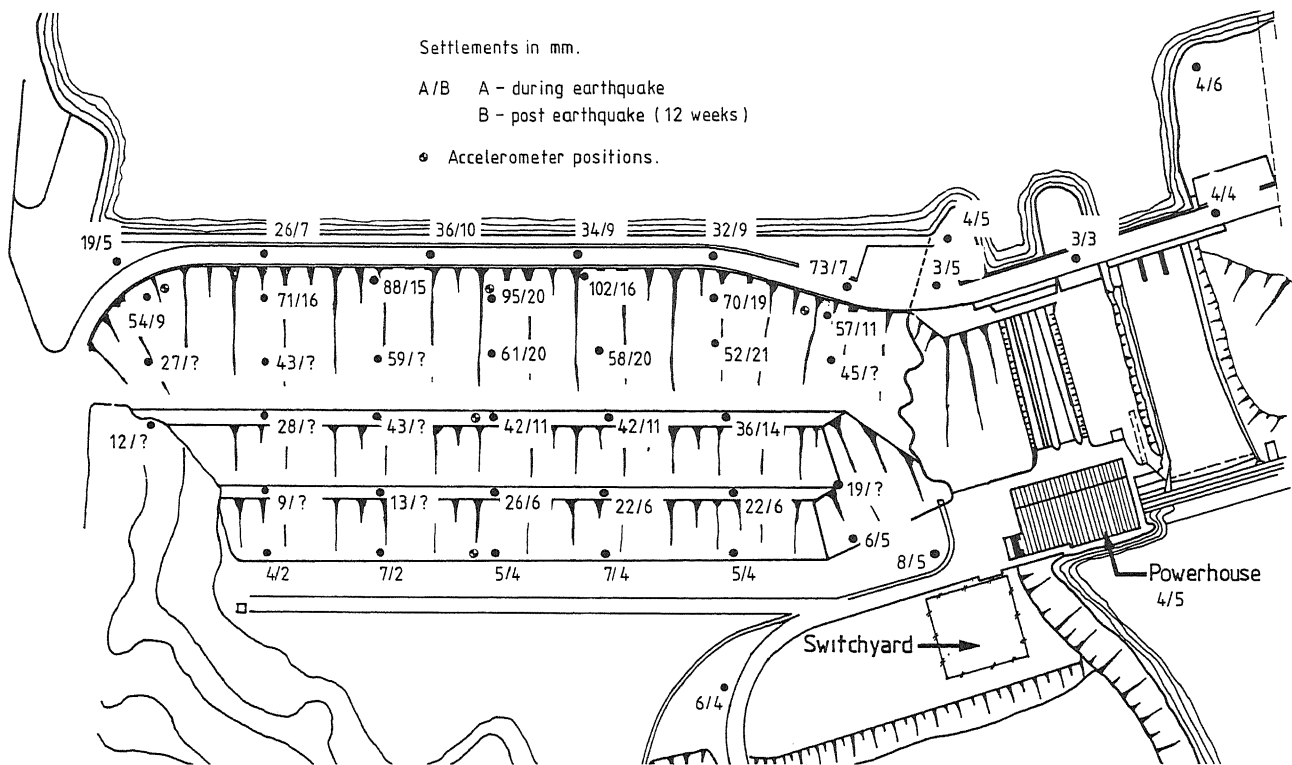
Figure 6. Settlements resulting from earthquake.

Measured settlements of survey points are shown in Figure 6 (Currie, 1987). These show the very small settlements of the left abutment spur and the much larger settlement of the dam immediately after the earthquake. Given the level of shaking the settlements are not considered excessive but they were viewed with concern because of the core cracking and erosion associated with lake filling.

The long term settlement of the left abutment spur was unexpected (Figure 6). The results indicate a fairly uniform settlement without tilting. The settlement caused increased leakage into the powerhouse. Initially it was suspected that the spur settlements may have been tectonic in origin but level traverses across the Waiohau fault did not support this. It is possible that the silt which is inferred to underlie the ignimbrite sheet compacted, developing excess pore pressures which took some weeks to dissipate.

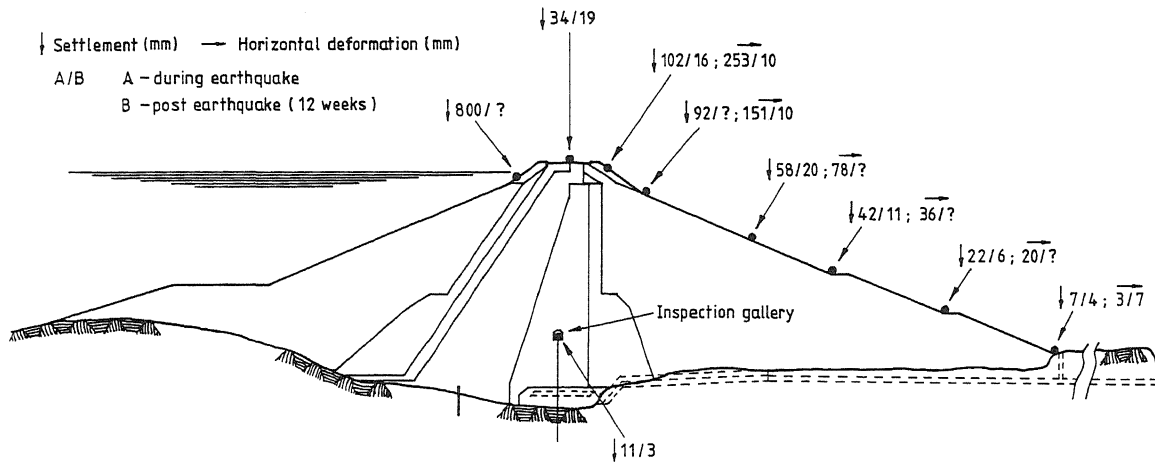
Figure 7. Deformations at centre of dam

Settlement of the dam continued for several weeks. During this time the crest settlements were less than the rockfill settlements as would be expected. Measurements from the inspection gallery do not suggest significant foundation settlement (Figure 7).

The displacement of the downstream rockfill shoulder is shown in Figure 7. The maximum displacement of 253 mm compares with about 220 mm during the lake filling period. The ratio of long term crest displacement/settlement (typically 2.5) is similar to that observed during the earthquake.

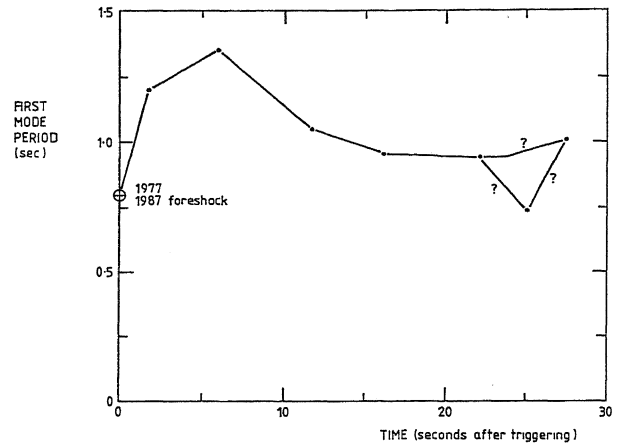
Figure 8. Variation of transverse first mode period during the mainshock (McVerry, 1987)

The results for the transverse crest response (Figure 8) show that the first mode period lengthens from about 0.80 seconds in the foreshock to 1.36 seconds during the time of strongest response. The period drops to about 0.92 seconds in the decay portion of the record. First mode damping reached about 25% of critical in the largest amplitude motion dropping to about 7% in the decaying portion of the response.

The results of the analysis to date show evidence of mainly hysteretic behaviour. The recovery in the decay portion of the transverse crest record (Figure 8) is reassuring but shows evidence of softening. The lack of mid crest accelerograms in the aftershocks prevents direct determination of the post earthquake first mode period. It is hoped that analysis of aftershock records from the other accelerometers will provide information on the post earthquake properties of the dam.
