Damage and Remedial Measures for Buildings on Hill Slopes

SYNOPSIS The paper deals with details of geotechnical investigations carried out for evaluating the reasons of damage to the buildings resting on hill slopes in northern region of India and also to evaluate the soil parameters for designing retaining walls and other remedial measures for preventing further damage to structures. Three causes of failure were identified namely (i) instability of slopes, (ii) improper design of retaining walls and (iii) differential settlement of structures. Shear strength parameters of the soil mass required for the analysis of slope stability and stability of retaining wall sections have been chosen based on three methods of investigations viz. large scale direct in-situ shear tests, plate load tests and the back analysis method. The stability analysis of various sections of slopes have been carried out and measures for strengthening of slopes have been suggested.

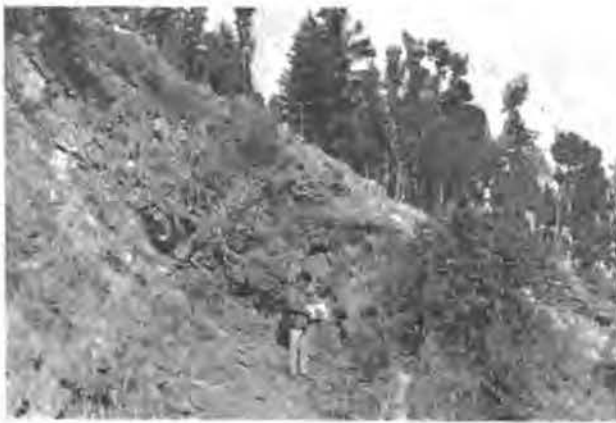
Fig.2 Tilting of Trees on Slope

The clayey and sandy soil which forms a shallow cover over the phyllitic rocks, have a tendency to slide down these steeper slopes. This slow but active sliding of the soil mass is indicated by the tilting of trees on the slopes (Fig.2).

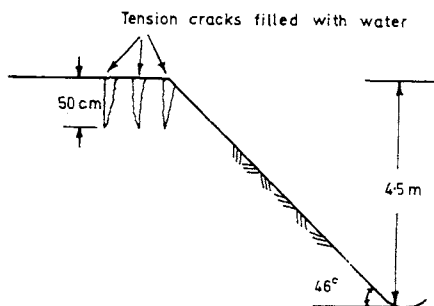
Fig.5 Slope along nala

Figure 5 shows a slope along nala in incipient failure condition. Several tension cracks had developed and slope may collapse in near future.
