Factor Analysis of Damage to Small Earth Dams Due to the 1995 Hyogoken-Nambu Earthquake

FACTOR ANALYSIS OF DAMAGE TO SMALL EARTH DAMS DUE TO THE 1995 HYGOKEN-NAMBU EARTHQUAKE

Paper No. 3.07

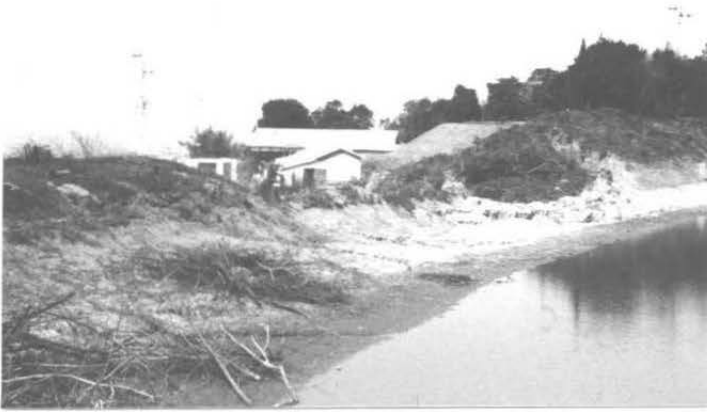
Photo. 1 Liquefied earth dams of Grade 4 (Ichinomiya-cho in Awaji Island)

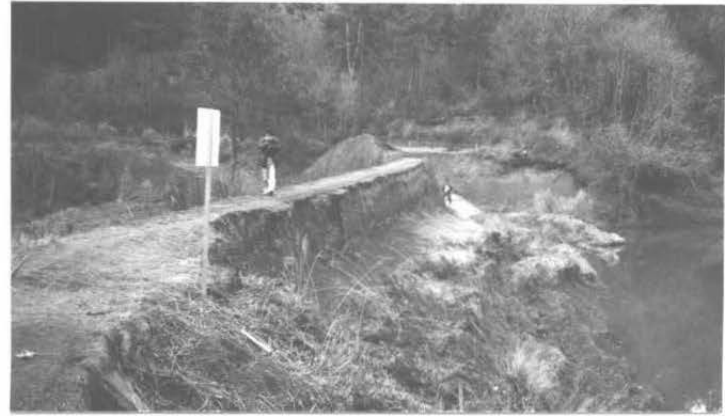
Photo. 2 Slid earth dams of Grade 4 (Ono City in Honshu Island)

Honshu Island The attenuation of damage to dams was not observed clearly because we focused our investigation on severely damaged earth dams far away the fault. In spite of the long distance from the fault, several dams on alluvium, terrace deposit and diluvium of the Osaka group suffered severe damage. Three earth dams on the Osaka group of 20 to 30 km away from the fault suffered large-scale slides (Damage Grade 4). The view of one of them is shown in Photo. 2. These dams were constructed over 70 years ago and had shapes with steep slopes.

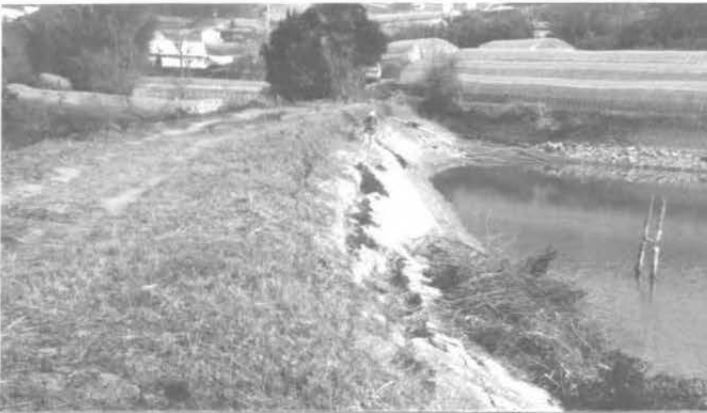
Photo. 3 Damaged earth dams of Grade 3 (Ichinomiya-cho in Awaji Island)

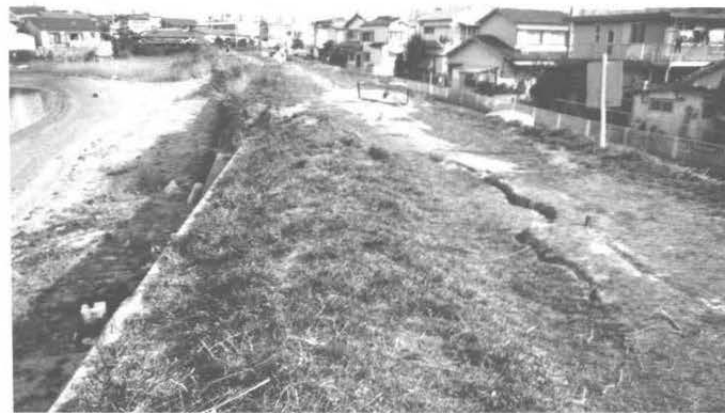
Photo. 4 Damaged earth dams of Grade 2 (Akashi City in Honshu Island)
