Behavior of Reinforced Wall System During the 1999 Kocaeli (Izmit), Turkey, Earthquake

BEHAVIOR OF REINFORCED WALL SYSTEM DURING THE 1999 KOCAELI (IZMIT), TURKEY, EARTHQUAKE

ABSTRACT

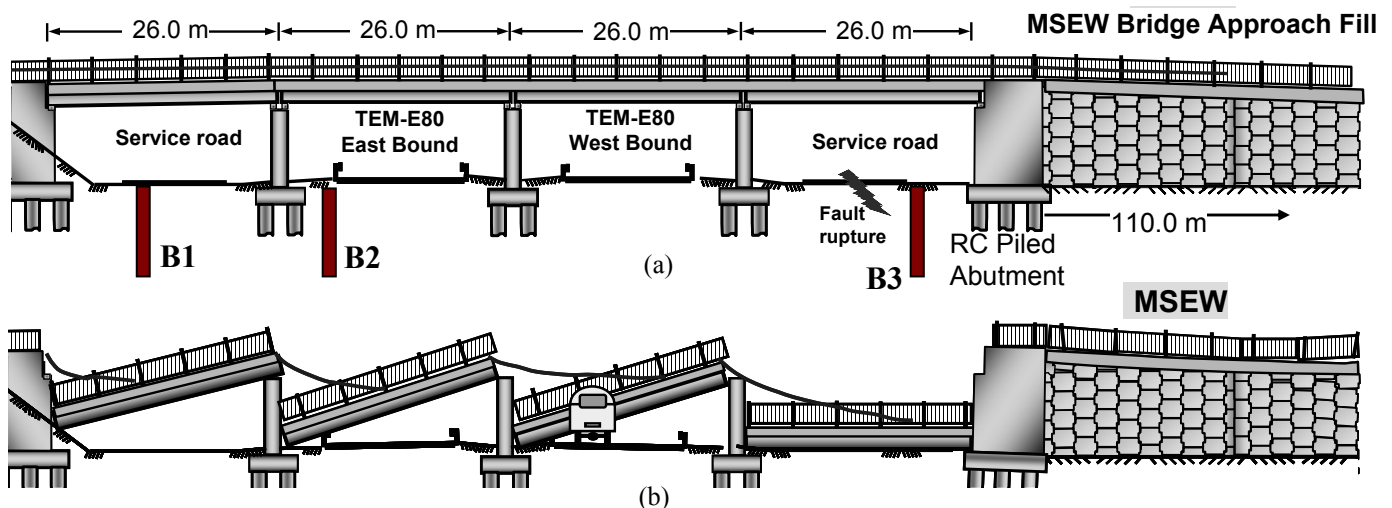
During the earthquake, the majority of the highway facilities performed well, except that the bridge overpass in Arifiye (Fig.2), located less than 50 km eastward of the epicenter, collapsed due to tectonic movement along the fault zone. The surface fault rupture passed beneath the northernmost span of the overpass while causing substantial surface deformations. The collapsed bridge blocked the TEM and caused serious delays in transporting immediate disaster-caused emergency needs in the epicentral area. Moreover, nearly a dozen people died when a passenger bus crashed into a collapsed deck while passing under the overpass.

the earthquake. Major damage to the walls was not from seismic design, but a combination of adverse effects by the nearby fault movement and, possibly, bearing capacity problems associated with underlying foundation soil. Figure 2 depicts the overpass and the reinforced walls before and after the damage, respectively.

Fig. 2. The bridge overpass at Arifiye and mechanical stabilized bridge approach fill walls (a) before, and (b) after the earthquake.

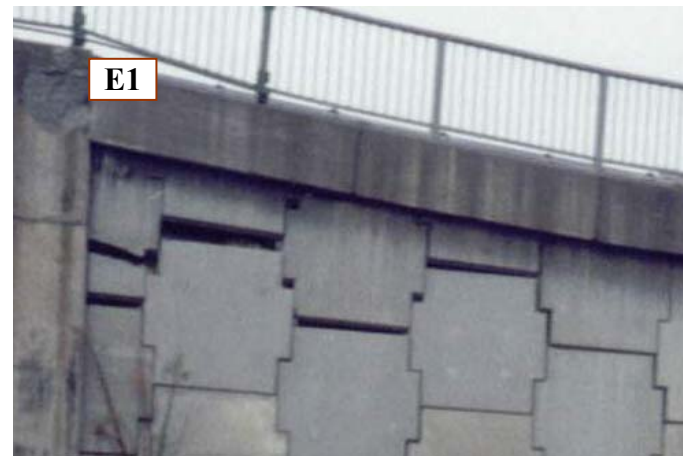
Fig 6. Damage details for (a) E1 and (b) E2 on eastern MSEW face (photos after Ozbakir).

both locations were also different. At E1, the vertical ground deformation was so large that the flexible wall face was forced to be displaced both vertically and longitudinally. However, the movement in the longitudinal direction was greatly prevented by the rigid abutment. This caused large panel separations and cracks at the higher levels (Fig. 6a), but no damage observed at lower wall elevations.

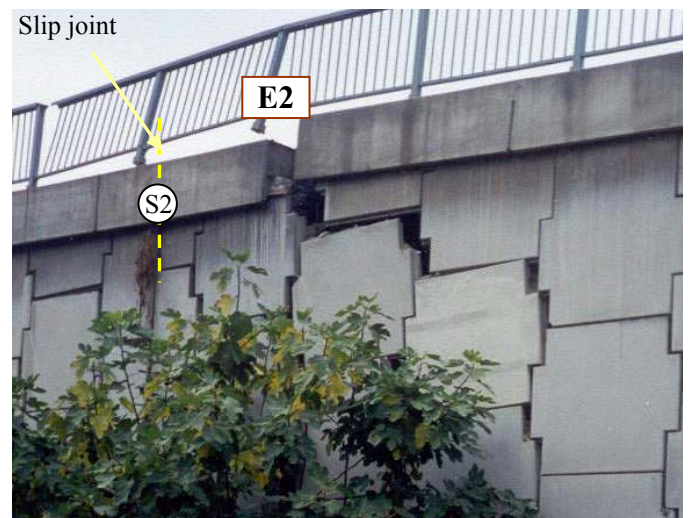
(b)

The tilting in the cross section resulted in different damage states above the culvert at E2 and W2 such that the western wall buckled in the vicinity of W2 (Fig. 7a), whereas the eastern wall face were stretched outward (Fig. 6). The buckled side increased compression on the facing panels at W2, whilst crashing and forcing the panels displaced (Fig. 7b). On the other hand, the largest damage in the reinforced walls was observed at E2 as shown Fig. 6b. At this location, the wall displaced both vertically and horizontally for about 25-30 cm. The displacements at this locality was so large that they exceeded the allowable design limitations for an independent panel movement. Thus, the panels could not accommodate the ground deformation, and finally, large panel separations and cracks (especially at lower elevations of the wall) occurred. However, the facing panel connections with the metallic reinforcements did not fail, and their flexible joints allowed large displacements and differential settlements.

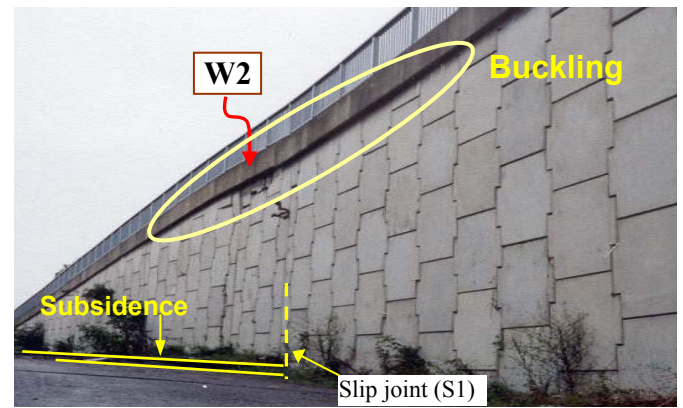
Fig 7. Western MSEW face: (a) buckled wall, looking from south to north; (b) damage details at W1 and W2, looking from north to south (photos after Ozbakir).

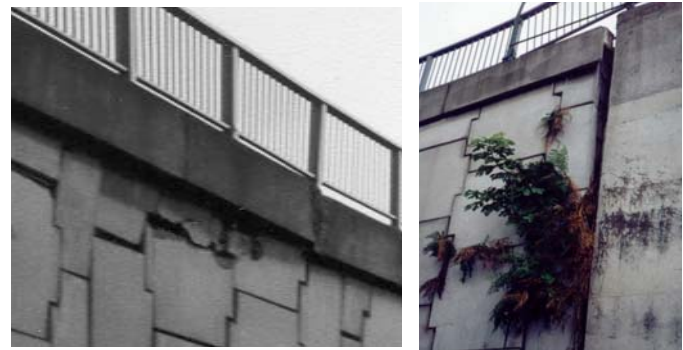
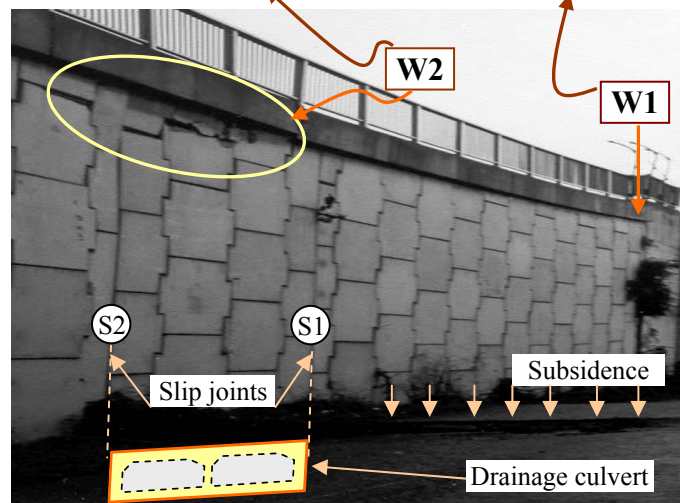
(b)

large compared to E1. On the other hand, a gap of about 10 cm occurred between the panels and the abutment as shown in Fig. 7b. This gap appeared to be resulted from the buckling in the same wall face in vicinity of W2 (Fig. 7a). That is, once the wall buckled at W2, the wall face was pulled longitudinally (northwardly) as a whole. This behavior along the western side of the approach ramp did not cause any damage in the facing panels between W1 and W2. This was an interesting observation indicating that the reinforced wall system was very flexible.
