## Case History – Performance Monitoring Success

## CASE HISTORY - PERFORMANCE MONITORING SUCCESS

The City Creek Center urban redevelopment project in Salt Lake City, Utah involved excavations up to 65 feet deep. Shoring systems included more than 29,000 square feet of anchored diaphragm walls, 100,000 square feet of soil nail walls, and 860 linear feet of underpinning. Detailed performance monitoring alerted the project team to unacceptable performance of an anchored diaphragm wall adjacent to an occupied twenty-five-story building on shallow foundations. This knowledge allowed the team to react quickly, stabilize the excavation, investigate the situation, and develop successful remedial measures. The diaphragm wall was reinforced with additional anchors and subgrade concrete struts, allowing the excavation to proceed with minimal delay and no damage to the adjacent building.

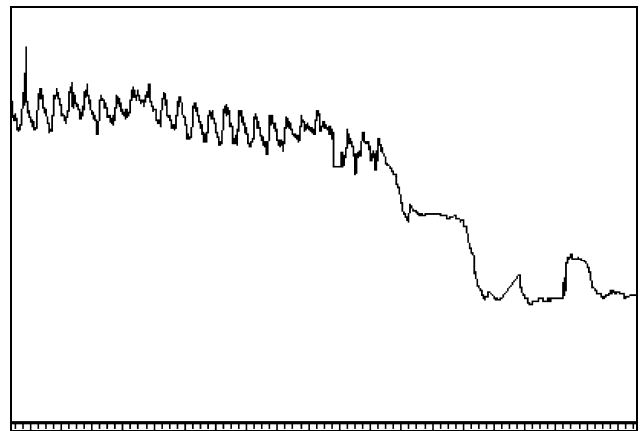
*Fig. 2. Automated Survey Plot*

An example of a report from the automated monitoring system is presented in Fig. 2. Small cyclical variations and occasional spurious readings are evident in the graph, and these are typical of optical survey measurements, but the trend in the data is also apparent. Specific events, such as an excavation stage or the installation of an anchor, can be tied to changes in the readings that lie outside the normal variation or deviate from the long-term trend.

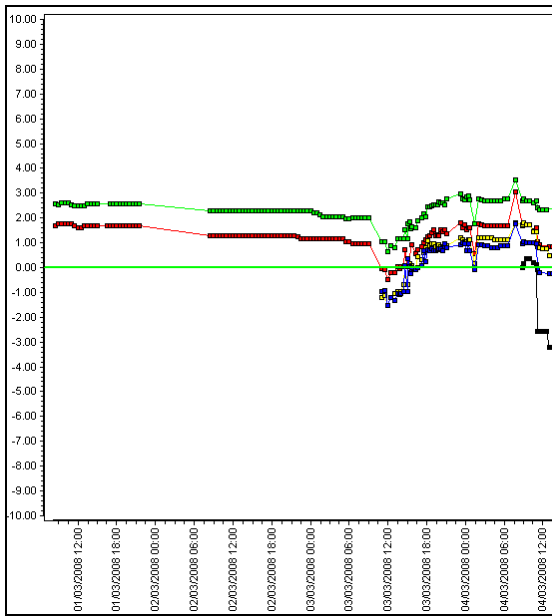
Fig. 3. Diaphragm Wall Displacement Plot

Excavation for the fourth level of anchors proceeded as scheduled. Within a few days, the automated optical survey system began to show anomalous displacements, as can be seen in Fig. 3. A weekly inclinometer reading on a Tuesday showed a significant acceleration of movement in the lower part of the wall, including the section below subgrade, which had displaced approximately 1/4 inch over a period of about four days.

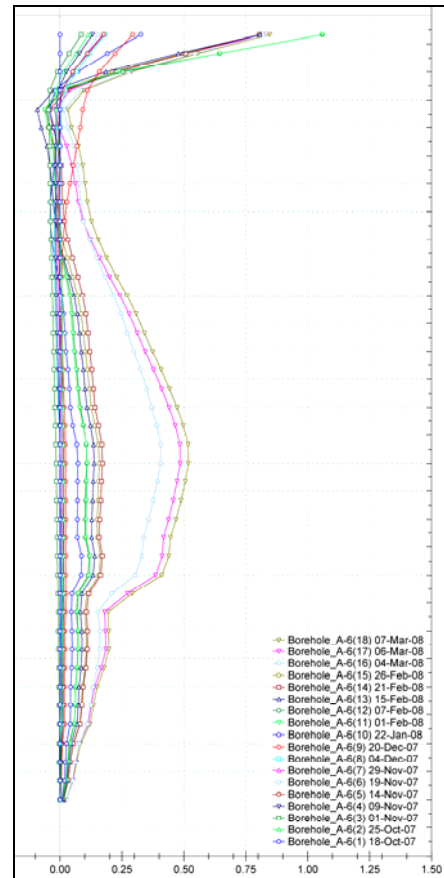
Fig. 4. Inclinometer Plot

Follow-up readings on Wednesday and Thursday confirmed the trend of continuing movement, as shown in Fig. 4. Analysis of the monitoring data led the project team to conclude that the excavation support system was at a point near failure, and that movement would continue unless appropriate action was taken. Considering the proximity of the occupied twenty-five-story office building and the obvious consequences of failure, emergency measures were immediately implemented.

Additional geotechnical borings were made along the wall alignment. The borings indicated the presence of a 20-foot-thick layer of interbedded silt and clay with numerous sand seams overlying the medium-stiff clay and silt. This layer had not been detected in the original geotechnical exploration program and was not observed in other portions of the site. A review was made of the diaphragm wall panel installation records and anchor drilling logs and test reports. This review corroborated the presence of the interbedded silt and clay stratum. This layer imposed much greater lateral pressures on the diaphragm wall than the dense sand and gravel that had been expected, and additionally provided lower ultimate bond stresses for the anchors supporting the wall. Significant remedial actions would be required to address the presence of this layer, protect the existing twenty-five-story building, and allow the redevelopment project to proceed.
