Excessive Settlement in Buildings

A. Verghese Chummar
F. S. Engineers (P) Ltd., Madras, India

The paper deals with three case studies where the foundations of buildings in the coastal areas of South India settled from 10 to 100 Cms resulting in excessive tilt or cracks in the superstructure. Details of soil exploration work carried out, description of the soil characteristics and the analysis of the causes of settlement are dealt with in this paper. The remedial measures suggested for the possible rectification of the damages are also presented.

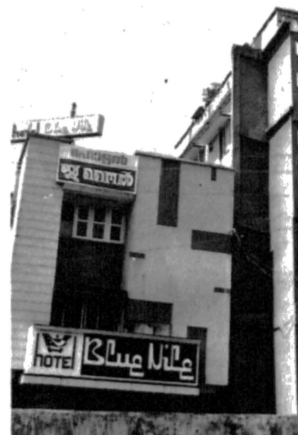
Fig.1 Settlement of the Building in Cochin

This particular case came up for investigation with the complaint filed by the owner of a five storeyed building in Cochin, Kerala stating that the neighbouring three storeyed building is falling on to his building. The complaint looked genuine as could be seen in Fig.1. The three storeyed building had a settlement of about 100 Cms on the side close to the five storeyed building. The investigation work was requested by the owner of the three storeyed building to defend the case.

ments were within the allowable limits, no cracks developed in the structure. At this time, a single storeyed old building in the neighbouring compound was demolished and the five storeyed building was constructed on a full raft foundation. The clear gap between the foundations was only 1.5 M. Within an year after construction, excessive settlements were noted on the side of the three storeyed building close to the five storeyed building. The five storeyed building settled by 10 Cms on the side close to the three storeyed structure and by 3 Cms on the opposite side.

This indicates that, due to the construction of the five storeyed building the silty clay layer has been loaded to 70% of its ultimate capacity for a 1.5 M wide section. According to Peck, Hanson and Thornburn (3) creep in clays could occur at loads greater than half its ultimate strength. The full raft of 18 M width could absorb this settlement due to creep, while the 2 M wide raft tilted excessively to one side.

The analysis clearly indicates that the construction of the five storeyed building on the raft foundation violated the permissible limits of settlement and loading. The tilt of the three storeyed building was therefore caused by the wrong design of the foundation of the five storeyed building. With this data submitted the case was withdrawn by the owner of the five storeyed building.

The remedial measures for correcting the tilt was seen to be difficult due to the reason that the soil has been overloaded in one section. The possible solution was to induce a settlement in the three storeyed building on the opposite side. For this purpose loading on one side of the building and also the area opposite to the side where tilt has taken place were suggested. Sand drains to a depth of 18 M was also recommended to accelerate the settlement. Loading of 0.8 Kg/Cm² of the area close to the building for a width of 10 M which is vacant could induce a settlement of about 40 Cms. This would at least prevent the leaning of the three storeyed structure on the neighbouring structure.

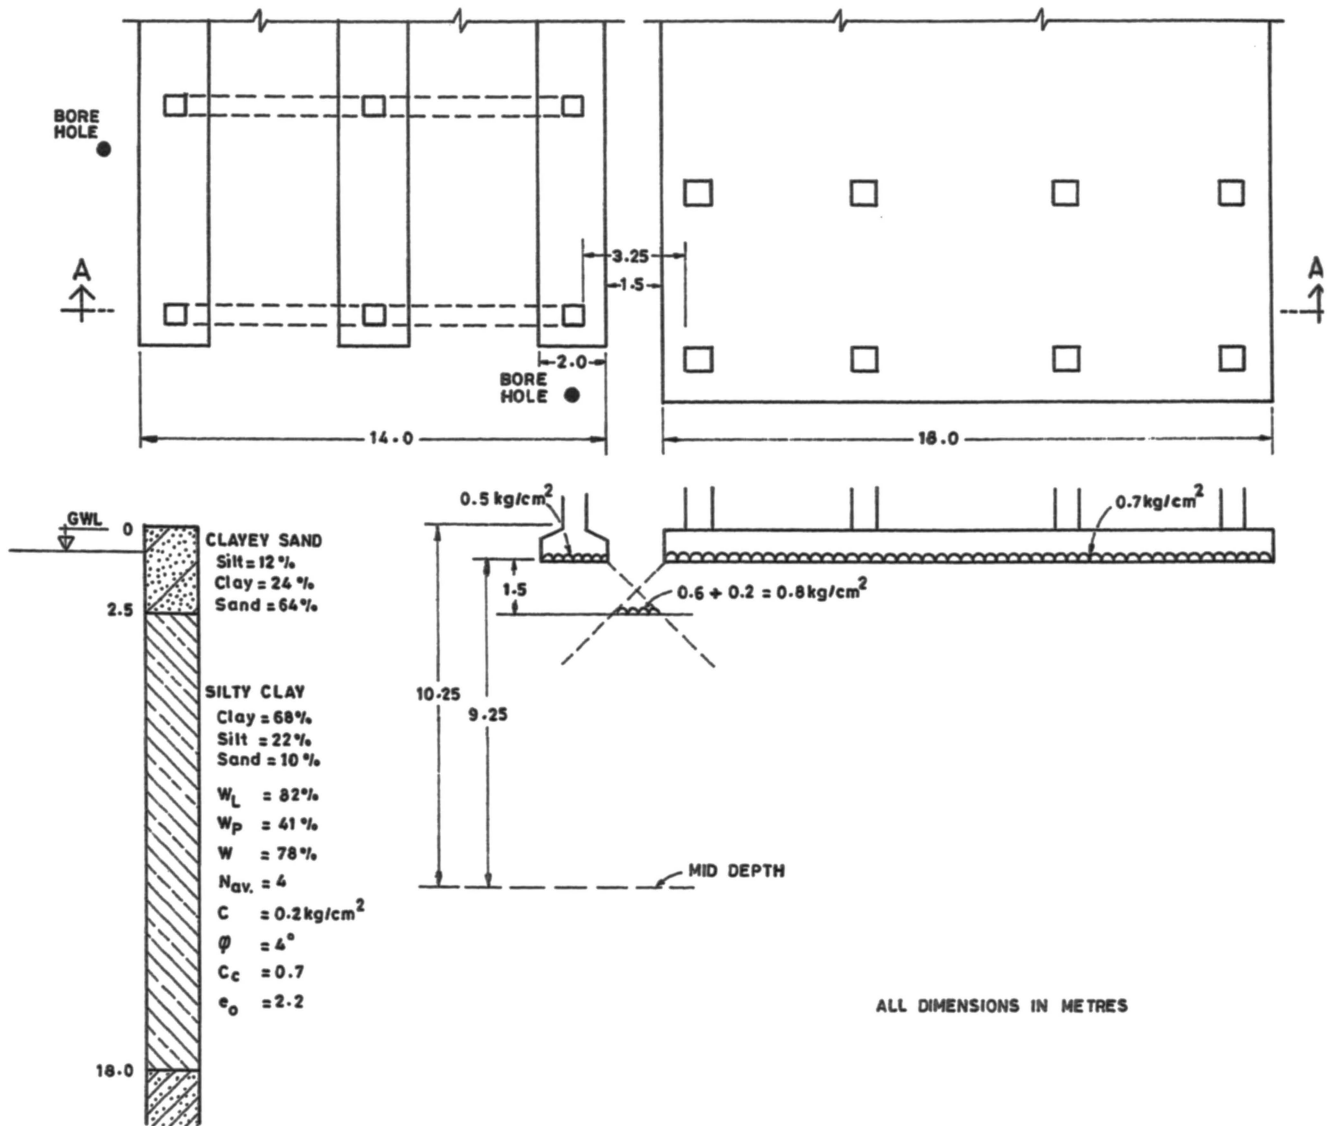
Fig. 2 Plan, Soil Profile and Section

Due to the limitation of space, the soil exploration could be undertaken only at two locations by the side of the three storeyed building. The soil profile, the soil properties and the loading details are given in Fig.2.

The soil exploration indicated that there is a marine silty clay layer present in the area from a depth of 2.5 to 18 M. Properties of this layer are given in Fig.2. The compression index C_c and natural moisture content W of the silty clay layer were seen to be of high order.

Considering 45° load spread it could be seen from Fig.2 that the silty clay layer at a depth of 2.5 M in the gap between foundations is loaded upto 0.8 Kg/Cm²; 0.2 Kg/Cm² from the strip raft and 0.6 Kg/Cm² from the full raft. The ultimate bearing capacity of the silty clay layer is computed using the formula,

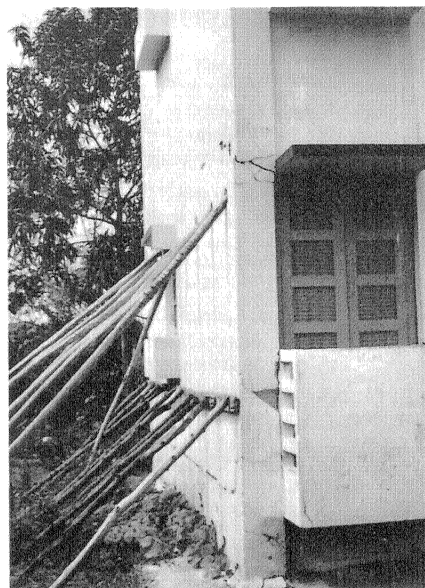
Fig. 3 Cracks in a three storeyed building in Madras

In this case three storeyed residential quarters constructed in Madras was seen to develop excessive settlement in the peripheral walls during the drought season. The drought occurred nearly two years after the completion of the structure. No cracks or settlements were visible during the two year period. The magnitude of the damages in the structure due to settlement are indicated in Figs. 3 & 4. It could be seen that the ground floor wall has come out of plumb and the skirting has settled by nearly 20 Cms. Investigation conducted at a number of points in the area gave a generalised soil profile as indicated in Fig.5.

This settlement which is within the allowable limits, indicates that the cracks have not developed due to consolidation. Observation of the shrinkage limit W_s of 7%, differential swell of 70% and the lowering of the water table from a normal depth of 1.5 M to 7 M below ground level during drought clearly indicates the cause of the settlement as that of the volume reduction due to the shrinkage of the sandy clay layer present upto 4.5 M. According to Holtz and Gibbs (4) when the shrinkage limit is less than 11% volume change of the order of 30% of the thickness of the layer could take place due to moisture variation. The settlement due to shrinkage of the sandy clay could thus be upto about 90 Cms. When the water table was lowered to 7.5 M, the moisture content became 12% at 1.5 M depth, 18% at 4 M. The moisture content at saturation was seen to be 38%. The water table normally being at 1.5 M the soil layer remained saturated. By lowering of the water table reduction in moisture content occurred resulting in considerable volume reduction.

Treatment of the clay by lime has indicated an increase in the shrinkage limit and reduction in the swell pressure. Treatment by pressure grouting is seen to be ineffective due to the low permeability of the clay layer. Instead a mixture of 2:1 powdered unslaked lime and sand could be inserted into the soil by drilling boreholes of 100 mm dia at an interval of 1 M by the side of the foundation to the full depth of the expansive clay layer. Treatment of this nature undertaken for one of the structures was seen to be very effective (5). The treatment of the expansive sandy clay layer by lime in boreholes was recommended in this case. A layer of 15 Cms of lime and sand was also recommended to be placed below the skirting and flooring as the first layer above the expansive clay layer. Wherever the walls had become structurally weak, adequate strengthening was proposed. The R.C. beams and slabs were seen to have no damages.

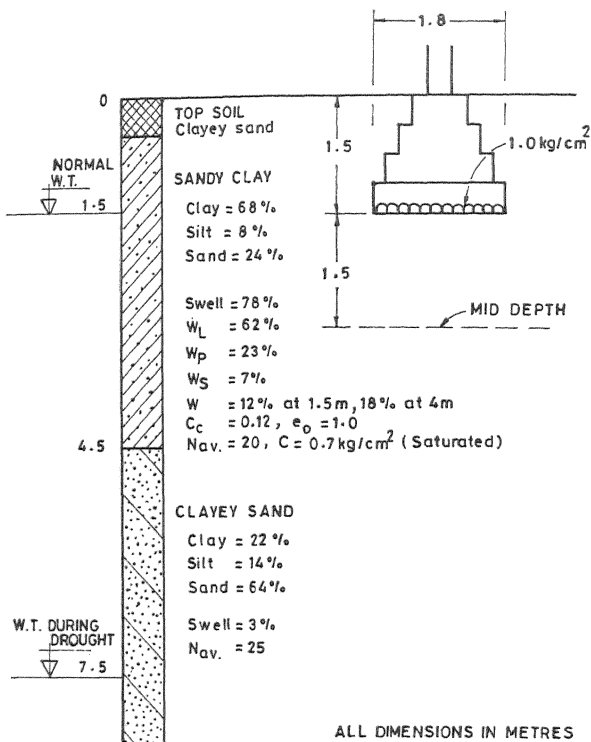
Fig. 5 Soil Profile and Loading Details

The consolidation settlement of the sandy clay layer computed as per the parameters given in Fig.5 is,

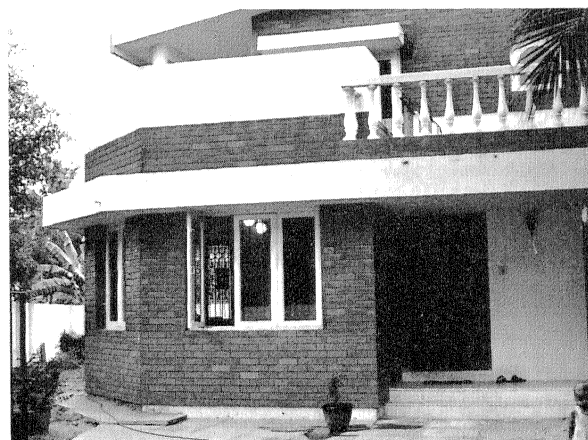
Fig. 6 Single storeyed portion of building which developed cracks

In this case, the single storeyed portion of a residential building in Madras shown in Fig.6 settled and developed cracks during the drought season. A typical crack developed is shown in Fig.7. The foundation of the structure is on under-reamed piles. The single under-reamed piles were terminated on the clay sand layer present at a depth of 4 M. Normal water table is at 1.5 M. During drought season the water table was lowered to 8 M below ground level.

since further reduction in the water content of the layer is not likely. The increase in volume of the layer on increase in moisture content would be small since the silty clay is not expansive as could be seen from the values of percentage swell of 8% and shrinkage limit of 16%. It was therefore recommended to undertake the repair of the building without any treatment of soil.

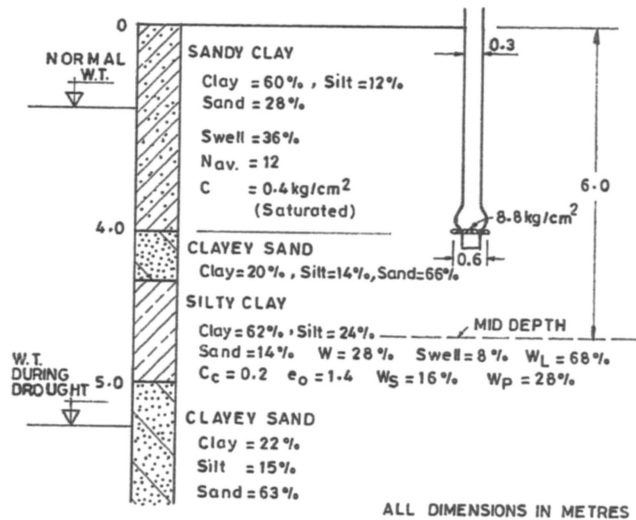
Fig. 8 Soil Profile and under-reamed pile

Detailed investigation revealed the soil profile indicated in Fig.8. A layer of silty clay was seen to be present from a depth of 5 to 7 M only in the area where cracks developed. The settlement of the silty clay computed assuming that the entire load is transmitted at the bottom of the bulb of the pile is,

The settlement of the pile noted was of the order of 6 Cms. This indicated that the settlement occurred not by the loading from the pile but by lowering of the water table beyond the depth to which the silty clay layer is present. The water content of the silty clay with the water table at 8 M was 28%. The water content at saturation was 42%. It could be concluded that the reduction in the moisture resulted in settlement of the layer causing the piles to settle. The settlement that occurred could be considered to be the maximum that would occur
