International Conference on Case Histories in Geotechnical Engineering (2008) - Sixth International Conference on Case Histories in Geotechnical Engineering

Evaluation of the Taum Sauk Upper Reservoir Failure

EVALUATION OF THE TAUM SAUK UPPER RESERVOIR FAILURE

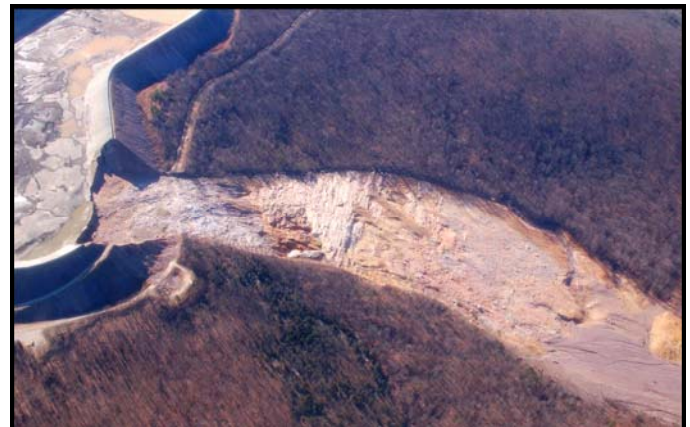
Fig. 1. The upper reservoir breach and a portion of the flow path (photo courtesy of J. Spooner, 2005)

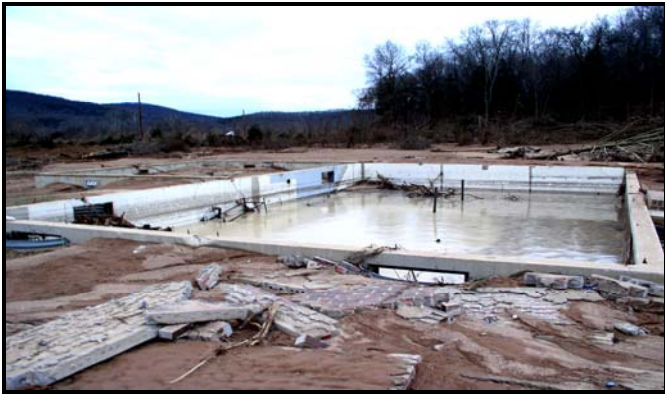
During the early morning hours of December 14, 2005, the Taum Sauk Upper Reservoir rock-fill dike underwent a catastrophic failure, releasing more than a billion gallons of water down the northwest side of Proffit Mountain. The release of water downstream ripped the land of existing vegetation and soil cover and the resulting wall of water demolished one residence directly in the flood path. Severe flash flooding was experienced on the East Fork of the Black River, including Johnson's Shut-Ins geological features and Johnson's Shut-Ins State Park campground. Figures 1 and 2 illustrate the consequences of the water release from the Upper Reservoir. Figure 1 displays downstream sedimentation and a portion of the downstream flow path. Figure 2 displays the residence that was demolished by the flash flood waters.

Fig. 2. Remnants of the Park Ranger's residence (Hoffman, 2005).

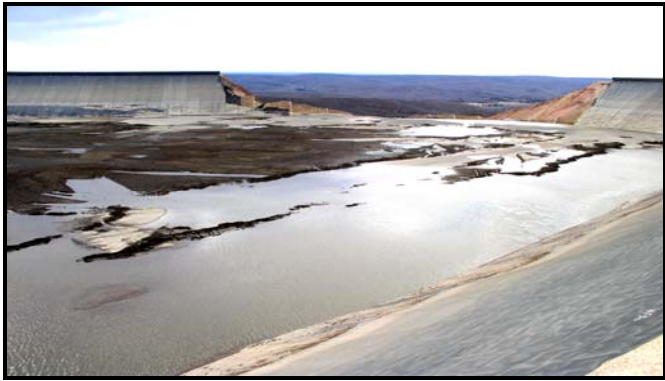
The breach occurred along the northwest radius of the Upper Reservoir over a distance of about 680 feet at the crest and through the entire height of the dike. Figure 3 illustrates the breach area of the rock-fill dike. Water began overtopping the reservoir on the morning of the failure. Overtopping at specific locations around the perimeter of the Upper Reservoir and possible failure mechanisms associated with the failure events after initiation of overtopping, are within the scope of this study. The cause of overtopping is of importance but is not within the scope of this evaluation.

Fig. 3. View of breach looking northwest across reservoir (Hoffman, 2005).

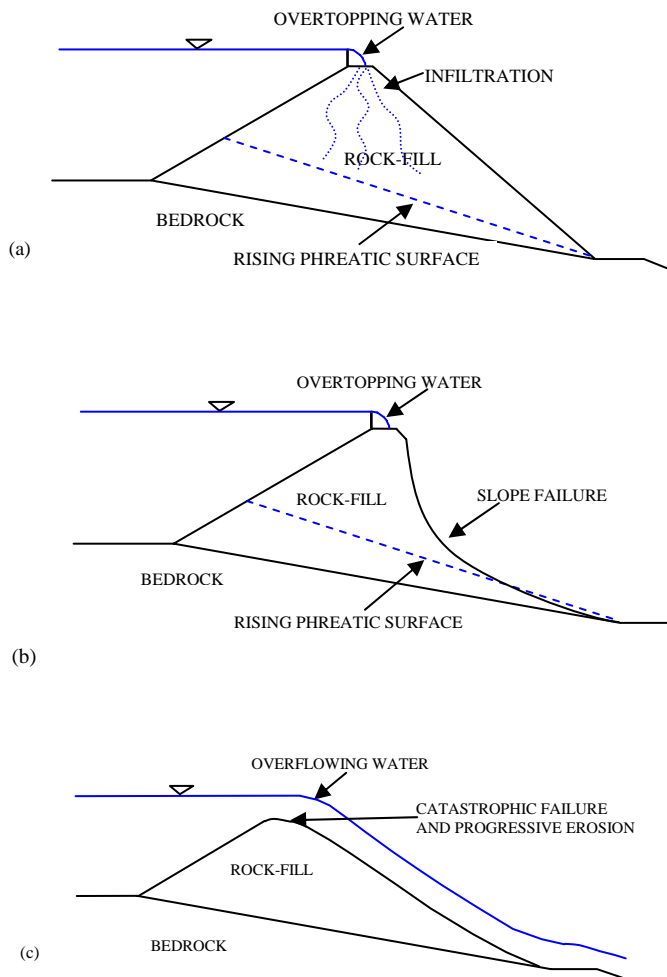
The following summarizes failure mechanism #1: As overtopping of the Upper Reservoir rock-fill dike was initiated, water spilling over the concrete parapet wall infiltrated into the dike. The resultant increase of water within the dike subsequently caused the phreatic surface to rise within the rock-fill. The rising phreatic surface exerted excess pore pressures

within the rock-fill material, consequently reducing the effective stresses acting on the bedrock and rock-fill interface. The reduced effective stresses lowered the shear strength of the rock-fill material. The reduction of effective stresses caused either a global slope stability or localized toe slope stability failure on the downstream slope of the Upper Reservoir.

If a localized toe stability failure occurred due to the aforementioned reduction of effective stresses, the global stability of the reservoir would be sufficiently weakened to the point of global slope stability failure. The capacity of the rock-fill dike to hold back the contained water, after either case of slope failure, would have been severely compromised. Complete failure due to a rising phreatic surface and reduced slope stability could have resulted. Figure 5 illustrates sketches of each stage of the proposed failure mechanism.

Fig. 5. Failure mechanism #1. (a) rising phreatic surface, (b) slope instability, (c) catastrophic failure with progressive erosion (not to scale).

Given the time frame of the failure events, it is unlikely that the phreatic surface elevation in the area of the breach reached an impending failure condition. From the aforementioned discussion and the performed analyses, a rising phreatic surface condition was not likely responsible for the rock-fill dike failure.

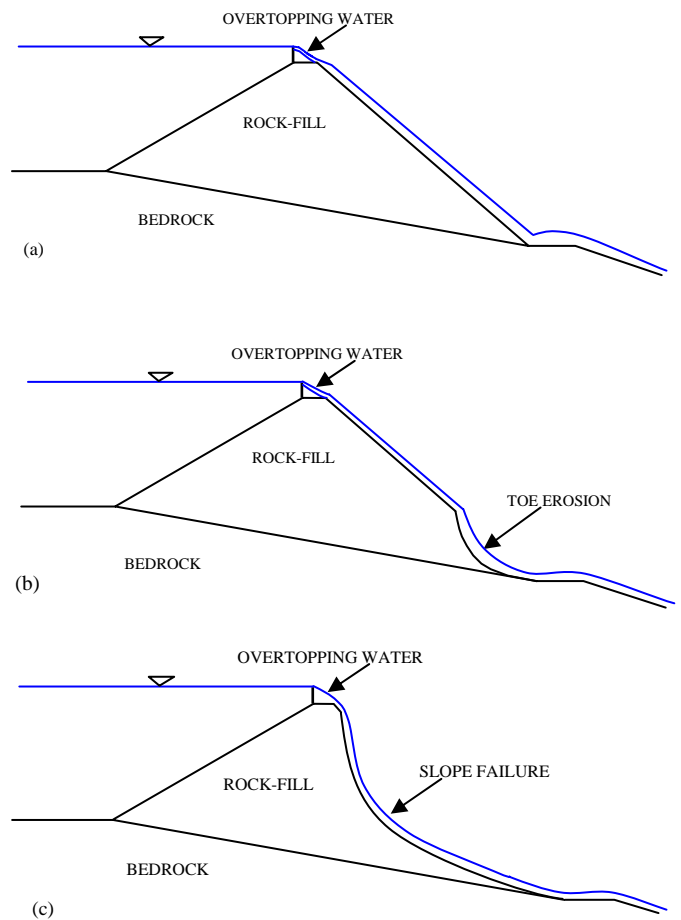
over the concrete parapet wall was allowed to flow down and along the downstream slope surface of the dike. If the water flowing along the surface reached the toe of the slope with a sufficient flow rate, a hydraulic jump could have been formed. Once a hydraulic jump formed, erosion could have been initiated at the downstream toe of the reservoir. This erosion process removed rock-fill material beginning at the downstream toe and progressively moved upward along the slope. The removal of material is similar to that of the localized downstream toe stability and could have affected the global slope stability of the dike. Once a sufficient amount of material was removed, the downstream global slope stability was severely compromised to the point of failure. The capacity of the rock-fill dike to hold back the contained water, after global slope failure, would have been severely compromised. Complete failure due to erosion at the toe and reduced slope stability could have resulted. Figure 6 illustrates sketches of each stage of the proposed failure mechanism.

Fig. 6. Failure mechanism #2. (not to scale). (a) water flowing across downstream slope, (b) progressive toe erosion, (c) resulting slope failure, (d) catastrophic failure with progressive erosion, same as Fig. 5(c).

Through the analyses it was determined that a sufficient flow could have existed to mobilize granular material at the toe and initiate the erosion process. If this process occurred it would have severely weakened the rock-fill dike structure in terms of global slope stability. This effect would be similar to the effect that a localized toe failure would have on global slope stability. In areas where the overtopping flow was not sufficient to keep mobilized granular material suspended, deposition of the material along the downstream slope and along the downstream toe occurred. Evidence of an accumulation of granular material at the toe of the dike in non-failed, overtopped, areas suggests that a similar condition may have occurred in the breach segment before failure.

Analyses were conducted to quantify the possibility that overtopping water could initiate the erosion process along the downstream slope. The infinite slope analyses revealed that the downstream slope was marginally safe with respect to sloughing and planar failure and exhibited a safety factor of 1.1. Flow across the surface of the downstream slope or infiltration as water flowed down the slope could have reduced the safety factor and increased the effects of erosion, leading to either increased crest erosion, reduction of the embankment cross-section, and/or increased toe erosion.

The possibility that erosion could take place at the downstream toe of the Upper Reservoir existed given the condition that no material mobilization occurred at the downstream crest or along the downstream slope as water flowed downstream. The aforementioned discussion and post-failure evidence in other areas that experienced overtopping discount the likelihood of this process occurring. From the discussion and analyses, downstream toe erosion was likely not responsible for the rock-

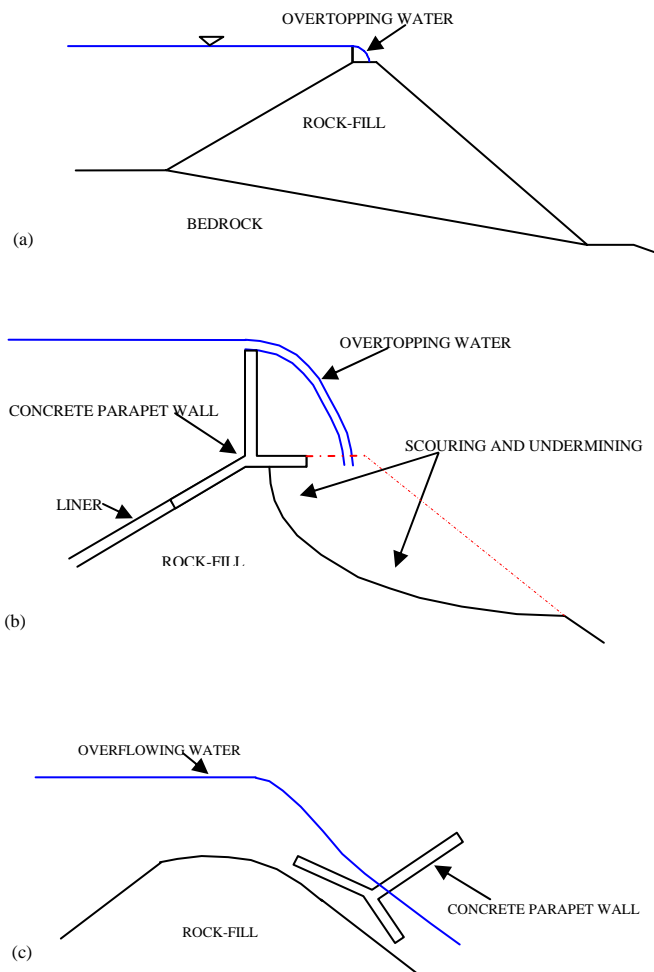
The following summarizes failure mechanism #3: As overtopping of the reservoir was initiated, water spilling over the concrete parapet wall caused erosion and scouring at the downstream crest of the dike. This process began to undermine the concrete parapet wall foundation. As undermining and scouring progressed, the rock-fill material was transported down the slope. Once the undermining process removed a sufficient amount of rock-fill, the stability of the concrete parapet wall and the shear capacity of the rock-fill directly below the wall became severely compromised to the point of either wall failure and/or shear failure. After the aforementioned wall/crest failure(s), more water (10-feet) and consequently more flow was released in the area of the breach. The additional flow continued the erosion process down to the toe of the reservoir yielding the catastrophic failure. Figure 7 illustrates sketches of each stage of the proposed failure mechanism.

Fig. 7. Failure mechanism #3. (not to scale). (a) overtopping water, (b) scouring and undermining, (c) parapet wall failure, (d) catastrophic failure with progressive erosion, same as Fig. 5(c)

As undermining, scouring, and erosion progressed, the possibility existed that enough rock fill material was removed directly beneath the base of the wall to cause a localized soil shear failure. If localized soil shear failure occurred, the effects would have been similar to sliding or overturning instability of the wall. Both proposed circumstances could have caused wall failure, leading to the eventual complete discharge of stored water in the reservoir. The near 700-foot wide breach suggests, in the opinion of the writer, a sudden collapse of parapet wall segments and continued erosion and scouring down to bedrock.

analyses support the concrete parapet wall instability and subsequent erosion of the rock-fill dike as a possible mode of catastrophic failure. From the discussion and analyses, the concrete parapet wall failure and resulting erosion of the rock-fill dike were likely mechanisms for the reservoir failure.

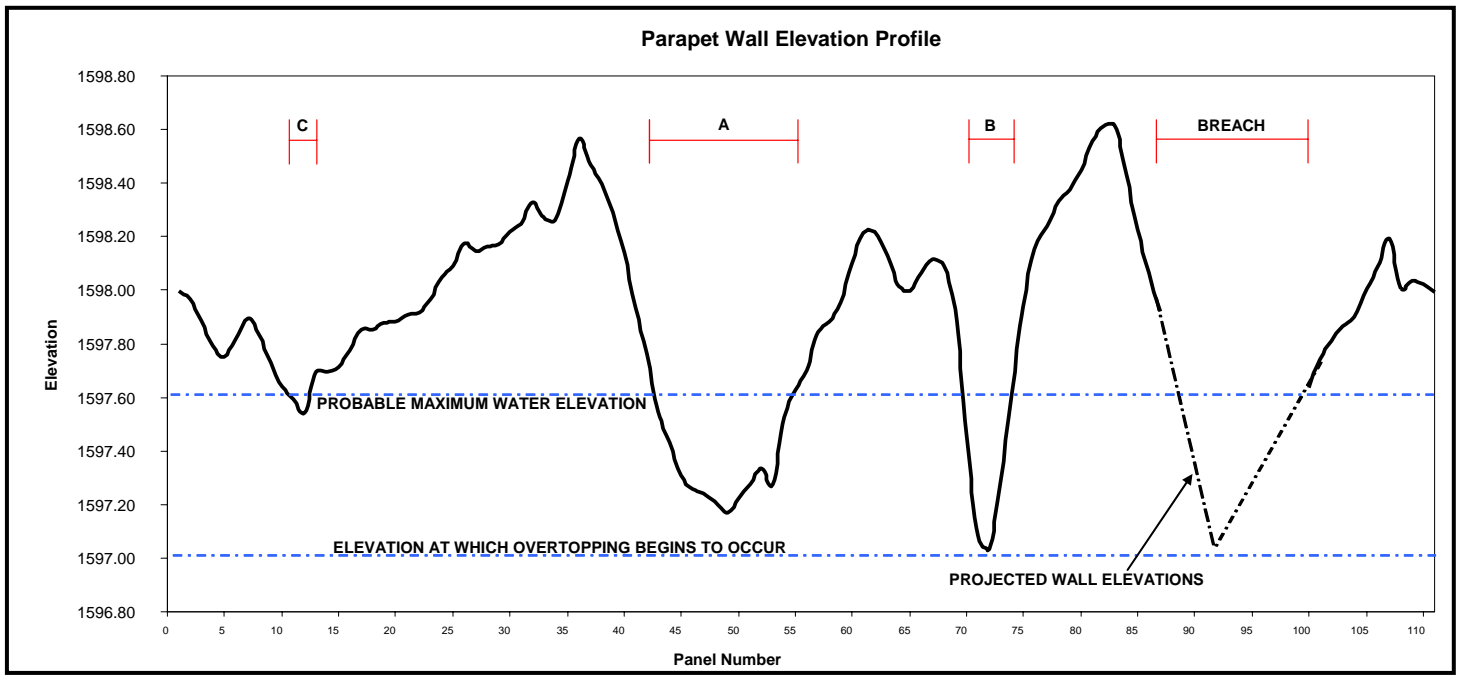
Analyses were performed to quantify overtopping water flow and scouring and undermining at the downstream crest. Figure 8 illustrates the concrete parapet wall profile, the probable elevation at which overtopping started, and the probable maximum water elevation during the failure events. The analyses revealed that overtopping flow could initiate scouring and undermining. The extent of scouring and undermining varied as a function of the parapet wall crest elevation and overtopping flow depth at various locations. Flow depth was defined as the height of water flowing over the parapet wall sections.

The segment between panel 70 and panel 74 experienced a greater effect from scouring and undermining than the location between panel 43 and panel 54. Due to the lower wall crest elevations between panel 70 and panel 74 and the resulting higher flow rates exiting the reservoir at this location. Also, the segment between panel 70 and panel 74 began overtopping before the segment between panel 43 and panel 54. The time factor associated with scouring and undermining caused less scouring and undermining between panel 43 and panel 54. The maximum differential settlement between the two locations was approximately 0.2-feet. If the parapet wall segments in the breach area experienced settlements similar to panel segments 70 through 74, the effects of scouring and undermining could have been similar.

Fig. 8. Parapet wall elevation profile (source: MoDNR data).
