Moisture Induced Damages to Building Foundations

Case One: Building and Parking Lot Distress, Clear Lake City, Houston, Texas

Case Two: Basement Floor and Sidewalk Settlement, Downtown, Houston, Texas.

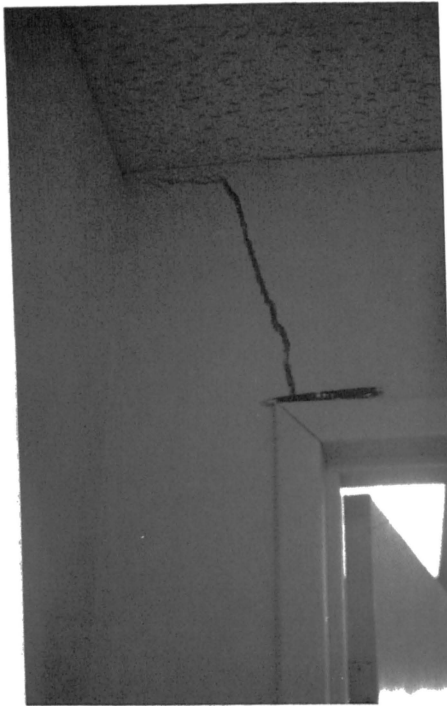
FIG. 1. Typical Damage to the Building Wall

6. Significant cracks in the north wall of the building and an area of maximum floor heave in the offices along the north side are adjacent to the area of the water line break.

Cause Of Cracking And Deformation: The pattern of deformation and presence of high plasticity clays warrants the conclusion that observed movements were caused by moisture variations in the high plasticity clays underlying the site. However, it appears that two separate conditions of moisture change occurred as follows:

1. Moisture decrease due to withdrawal of moisture by trees and vegetation caused shrinkage and cracking of soils beneath pavement areas.
2. Moisture increase, due primarily to the water line break and possibly from watering of flower beds, caused swell of soils beneath the building.

Location of hedges and particularly oak trees with respect to distressed pavement areas is believed conclusive evidence of the cause for pavement failure. Similarly, occurrence of significant wall cracks and floor heave immediately adjacent to the area of the water line break, and more significantly, occurrence of structural movement within the last six months following the water line break and a period of 12.5 years without structural movement, is believed conclusive evidence that movements were caused by excess moisture supplied by the water line break. Structural movement in the east wall, a considerable distance from the water line break, must also be related to the excess moisture supplied by the break since movement in this area also occurred within the last six months. The presence of slickensides and fissures in the clays resulted in rapid flow of water from the break to the south side of the building or other areas beneath the building, depending on the frequency and continuity of the fissures. However, excessive watering of flower beds due to day weather conditions may also represent another source of excess moisture that would induce heave of the supporting soils.

Corrective Methods: The potential for continued movement in the foundation soils under the building at a decreased rate until equilibrium is established necessitated that no corrective action be undertaken until movement was complete. Several measurement points were therefore established at crack locations on the walls to determine if movement was continuing or was complete. Given below are the results of the crack monitoring program;

As can be seen, no appreciable movement was noted during the next five months and the client was advised to make necessary repairs.

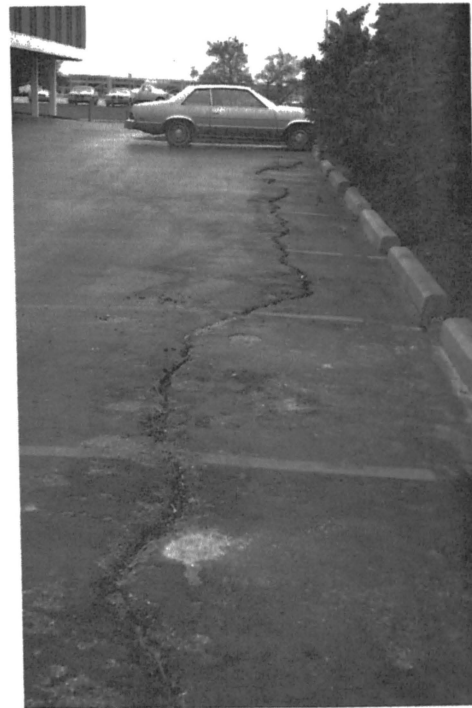
3. The areas of pavement distress appear to be exclusively related to the presence of vegetation with areas of maximum movement generally adjacent to areas with oak trees.

FIG. 2. Typical Pavement Distress in the Parking Lot

The cause of movement in the parking area, namely vegetation and trees adjacent to distressed areas, clearly indicates that prevention of future pavement failure would necessitate replacement of vegetation and in particular the trees with foliage that has a shallow root system and can be watered effectively from the surface. It can be anticipated that pavement movements may encompass a large area as existing root systems expand with tree size. Accordingly, the following programs were recommended.

1. Replace existing trees and vegetation with foliage that has a shallow root system and minimum water requirement.
2. Relevel and pave distressed areas.

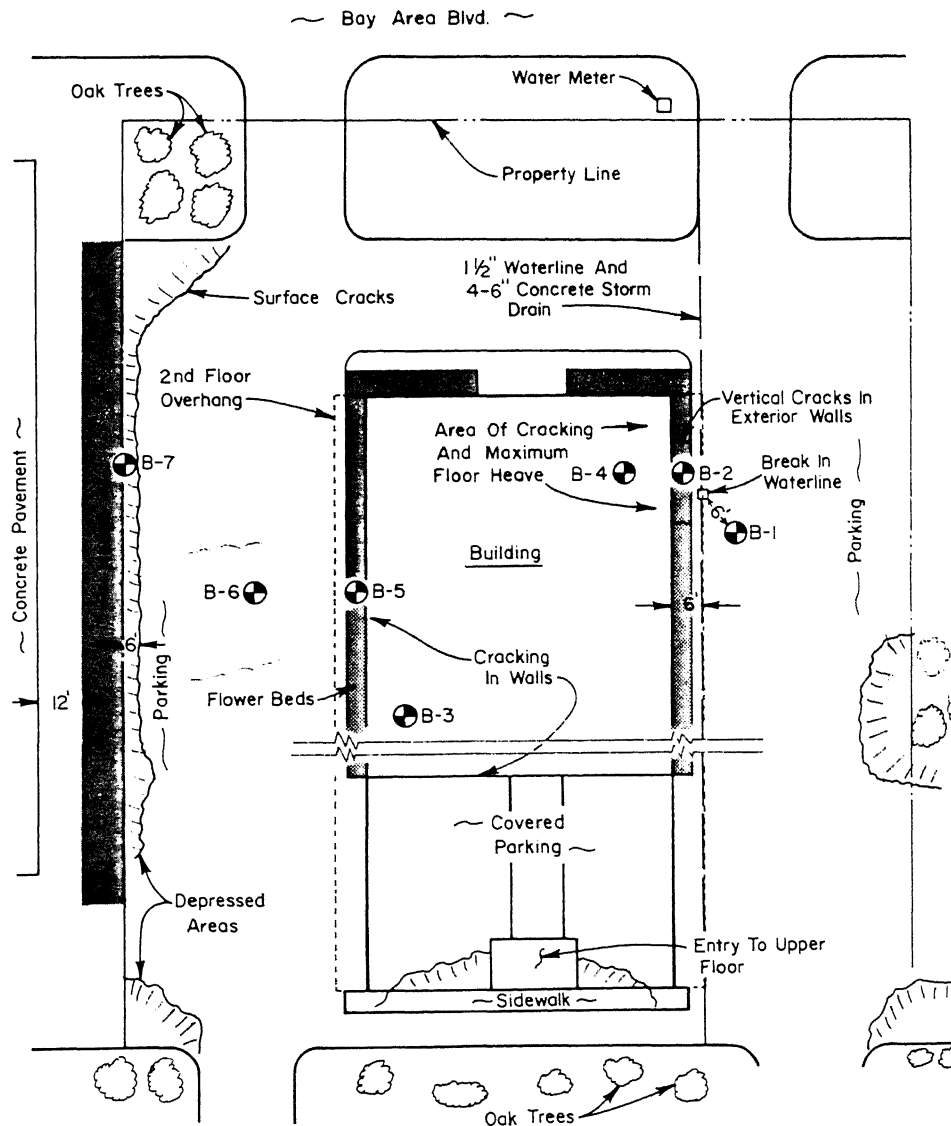
FIG. 3. Building Layout and Plan of Borings

4. No sewers or water lines are present beneath the structure. However, a 1-1/2 inch water line and a concrete sewer line are located within 6± feet of the north wall as shown on Fig. 3.

Field Investigation: Subsurface conditions in the building and parking lot area were defined by seven borings drilled to a depth of 10 feet. Locations of the borings are shown on Fig. 3. Two of the borings, B-3 and B-4, were inside the building; borings B-2 and B-5 were in the flower beds on the north and south sides of the building and the remainder of the borings were located in the parking lot. Borings B-2, B-3, B-4 and B-5 were hand auger and jar samples were obtained at regular intervals. Undisturbed samples were obtained continuously at other locations to a depth of 10 feet.

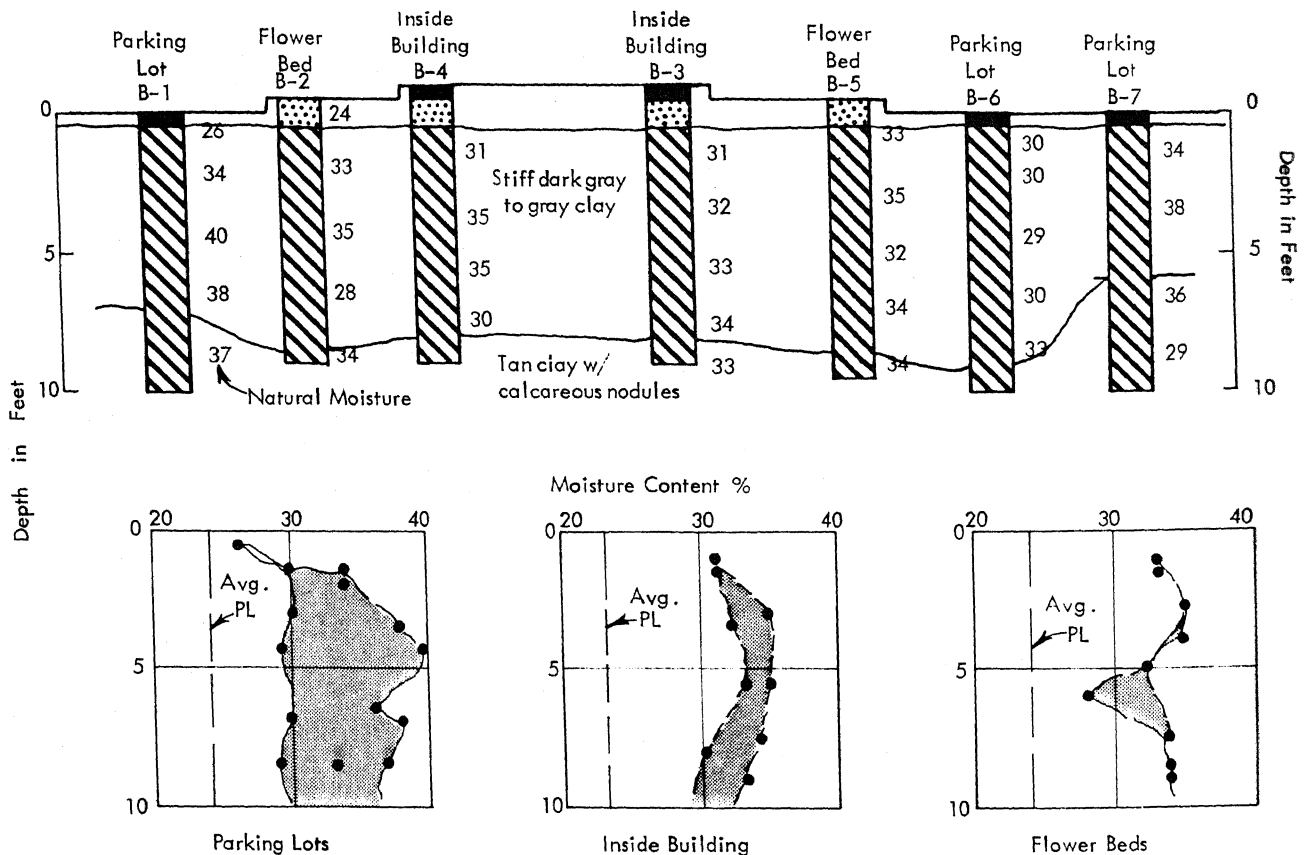
FIG. 4. Generalized Stratigraphy and Summary of Test Results

Site Stratigraphy: Stratigraphy defined by the study is shown in profile form in Fig. 4 together with the moisture content and plasticity data. Deposits at this site consist of stiff dark gray to gray clay underlain by tal clay. The clays are slickensided and deeper zones con-

Soil Moisture Conditions: Moisture content data are tabulated on the profile and grouped by areas in the lower data plots in Fig. 4. Comparison of the data shows that moisture contents are presently above the plastic limit. Moisture contents for soils underlying the parking lots show that a substantial range in values exists in these areas as compared to data for soils below the building and flower beds adjacent to the building. Pertinent moisture data are summarized as follows:

1. Moisture contents beneath parking areas vary from an average of 30 percent to an average of 37 percent. Maximum average values were measured in B-1 near the area of the water line break. Boring B-7 near a crack in the pavement also exhibited maximum moisture contents. Boring B-6 in the central area of the parking lot that is not cracked exhibited an average moisture

2. Average moisture content in soils below the building is on the order of 35 percent in B-4 nearest the water line break and 33 percent in B-3 in the southeast corner of the building.
3. Average moisture content in soils below the flower beds averages 34 percent.

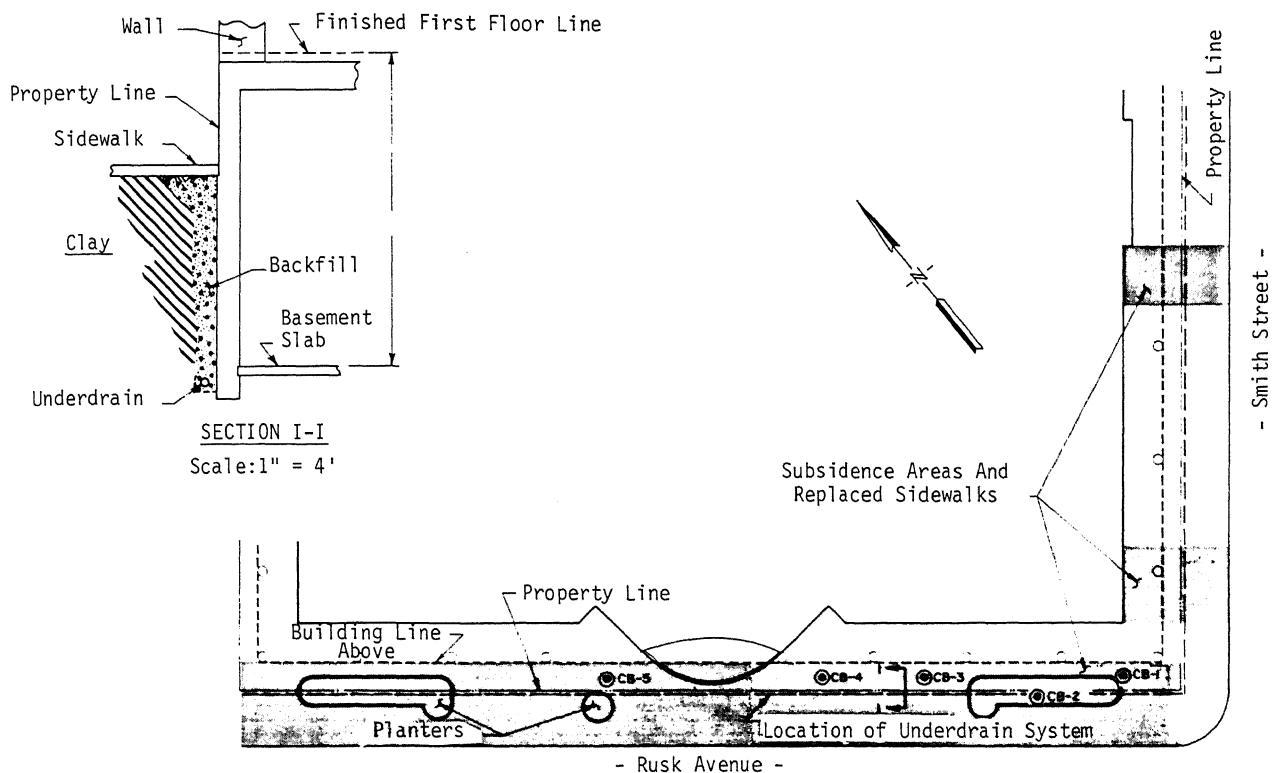
FIG. 5. Plan of Borings and Section

Field Investigation: Subsurface conditions in the sidewalk area were defined by five borings drilled to a depth of 20 feet below sidewalk elevation. Locations of the borings are shown in Fig. 5. Undisturbed samples were obtained continuously from the surface to a depth of 12 feet and then at depths of 15 and 20 feet.

During an interview with the building manager, it was disclosed that, in recent years, a water pipe under the building broke on two different occasions. A considerable quantity of sand and gravel along with fines was removed from two sump pits connected to a drainage pipe located immediately outside the exterior building wall at the elevation of the basement floor level. The sand and gravel removed from the sumps during the water line breaks most probably originated in the filter material around the drainage pipe. Furthermore, the presence of these coarse soils inside the underdrain indicates that this conduit may be broken. Another possible source for the coarse soils found in the sumps is the sand bed under the basement slab. This indicated the development of voids under the floor slab close to the basement wall. Concurrent with this, a void 12 inches deep was recently discovered under the basement floor during grouting operations. Recurrent settlement of the sidewalk can therefore be connected with yielding of the clay fill into the voids created by departure of the sand from around the perimeter drainage pipe. Soft clay zones were found in borings CB-1 and CB-5 at depths within the range of 10 to 14 feet while the - probably broken - drainage pipe runs just outside the perimeter building wall, below the sidewalk, at a depth on the order of 11 to 12 feet.

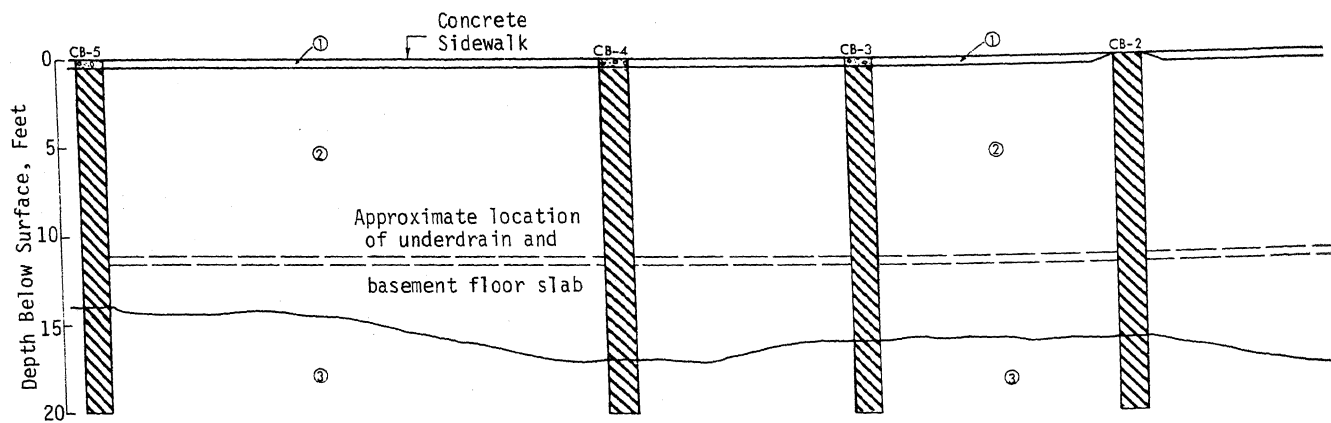
FIG. 6. Generalized Stratigraphy

General Soil Conditions: Typical stratigraphy in the sidewalk area is shown by the profile in Fig. 6. Soil conditions are generally uniform. Fill 14 to 18 feet thick was found below the concrete sidewalk. The fill generally consists of firm to stiff brown and gray clay with sand, concrete rubble and gravel inclusions. It also contains organic roots and calcareous nodules. Undrained shear strength of the clay fill generally ranges from 600 to 1800 pounds per square foot, except at some soft spots. The unit dry weight generally ranges from 99 to 105 pounds per cubic foot.

Stiff to very stiff red slickensided clay underlies the fill. This clay is typical of the Beaumont formation and is overconsolidated. The preconsolidation pressure of this clay is on the order of 10,000 pounds per square foot. The plasticity index of this clay ranges from 27 to 34 and the natural moisture content ranges from 27 percent to 33 percent. The unit dry weight is about 100 pounds per cubic foot. Groundwater was found eight to 10 feet below the sidewalk surface elevation.

Cause Of Sidewalk Settlement: It can be concluded at the outset that the overconsolidated red clay below the fill will not consolidate under current overburden pressure, because it has been consolidated before under a much higher load, which is known as "preconsolidation pressure." Preconsolidation pressure is generally estimated from the void ratio-vertical pressure plot obtained from laboratory

consolidation tests. The estimated preconsolidation pressure of the red clay, as found from the consolidation test results, is on the order of 10,000 to 12,000 pounds per square foot, which is much higher than the existing overburden pressure, including any ordinary surcharge. Therefore, deformations must have occurred within the fill.

Based on the above discussion, it was concluded that the sidewalk settlement is probably directly related to voids that exist in the filter material around the perimeter drainage pipe located at the basement floor level. The voids in the filter material resulted from water pipe breakdowns and subsequent wash out of sand and gravel material through the pipe. Additional voids may have been created in the backfill behind the basement wall.

1. The most simple alternative would be to allow the sidewalk to settle for some time and then replace it with proper grade elevation and compaction. The disadvantage of this alternative would be the relatively long time and costs involved.
2. Inspect the area of maximum settlement with the aid of a T.V. camera to determine location and extent of damage to the underdrain system. The advantage inherent in this alternative would be the relatively low cost of locating the breaks and the consequent reduced cost of the subsequent repairs.
3. Excavate to the level of the underdrain along the settlement area to check for breaks in the drainage pipe and replace it with a perforated pipe surrounded by filter material and filter fabric, then backfilling under the sidewalk area with properly compacted granular or non-cohesive material.

Grouting techniques were not considered suitable because of the risk of plugging the underdrain.
