REGULATORY, ENVIRONMENTAL AND GEOTECHNICAL SOLUTIONS TO CONSTRUCTION OF A ROADWAY EMBANKMENT OVER A LANDFILL

Victor A. Modeer
District Engineer, District 7
IDOT, Effingham, IL 62401

Mary C. Lamic
Studies and Plans Engineer, District 8
IDOT, Collinsville, IL 62234-6198

Paper No. 10.11

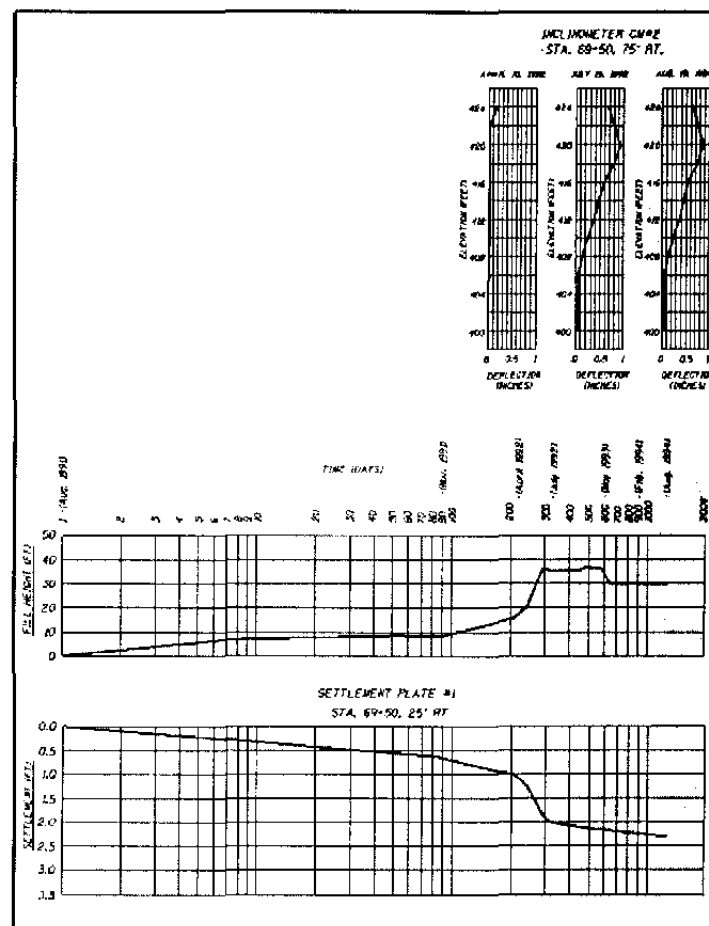
Fig. 2 - Settlement and Inclinometer Plots

Additional inclinometers were installed along the toe of the bridge cone end slope. See Figure 1. The inclinometers were installed 25 to 50 feet below the ground surface along the perimeter of the embankment. Inclinometers were monitored bi-monthly. Figures 2 and 3 show the cumulative resultant deflection plots for inclinometer readings between August 1991 and August 1994. Each plot shows movement perpendicular to the slope and indicates the movement is outward. The maximum horizontal movement in the refuse

layer is 12 to 24 feet below the ground surface. The maximum deflections for inclinometers CM #1 and CM #2 were 0.9 and 1.2 feet, respectively. Most of the movement took place during construction of the embankment. The readings show the ground is moving horizontally away from the embankment at a current but decreasing rate of approximately 0.15 inch per year. Based on the rate of movement and the inclinometer plots, there are no indications that a failure surface has developed at this time.

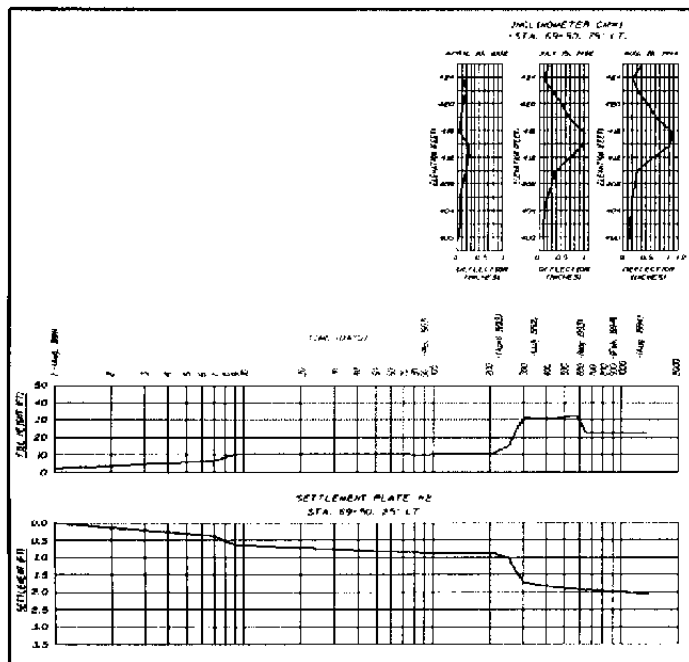
Fig. 3 -- Settlement and Inclinometer Plots

A total of fourteen settlement plates were installed prior to fill and surcharge placement. As the landfill was loaded, settlement was relatively immediate and settlement curves from all 14 settlement plates showed similar linear rates of settlement. Unlike normal clay soils the landfill consolidated immediately, typically 5 to 7 days of loading. As depicted on Figures 2 and 3 the maximum rates of movement occurred immediately after additional fill was placed. Because the settlement along the preloaded section was not monitored between the time the surcharge was removed and embankment construction commenced, it was unclear if the landfill rebounded after the load was removed. Assuming the refuse did not rebound significantly, total settlement including movement during preloading ranged between 2 feet and 3 feet for fill heights ranging between 18 and 25 feet. Settlement readings for all settlement plates showed 10 to 15% of the

landfill thickness consolidated beneath the embankment. Settlement plots two years after construction showed the landfill is settling vertically at a current but decreasing rate of .7 inch per year. Plots five years after construction show no movement.

The horizontal and vertical movements are characteristic of secondary compression and possibly undrained creep. The landfill material does not fit the category of soil types or conditions that would be susceptible to creep; however, this is the most similar plastic deformation model available to the authors and as such undrained creep was qualitatively analyzed. The initial log of strain rate versus log time plots after primary consolidation was completed have a slope that is flatter than 1:1 indicating creep to failure. The plots two years after construction have steepened indicating a stable condition.
