FAILURE OF EMBANKMENT ON SOIL-CEMENT COLUMNS FOR THI VAI PORT, VIETNAM

Nguyen Minh Hai

Bengt H. Fellenius

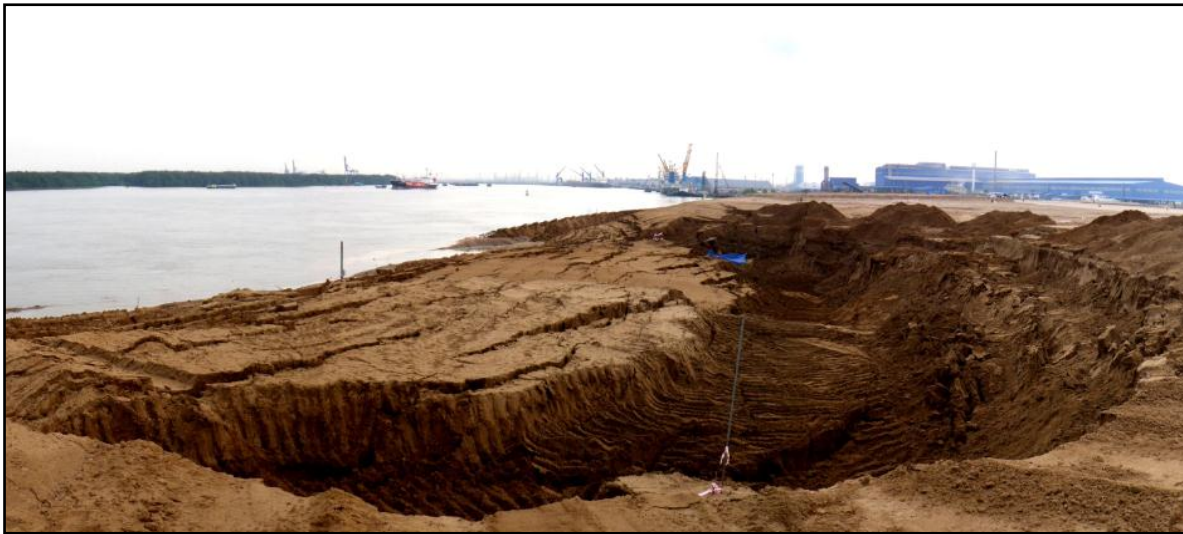
surface about 30 m from the bank along about 100 m length. The cracks are shown on the photograph in Figure 1. In the morning of July 12, 2010, the width of the crack noticeably and progressively increased until, at 07:50h, the river bank failed along an about a 200 m long stretch. Figure 2 shows a photograph of the failure. A significant crack developed parallel to the river about 30 m inland, extending about 400 m along the river bank. All soil-cement columns along that length broke about 11 m below the fill surface. Figure 3 shows an artist's view of the future Port with the failed area marked out.

Fig. 2 Slope failure on July 12, 2010, viewed upstream

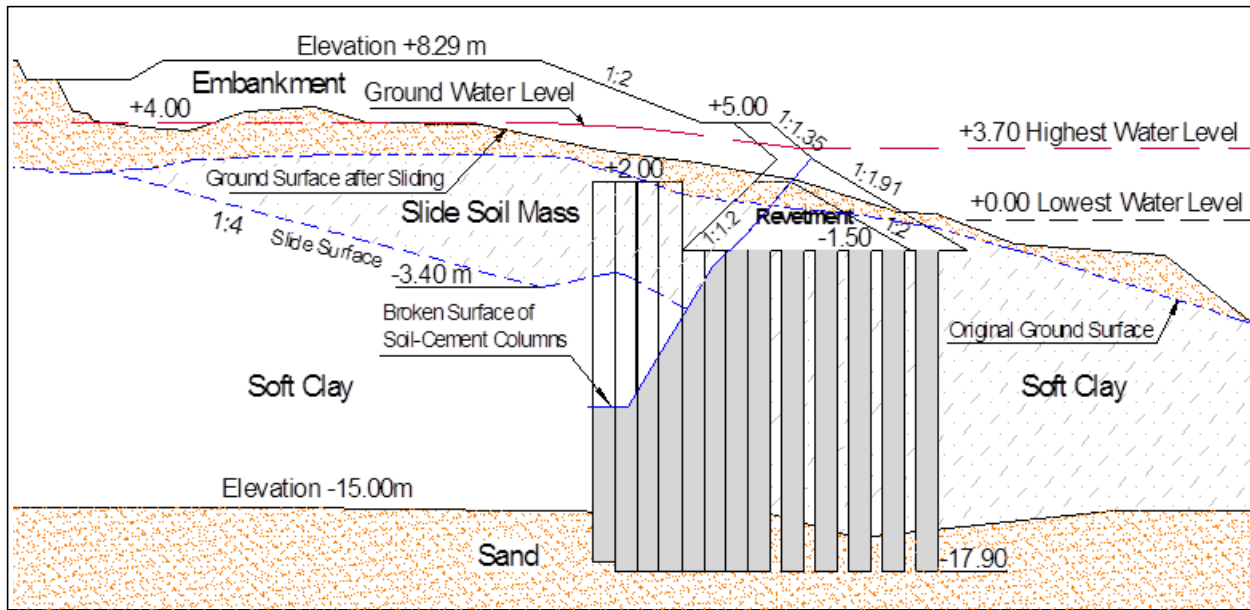
Figure 10 indicates the slide surface starting about 30 m from the river bank and sloping down at 1(V):4(H) toward the soil-cement columns at a depth of about 11 m below the original ground surface, breaking the columns. The lowest location of sliding surface was at Elev. 3.4 m, and the fill and ground surface after slope failure was lower than groundwater level (Elev. +4.0 m). The columns failed along an approximately horizontal plane, which suggests that the type of failure was by translational sliding and wedge.

Fig. 10 Cross section of failed embankment

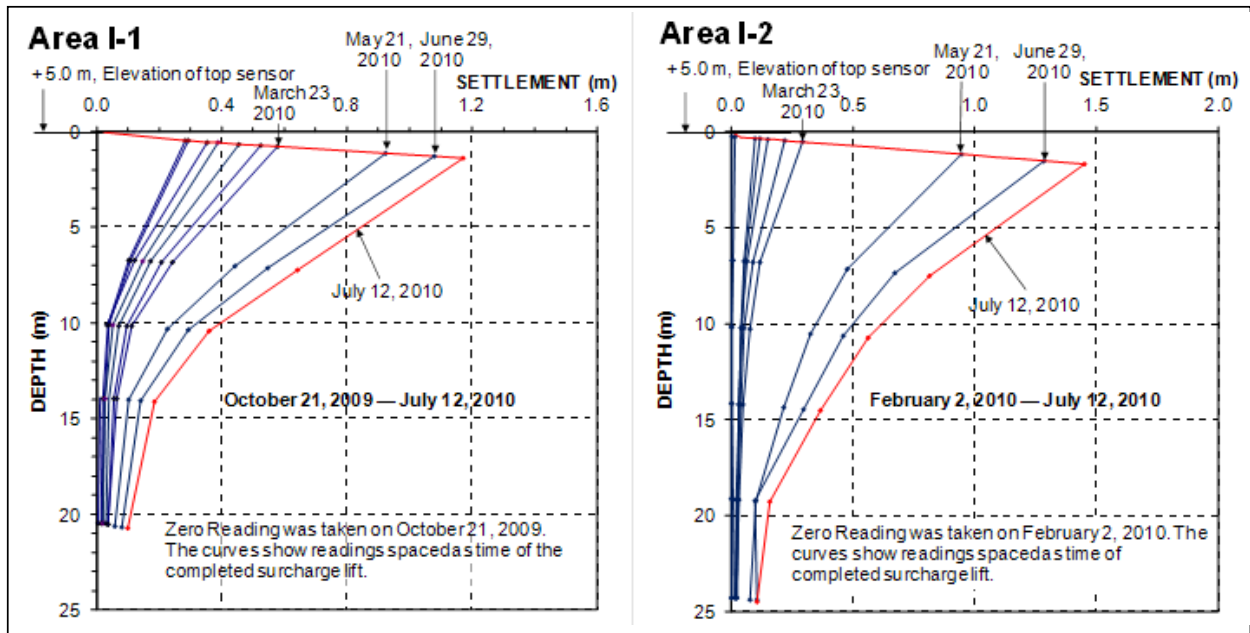
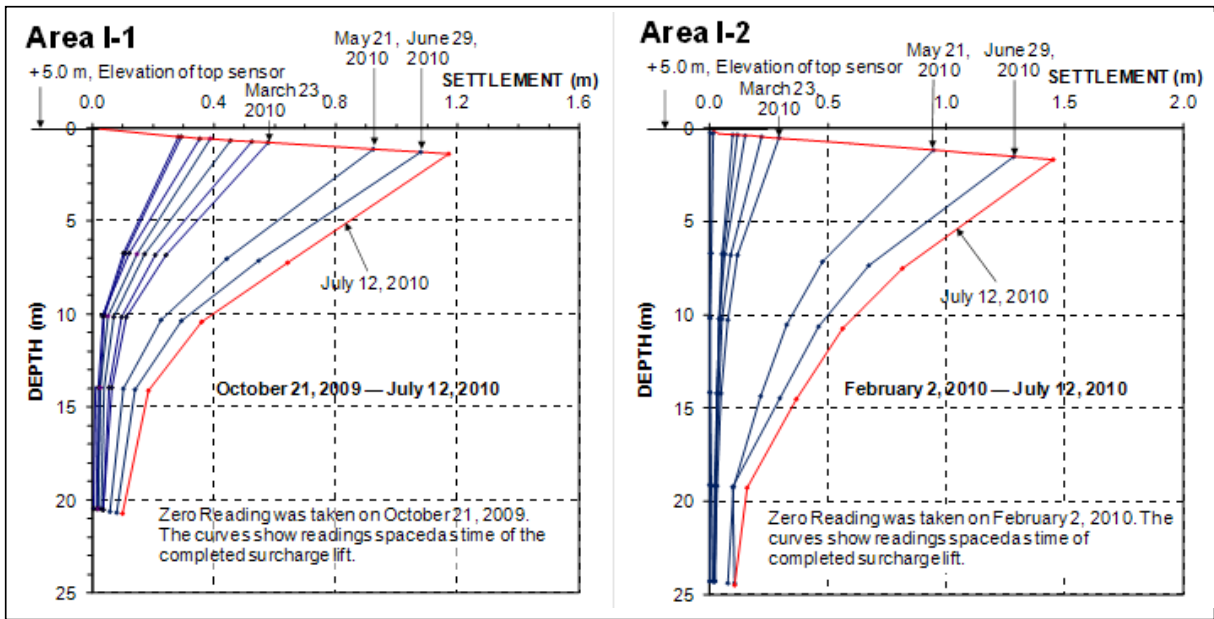
Figure 11 indicates the distribution of settlement versus depth at monitoring stations SS 1, P2 at Area I 1 and SS 3, P1 at Area I 2 just outside the failure area. The records were taken at the occasion of the completion of the placing of each, approximately equal, fill lift at the monitoring point. The recorded settlements are also indicated by the figure showing the records at the gradually increasing depth of each particular settlement anchor point.

The settlement readings in extensometer stations E1 and E2 in Areas I-1 and I-2 started on October 21, 2009 and February 2, 2010, respectively. The final set of readings (the red curve) is from July 12, 2010, the day of the slope failure. The records show increasing settlement between March 23 through May 21, 2010, in Area I-1, and March 30 through May 29, 2010, in Area I-2 respectively. This increase coincided with lateral displacements observed in inclinometer measurements taken during the surcharge lift to Elev.+8.1 m in Area I 1 and to Elev.+8.9 m in Area I 2.

Fig. 11 Distributions of settlement with depth below original ground surface at Areas I-1 and I-2

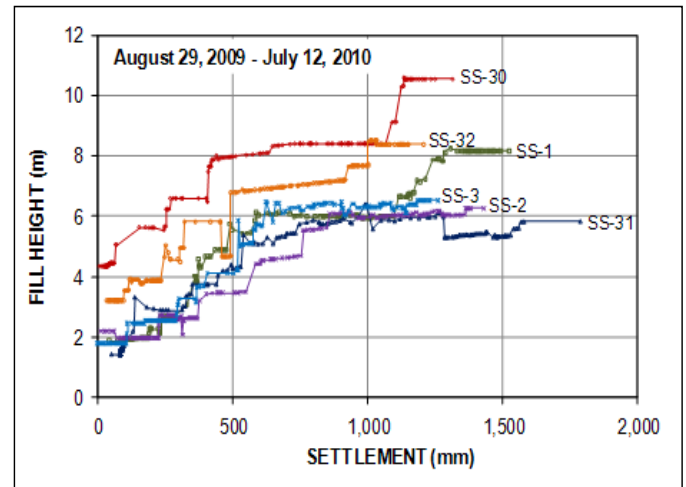
Figure 12 shows the measured settlement as a function of the fill height at the failure area, Areas I 1 and I 2. Stations SS-30 and SS-31 are inside the failure area. The settlements were monitored from August 29, 2009 through July 12, 2010, and October 28, 2009 through July 12, 2010, respectively. The graphs indicate that when the fill height of SS 30 in Area I 2 was increased to about 10.6 m (to Elev.+9.9 m), the settlement measured was smaller than that measured at SS 31, where the fill height was about 5.5 m (to Elev.+6.6 m).

The figure shows that at Station SS 31, where the about 1 m of fill was removed (May 7 through July 2), the settlements continued to increase, which is considered to be a consequence of the fact that the soil mass below SS-31 was moving laterally toward the river.

Fig. 12 Fill height vs. settlement

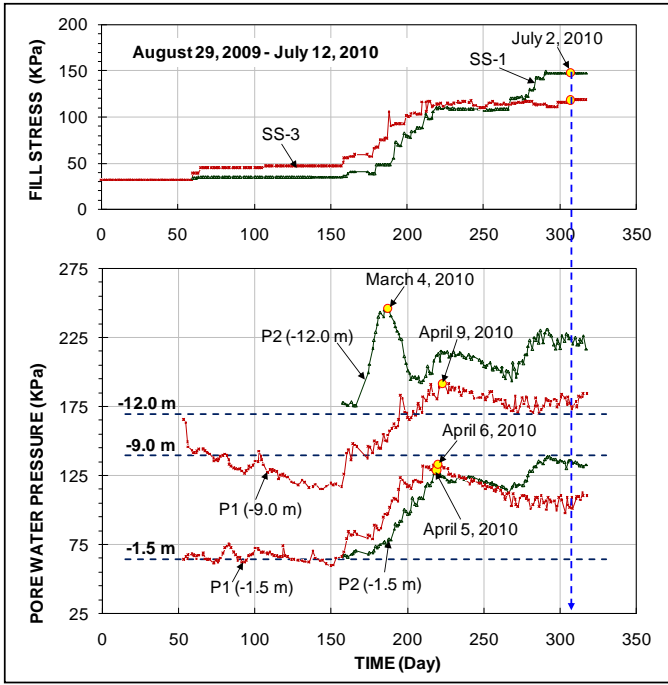
Figure 13 shows the measurements of pore water pressure at piezometers P1 (Area I 1) at Elevs. 1.5 m and -9.0 m, and at piezometer P2 (Area I 2) at Elev. 1.5 m and -12.0 m, both immediately outside the failure zone. The pore water pressures were monitored from October 21, 2009 through July 12, 2010, and February 2, 2010 through July 12, 2010, respectively (placing of fill started on January 30 and February 8, 2010, respectively). The dashed horizontal lines are the zero phreatic pore pressures at the indicated elevations.

The measurements show the pore pressures to rise as the placing of fill commenced. However, after about April 6, 2010, and March 4, 2010, in Areas I-1 and I-2, respectively, no further increase of pore pressure was measured. The measurements indicated excess pore pressures elevations at piezometer tip depth Elev.-1.5 m were at Elevs.+9 m to Elev.+13 m about 4 to 8 m above the original pore pressure phreatic height at that depth. The maximum phreatic elevations for the deeper down piezometers, P1 at Elev.-9 m

and P2 at Elev.-12 m, were Elev.+8 m and Elev.+11 m, respectively, about 3 to 6 m above the original pore pressure phreatic height at the piezometer tip depths. The excess phreatic heights correspond to a range of excess pore pressure of about 30 through 80 KPa. In comparison, the increase of total stress due the fill was about 150 KPa. It was expected that the wick drains and soil-cement columns would be effective in dissipating the increase of pore pressure due to the placing of the fill. However, it is likely that the horizontal shear movements developed pore pressures which counteracted the dissipation from the consolidation.

Fig. 13 Measured pore water pressure vs. applied stress

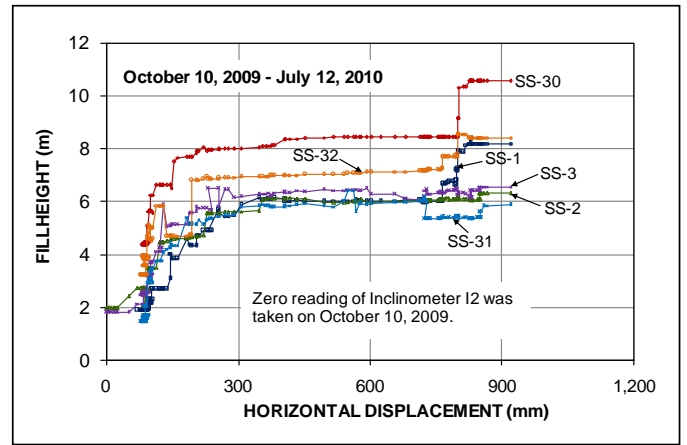
Figure 14 shows fill height versus horizontal displacement at all relevant monitoring stations. When the fill height at Area I-1 (SS-2, SS-3, SS-31, and SS-32) reached a height of about 5 m to about Elev.+7.30 m, corresponding to a stress increase of 100 KPa, the settlement increased significantly. In Area I-2 (SS 1 and SS 30), the similar increase occurred at a fill height of about 8 m (at about Elev.+8.0 m; stress increase of 150 KPa).

Fig. 14 Fill height vs. horizontal displacement

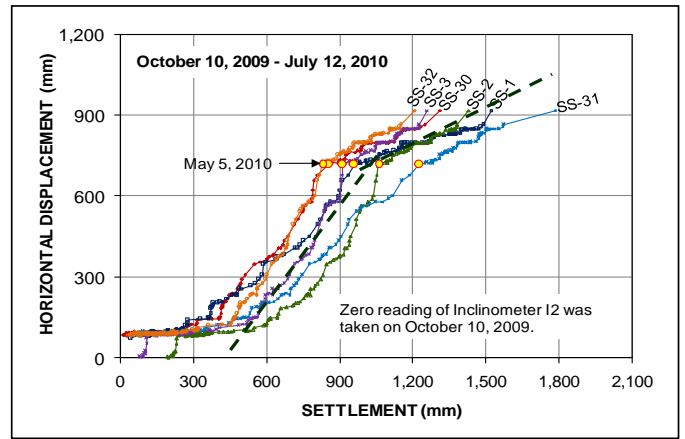
Fig. 15 Settlement vs. horizontal displacement

Figure 15 shows the horizontal displacement versus settlement obtained from inclinometer measurements. Until May 5, 2010, the horizontal displacements and settlements were about equal. However, thereafter, the horizontal displacement became about 2 to 3 times larger than the settlement. The dashed red lines in the figure show the average slopes of displacement to settlement of about 0.8 and 2.8, respectively.

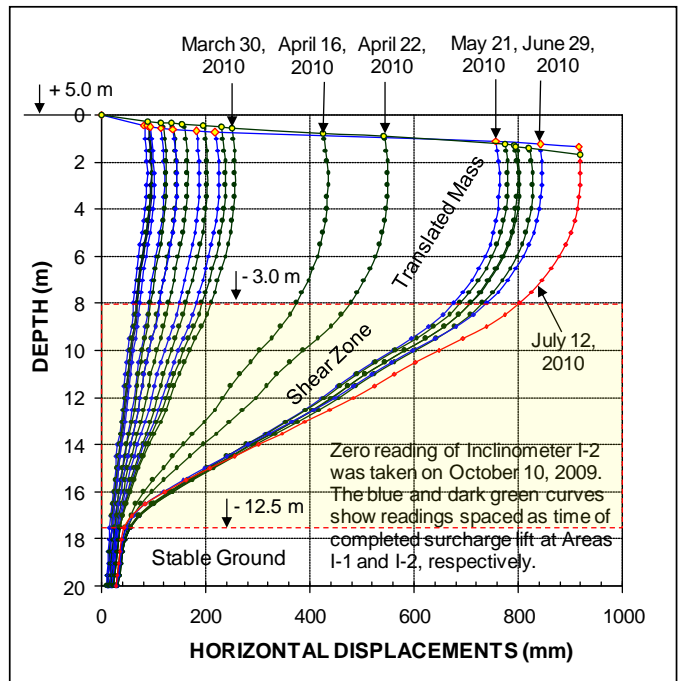
Figure 16 presents the measurements of horizontal displacement versus depth from October 10, 2009, through July 12, 2010, at the two inclinometer stations. The blue and dark green curves show the readings after completion of each surcharge lift at Areas I 1 and I-2. The lines connecting the top of each curve shows the fill surface level below the Elev.+5.0 m line on the date of the measurements. The measurements show that the onset of the sliding occurred after March 30, 2010, and that translation soil mass movement dominated down to Elev. 3.0 m, about 5 m below the original ground surface (Elevs.+2 to +3 m) and 8 m below the fill surface, with shear zone movements below and to Elev.-12.5 m, about 15 m below the original ground surface. The key zone for the analysis of the slope failure is at about Elev.-3 m, where soil shear can be assumed as fully mobilized by the slide.

Fig. 16 Horizontal displacement versus depth

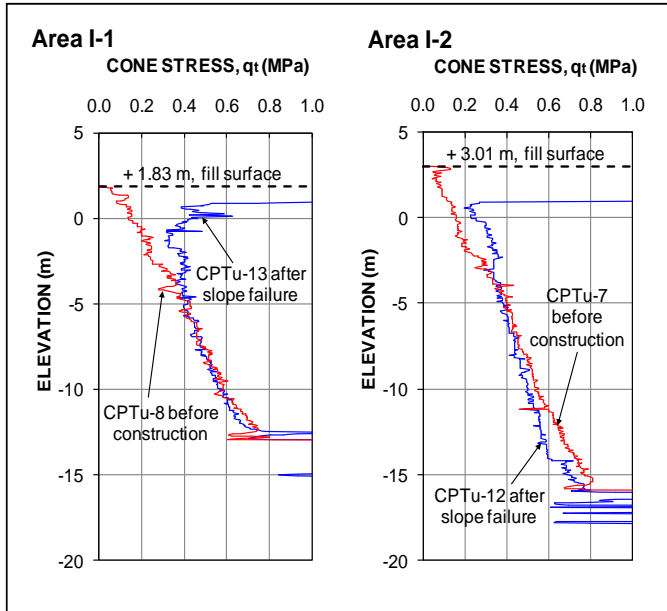
Figure 17 indicates a comparison between the distributions of cone stress from the CPTU soundings performed before and after the slope failure (correlated to elevation), suggesting little or no change between the cone stress for before and after the slide. An increase of shear strength would have resulted in an increase of cone stress. Instead, the cone stress from Area I-2 below Elev.-3 m even showed a decrease for the sounding after the failure.

Fig. 17 Cone stresses, q_b , versus depth in Area I-1 and I-2
