Stabilization of a Tailings Dam by De-Watering

SYNOPSIS The failure of the outer slope of one of the paddocks of a tailings dam, resulted in a significant decrease in the area available for tailings deposition. Overloading of the remaining five paddocks resulted. To maintain the stability of the existing dam whilst construction of new disposal facilities was in progress, three techniques were investigated; horizontal, push-in drains at the dam toe, a rock buttress around the operational paddocks, and vertical de-watering wells installed on the first terrace, or 'step-back' of the dam. De-watering wells proved most effective, and 165 wells were installed. A monitoring programme included regular determination of the water level in each well, and the installation of piezometers at selected locations around the dam. These observations were used to optimise the use of the five remaining paddocks, thus ensuring stability of the dam during the transfer of deposition operations to two new tailings dams.

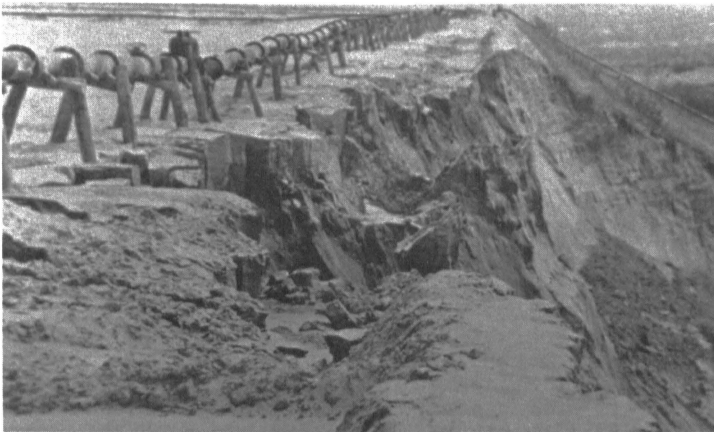
Whilst stability analyses were being undertaken using the water levels measured in these piezometers, a major slip of the North face of the dam occurred in September 1978. At the location of the slip, the dam was approximately 32m high, and as can be seen from Figure 1, the slip affected the entire outer height of the dam. It was about 110m long at crest level, and presented as a classic infinite-slope geometry. Fortunately, the line of two piezometers that was located in the area of the slip had been read only two days

before the slope failure occurred. Furthermore, the slope had been surveyed a few days previously, so the geometry of the slope and the location of the phreatic surface at the time of failure were extremely well defined.

Figure 1. Slope failure on north-eastern paddock of dam.

Observation of the failed slope indicated that the plane of failure was highly unlikely to have been circular, and was most likely a wedge-type failure, with a steep back slope and the horizontal portion confined to the underlying weak clay layer, (see Figure 3). The results of a number of undrained (with pore pressure

Immediate de-commissioning of the North-East paddock was implemented, thus decreasing the area available for tailings deposition by about 13%. As it happened, the above problem coincided with an increase in the amount of tailings produced, as a result of increased tonnages being mined and processed. Recognising that these factors would combine to result in the dam rapidly being loaded beyond its design capacity, and being mindful of the catastrophic failure of Bafokeng tailings dam in 1974 (Jennings, 1979), plans were immediately initiated for the design, construction and commissioning of alternative facilities for tailings deposition. A fuller understanding of the existing stability of the remainder of the dam, as well as a measure of how this would change as a consequence of the increased rate of rise was clearly necessary.

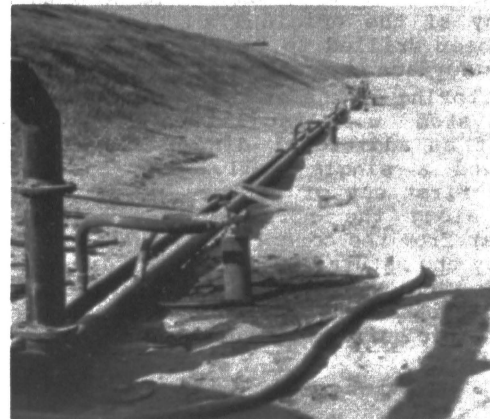
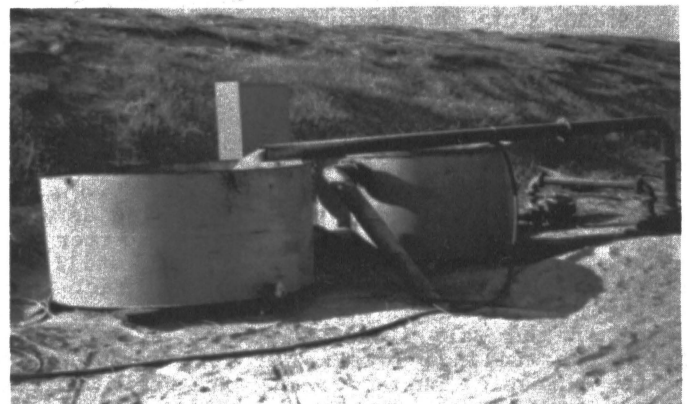
A venturi pump was installed in each well, and each group of twenty wells was connected to a supply and overflow reservoir. An idea of how the system works can be gained by reference to Figure 7. Figure 7a illustrates the drive line and return water line (which is of course a larger diameter), connected to the venturi pump systems. Figure 7b shows the supply and overflow tanks.

Figure 7. Arrangement of de-watering system.

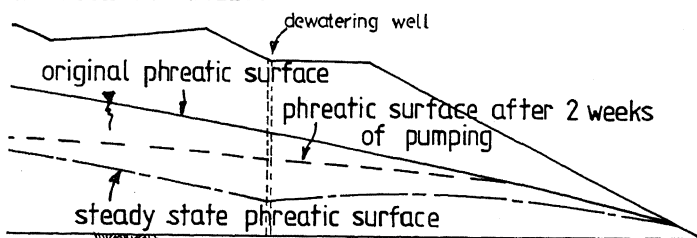
Figure 8. Section showing draw-down effect of de-watering system.

Results that were obtained using these piezometers are shown in Figure 8, which shows the drawdown for the section midway between two wells that was achieved after two weeks pumping as well as after 15 months continuous pumping. After two weeks of pumping, the drawdown was still in progress, which is attributable to the fact that at the time these readings were taken, the water level in the well itself was only about 18.5m below the tailings level. The long-term steady state phreatic surface can be seen to be significantly lower than the original elevation. The drawdown that occurred in the wells surrounded by the nest of nine piezometers is shown in Figure 9 for a nine-month period. It can be seen that it
