Comments Upon an Earth Dam Severely Damaged by Foundation Liquefaction

SYNOPSIS : The damage of the Draganesti earth dam on lower sector of the Olt river due to foundation liquefaction during 30 th May 1990, 0.12 g in site maximum acceleration, Vrancea earthquake is described. The dam is up to 20 m maximum height and border cross-wise and laterally the reservoir with 12.6 km length of the low head hydroelectric power station . The damage consisting of a large slide with about 60 m length at the dam downstream face and some cracks and lift-up of the reinforced concrete slabs at the corresponding upstream toe zone was placed in a zone where any special technology for increasing the relative density of the foundation loose sand layer was not applied . The natural relative density of the above mentioned layer having 1.20...7.00 m thickness was $D_r=0.15...0.30$, but it was increased up to 0.55...0.65 by vibrated-compacted gravel microcolumns technology, that was applied for over 80 % of dam foundation area. A comprehensive seismic backanalysis is performed in order to explain the damage mechanism.

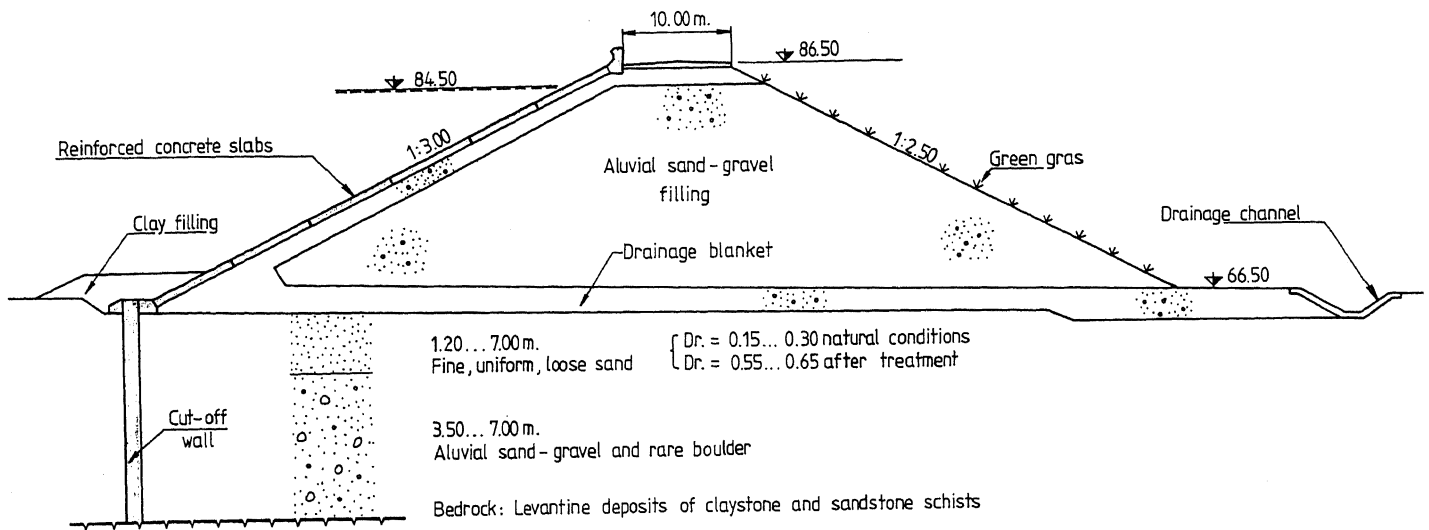
A cross section of the earth dam typical for Draganesti hydropower plant is presented in Fig.2. It consists of reinforced concrete lining on upstream face, drainage blanket and sand-gravel compacted fill. This cross section is common for a lot of earth dams built in Romania and its performances in operation has been full satisfactory.

Fig. 2. Typical cross section of the Draganesti earth dam and geological profile in the dam area.

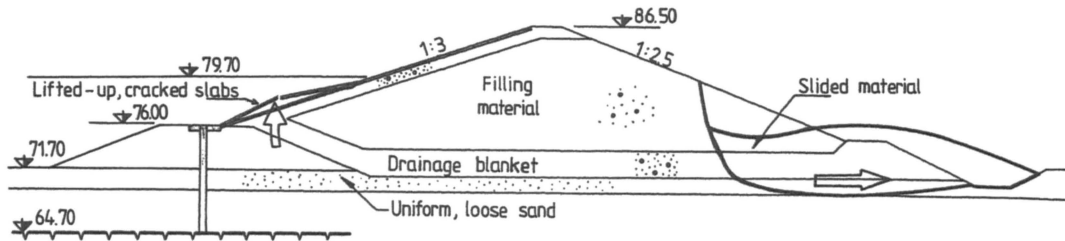
Fig. 4. Sketch of the Draganesti earth dam damage due to 30th May 1990 Vrancea earthquake.

A sketch of the along the river earth dam damaged zone is presented in Figure 4. This zone was about 60 m length, on the left bank of the Olt river, placed between km 3.900 and km 4.000 upstream from cross main dam (see Fig. 1,b). The reservoir level, during earthquake, was 4.80 m under reservoir normal operation level, respectively 6.80 under dam crest level.

The slide from the dam downstream face had a crack plane quite vertically beginning from half of the dam slope. In horizontal plan, the slide shape at upstream and downstream ends are circular arches closed in the dam downstream bench. Some diffuse water seepage were detected in this zone, which after sliding concentrated in two

springs of about 2...3 l/s. The site investigation has not detected any dam-foundation material erosion. The sliding material filled up the drainage channel from the dam downstream toe. Some cracks were noticed on the dam downstream bench in the slide neighbouring adjacent zones.

The judgement of the collected data from in-situ investigations, previous laboratory testings and computing numerical analysis conducted to conclusion that accident was due to liquefaction of the uniform, loose sand layer from dam foundation. Although a technology for improving the quality of this layer was applied for over 80% of the dam foundation area, it was not applied in the

accident zone. That special technology was not applied in the zones where sand layer thickness was under 1.5 m. In this case the compaction by vibrating roller of 160 kN was considered to be sufficient for a satisfactory increase of the small natural relative density of the sand layer. The accident shows that the expected performances did not carried out.

The remedial measures at the dam downstream face consisted of removing in the first stage of the slid material. In the second stage, the slide void volume was filled with drainage material compacted in layers of 0.5 m thickness by 160 kN liess roller excluding shaking. A stabilization bench of 10 m width was erected at the dam downstream face up to half of dam height in an old river bed zone. At the dam upstream face the joints sealing was repaired, the slab cracks were filled with epoxi resines and some slabs very damaged were replaced. The remedial works were carried out in two months.

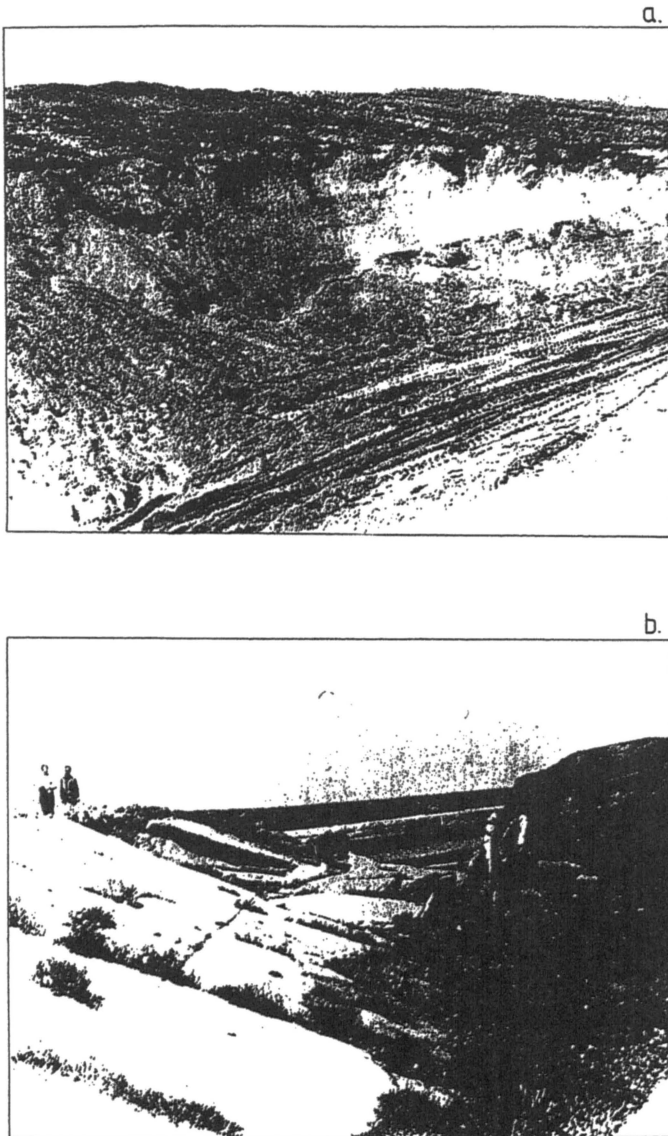
Fig. 5. Pictures of the damage : a- dam downstream face; b- dam upstream face.

The investigations carried out at dam upstream face corresponding to slide zone from downstream face have shown some important cracks and lift-up of the reinforced concrete slabs. Immediately after earthquake, the reservoir level was scheduled to be decreased with 0.5...1 m/24 hours speed. In this rate, the reservoir was partial emptied in the about next two weeks.

Some pictures of the dam damage at downstream and respectively upstream face can be seen in Fig. 5.

The damage at the dam upstream face seems to be provoked by the earthquake excessive uplift pressure. In the foundation corresponding zone the generated maximum ratio u/σ'_v resulted 0.9, but the seal of the upstream face stopped the dissipation of the earthquake generated pore pressures. Consequently, uplift pressures generated on internal face of the concrete lining provoked the lift-up of slabs, associated to joints sealing breaks and cracks.

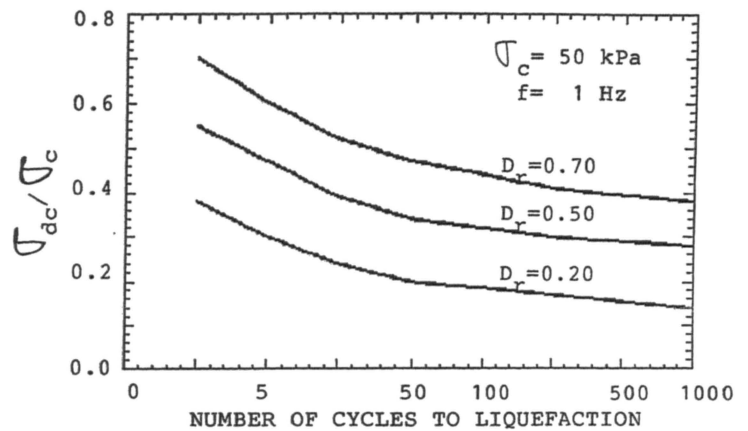
Fig. 6. Results of cyclic loading triaxial tests on Draganesti undisturbed samples (tests performed by INCERC-Bucharest).

Figures 6...8 illustrate some input and output data. The results of cyclic loading triaxial tests on undisturbed samples of the Draganesti-Olt sand are presented in Figure 6. The cell of the dynamic triaxial apparatus had 50mm diameter and 100 mm height. The consolidated undrained samples are initial compressed by axial vertical pressure σ_1 and radial confining pressure σ_3 . A dynamic cyclic stress σ_{dc} , modeled by a piston with double action, is added at the initial stress state. The initial σ_1, σ_3 stress state of the sample is according to the tested material place in the dam-foundation system. The dynamic cyclic stress σ_{dc} is computed according to earthquake characteristics. For the 30th May 1990 Vrancea earthquake with $M=6.7$ and peak ground acceleration in Draganesti dam area of 0.12g, the equivalent cyclic loading considered was 10 cycles of 1 Hz.

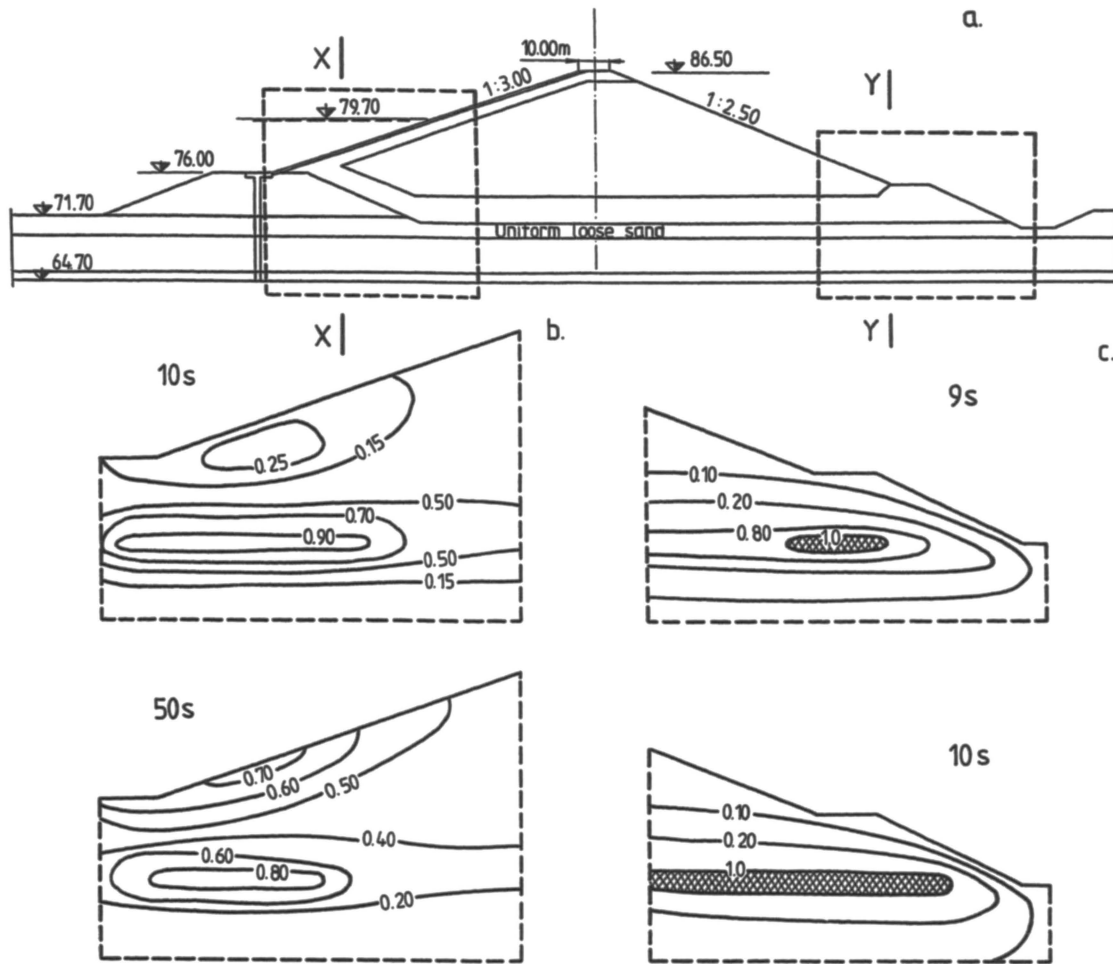
Fig. 7. Contours of the ratio u/σ'_v for different time steps during and after earthquake : a- dam-foundation system; b- dam upstream toe zone; c- dam downstream toe zone.

The contours of the ratio between pore water pressure (u) and effective stress (σ'_v) for different time steps during and after 30th May equivalent Vrancea earthquake are presented in Figure 7. More details concerning the variation of this ratio are illustrated in Figure 8 for two vertical longitudinal sections placed in the upstream and downstream toe zones of the Draganesti earth dam.

The results of the backanalysis conducted to the conclusion, that the dam downstream face slide was due to the uniform, loose sand layer liquefaction, existant in the dam foundation area. The layer liquefaction, according to the computed data, begins at 9 s after earthquake starting. The time moment of the slide seems to be at the end of the earthquake or at few seconds after earthquake ceasing.

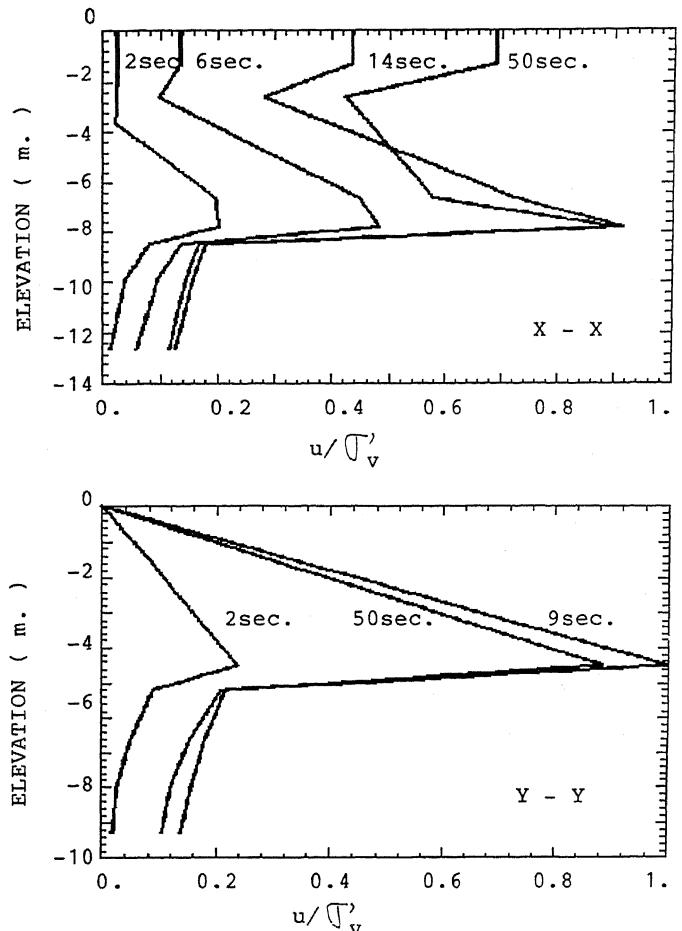
Fig. 8. Variation of the ratio u/σ'_v for different time steps during and after earthquake in longitudinal vertical sections X-X and Y-Y (see Fig. 7).
