Foundation Performance of Very Old Structures

S. C. Handa

Professor & Coordinator, Q.I.P. Centre, University of Roorkee, Roorkee, U.P., India

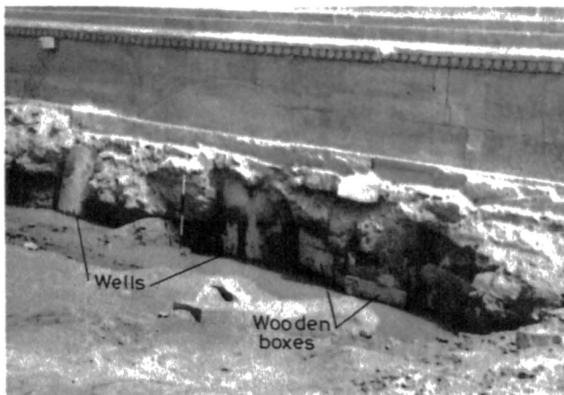
Fig.5: Exposed well foundations and wooden boxes under North wall.

The danger from the thrust of the waters of meandering river Yamuna were well realized by the constructors. Wells were also installed along the foundation on the river front. In addition wooden boxes filled with rubble have been located which serve as shock absorbers to avoid transmission of water shocks to the main structure, (figure 5). Series of wells away from the platform wall were also installed in the river bed to lessen and absorb the fury of river water and avoid any danger to Taj Mahal. These wells had been filled with sand and mud and were provided with wooden axles and spokes inside. These wells were constructed with bricks in lime mortar.

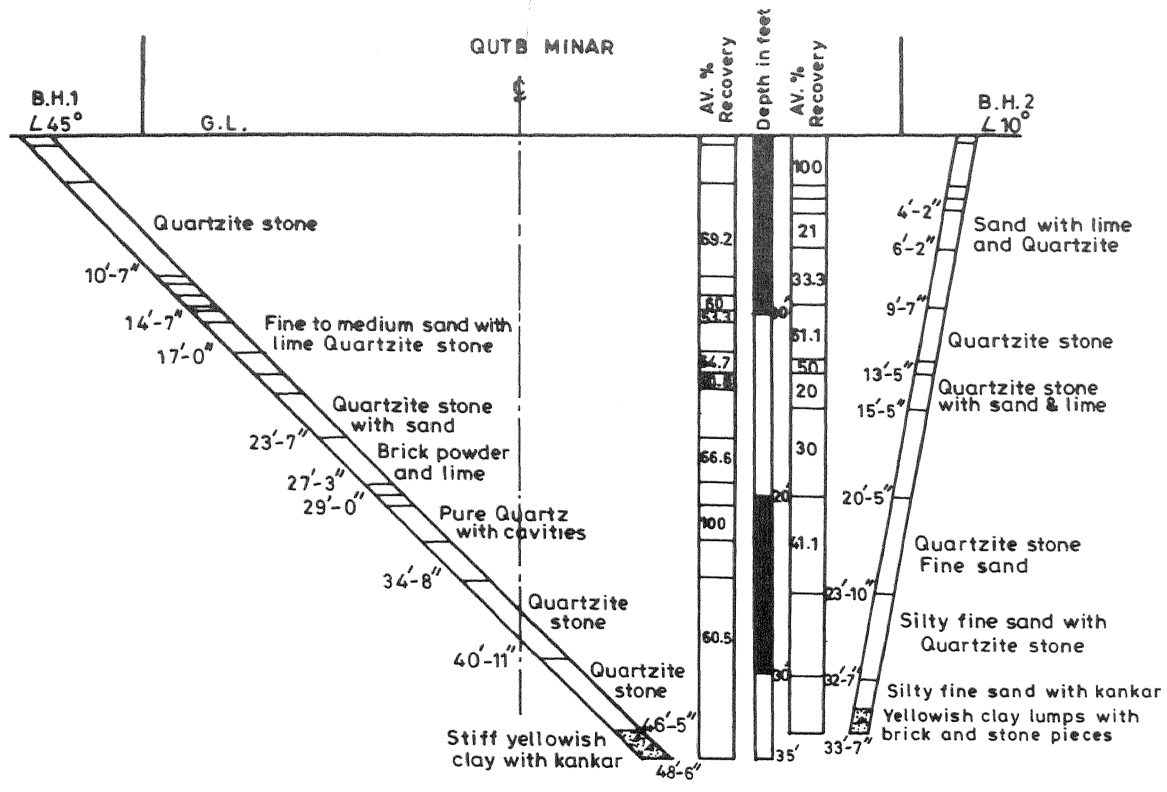
Fig.8: Borelogs at Qutb Minar

For the heavy loads and tall height of the minar, it had been believed for a long time that the minar would be resting on rock underground. The geophysical investigations were undertaken and resistivity measurements suggested that bedrock is located somewhere between 150 to 200 feet depth. This estimate would look uncertain for the fact that quartzite bedrock is exposed at the ground surface in nearby area to the minar. However, a study of the geology of Delhi and the subsoil profiles do confirm that the rock in Delhi sometimes have very sharp dips and the depth to the bedrock below ground level may vary rather too quickly over small horizontal distances. But one would wonder as to why the minar was not constructed on bedrock on a nearby location. The reason could only be its relative location to the mosque which was built by destroying and altering the existing temples. In order to have better idea about subsoil conditions, two boreholes were drilled in 1970. Borehole 1 was located in south-west direction and was inclined at 45 degrees and goes beyond the centre of the minar upto a depth of 35 feet. The second borehole was located in north-east direction and was inclined at only 10 degrees and was bored upto a depth of 33.6 feet. From the subsoil data, it can be seen that the strata is rather heterogeneous and consist mainly of quartzite stone with medium to fine sand. Strata consisting of sand and lime mixture is in a loose state having some cavities. There are cavities in the stone masonry also because of washing out of material from the space in between. The loss of water in the boreholes, the low percentage recovery and caving of boreholes support the theory of existence of cavities in the substrata. The bottom most layer at 32.8 feet depth in borehole 1 consist of stiff yellowish clay with kankar, which can be assumed to be the natural deposit, but however the similar clay deposit in borehole 2 contain brick and stone pieces. This somehow creates a doubt to say conclusively that natural deposits without filled up material exist below 32.8 feet depth. A deeper borehole could throw exact light on the subject but in its absence, it may be a fair assumption that the clay with kankar strata starting at about 32 feet depth is perhaps the natural deposit at site. The presence of lime between 13 to 20 feet depth does suggest that upto these depths, the rubble masonry was laid in lime to support the minar. It is also probable that below this and above yellowish clay with kankar, stone filling with earth was done.

However, the details do suggest somewhat heterogeneous construction material and techniques, (figure 8).

The percentage core recovery in the two boreholes is rather low but the percentage recovery in borehole 1 is better than that in borehole 2. The reason is that borehole 1 being more inclined goes under the minar even upto some distance beyond its centre line while borehole 2 is located by its side. The material in borehole 1 has thus been subjected to higher stress which should result in better core recovery. Moreover, borehole 1 is towards the south-west direction in which the minar is tilting and because of the increased stress in this direction, the material will be comparatively more compact thereby resulting in better percentage core recovery.

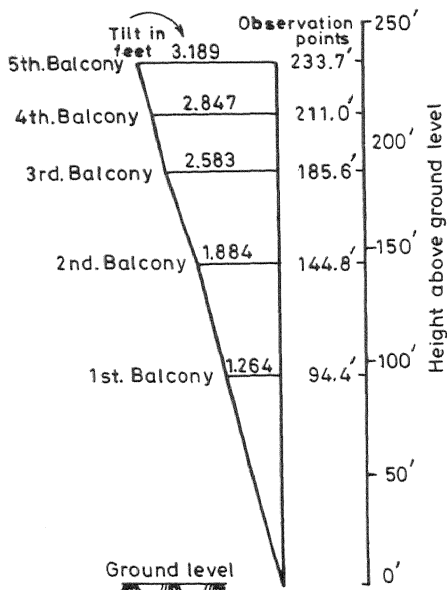
Fig.9: Tilts at Balcony levels (1976)

The observations taken by Survey of India in 1976 for the tilt of Qutb Minar at different levels is shown in figure 9. It can be seen that the minar is 3.189 feet out of plumb at the top in the south-west direction. The tilt of the minar and the weathering agents have resulted in cracks in the minar (figure 10).

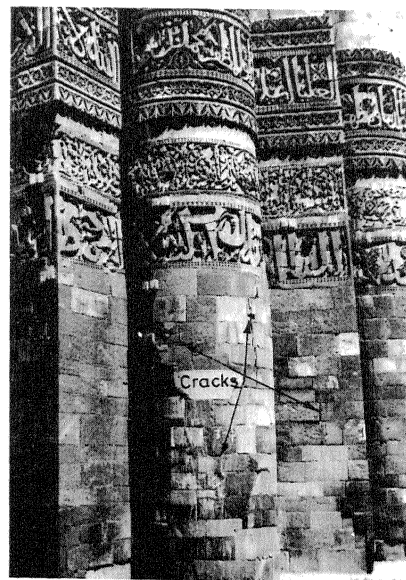
Central Building Research Institute took observations on Qutb Minar between 1976 to 1978. The crack width measurements were observed at several points with the help of deformeter after installing nylon pointers on two sides of the crack. Some of the cracks indicated continuous widening tendency suggesting immediate repair areas. Water level gauge and plumb assemblies were used for measuring tilt of Qutb Minar. For use of water level gauge, two water level pointers are fixed diametrically opposite to each other say one in S-W and the other in N-E

Fig.10: Cracks on outer face of Minar. Upper portion shows decorative bands.

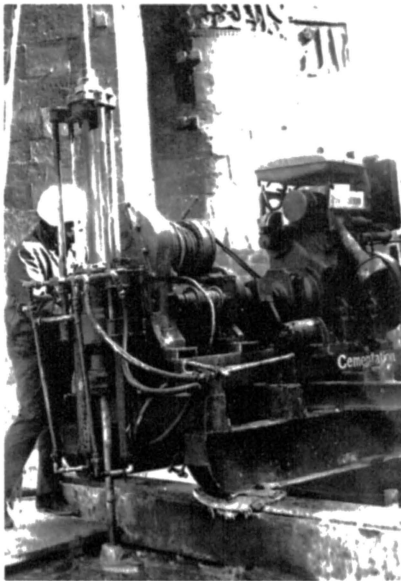
Fig.11: Grouting operation in progress at site (copy right A.S.I.)

In 1964, after the tilt in the minar was first observed, investigations into several aspects of the minar were undertaken. It was found that the substructure of the minar had open void spaces and the poor condition of its foundation could be the main cause of the tilt of this tower. The tilt though within safe limits at that time (25 inches) could increase and become dangerous. The differential settlement of the foundation was also the primary reason of some of the major cracks in the minar, the number and size of which was on the increase with time. With the increasing tilt the stresses in the soil could go beyond the ultimate bearing capacity and result in total collapse of the structure. In view of the above reasons, it was decided to strengthen the heterogeneous and weak foundation of the minar. The foundation was strengthened in 1972 by cement grouting which filled up all the voids in the foundation masonry thereby making it strong enough to withstand both static as well as earthquake loads in a better way, (figure 11).

The grouting also prevents any ingress of moisture into the substructure and the movement of soluble salts from the matrix. The grouting was done upto about 32 feet below ground surface. The grouting operation was performed in two phases. In phase I, a grout curtain was created by grouting holes along the periphery of the foundation platform making the grout curtain about 61 feet square in outside dimensions. Later the holes around the minar were grouted and then the holes in the four corners were taken up.
