Drake Lake Dam – A Performance Case History

DRAKE LAKE DAM - A PERFORMANCE CASE HISTORY

ABSTRACT

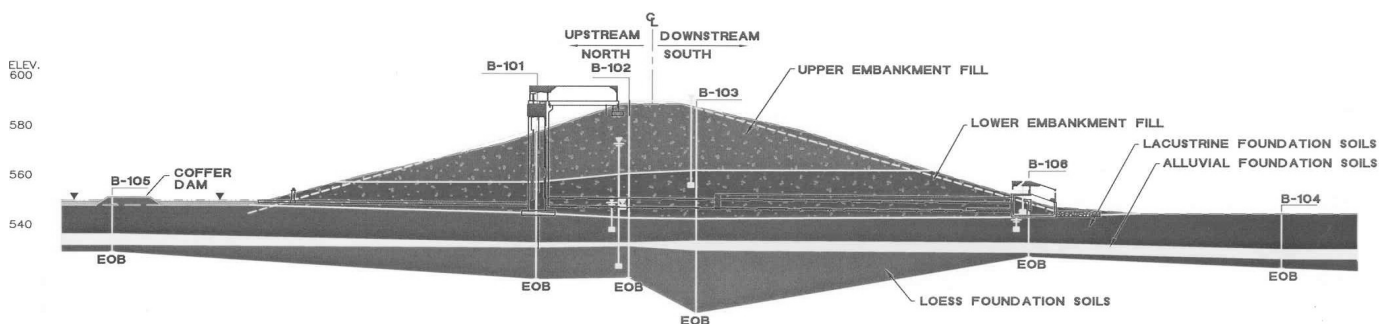
Fig. 2. Drake Lake - Cross Section

A cross-section depicting the subsurface conditions with the spillway structure super-imposed on the section as shown on Figure 2.

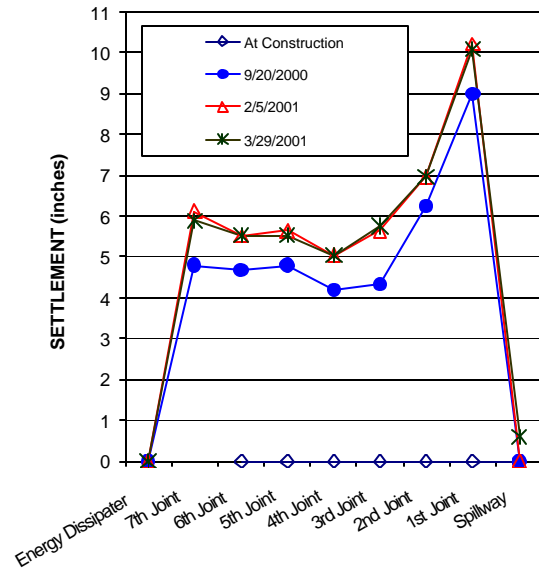
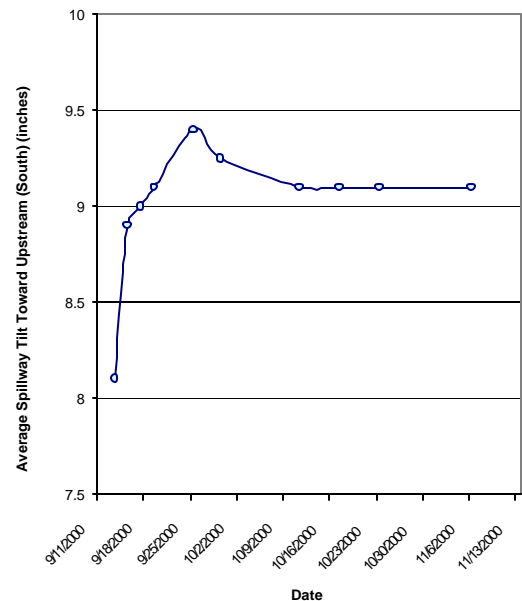
Measurements of the movement of the seven joints between the 20-foot RCP sections were also taken. The pipe joints were originally placed with minimal separation between the joints. The soils movement resulted in the separation of the joints. The joint separation readings indicated that the joint separation ranged from 0.72 to 3.54 inches. The greatest amount of movement occurred within Joint No. 2, located 40 feet downstream of the inlet structure.

Readings were taken of the joint separation along the outlet pipe, settlement measured at joints along the outlet pipe, and the amount of tilting that has occurred to the inlet structure. Results of these measurements are included on Figure 6A, 6B,

and 6C. Readings were also obtained to record the amount of tilting of the inlet structure in the south (upstream) direction. Assuming that the inlet structure was constructed level, the measurements indicate that the spillway tilted approximately 9.06 to 9.12 inches toward the upstream (south).

Horizontal movement measured in the principal spillway intake tower and the 36-inch RCP was apparently caused by lateral spreading of the embankment dam in both a downstream and upstream direction due to compressible and lower strength lacustrine foundation soils. We believe that rapid filling over the compressible lacustrine soil layer created a short time period of low shear strength in the relatively soft foundation soil due to excess positive pore water pressure. As a result, the soft foundation soil was overloaded, developed high positive pore pressures and essentially experienced plastic yielding or horizontal shear failure. Since the low strength foundation soils were restrained above by the embankment and below by the dense underlying till, the low strength silt crept laterally due to sustained driving shear stresses greater than the resisting stresses. Since the embankment dam was resting on a compressible silt layer, the dam and embedded structures moved horizontally and settled vertically in response to foundation soil movement. We believe that the principal spillway and horizontal pipe movements were caused by lateral spreading and vertical consolidation of the compressible lacustrine silt. The shear strength of the softer foundation soils material was considerably lower than anticipated, and the soft foundation soils could not consolidate fast enough under fill loading rates to limit lateral movement. Loss of drilling fluid in our mud rotary cased borings indicates that there were vertical cracks parallel to the dam alignment across the center portions of the recently completed dam with no pool. The ratio of settlement to horizontal movement that was measured in this dam (e.g., dh/ds equaled 0.7) should have caused cracking in the embankment. The maximum recommended dh/ds ratio for stable fills on compressible foundations should not exceed 0.4 per Ladd (1991).

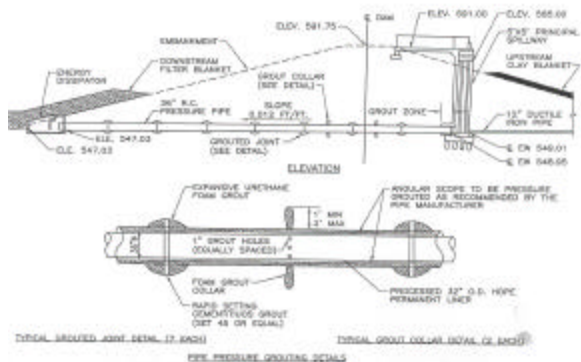
Fig. 8. Outlet Pipe Repairs NTS

The 36-inch RCP had joint separations up to 3.54 inches wide. Also, some sections had cracks along the pipe crown. The pipe was considered unsuitable to convey water through the embankment. The open joints and cracks could allow water to enter the dam embankment, which could result in a piping failure of the dam. Also, if the pipe was subjected to high flows, the openings in the pipe may act as a siphon, which would suction embankment material into the outlet pipe, resulting in voids at the openings. Due to these factors, the pipe was lined. A synthetic felt material, impregnated with heat-activated resin and HDPE liner systems, were evaluated for this project. The 30-inch diameter HDPE liner was selected since it is more ductile and able to accommodate future lateral and horizontal strains anticipated during the life of the structure. The HDPE liner pipe selected was a 1,000 Series PE 3408, Driscopipe with a 50 psi pressure rating.

Prior to installation of the liner system, the existing RCP joint cracks were grouted as an additional preventive measure against water seepage from the pipe into the surrounding subgrade. This grouting was performed from within the pipe at each joint using an expansive urethane foam grout. Figure 8 shows the HDPE liner system and the joint grouting detail.

Two cement grouted "dough-nuts" or anti-seepage collars were installed along the pipe between Joints 1 and 2 and between Joints 2 and 3. These collars were created with a pressure-grouted zone extending 1 to 2 feet outside the pipe. Figure 8 shows the grout collar concept.

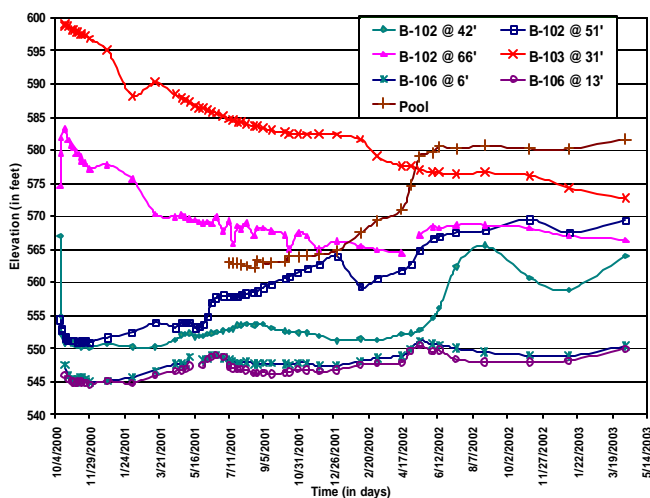
Fig. 9. Piezometer Results as of April 2003

As of May 2002, the lake level had risen to within 6 feet of the normal pool level. Instrumentation monitoring has continued to evaluate the dam performance as the reservoir fills. As indicated by the inclinometer and piezometer readings, the structure appears to be performing satisfactorily. Pore water pressure within the lower fill continues to dissipate as shown on Figure 9. There has been some continued settlement of the dam and its foundation as noted by inclinometer casing movement towards the centerline of the dam, shown on Figure 10. It is anticipated that some settlement of the crest of the dam will continue as the structure within the embankment

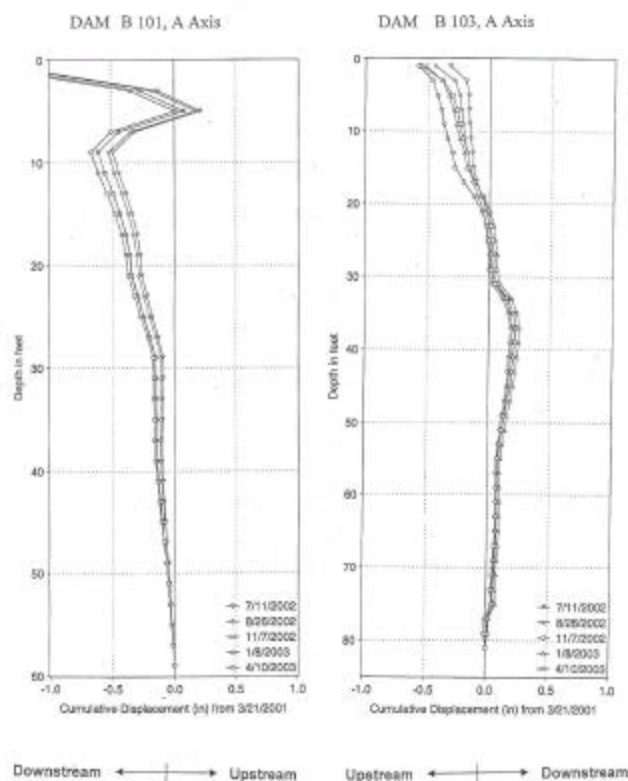
Fig. 10. Inclinometer Results as of April 2003

continue to heal by filling in with softened embankment soils. To date, the dam has performed as anticipated in the redesign of the structure. However, monitoring of the dam will need to continue.
