Missouri University of Science and Technology  
Scholars' Mine

International Conference on Case Histories in  
Geotechnical Engineering

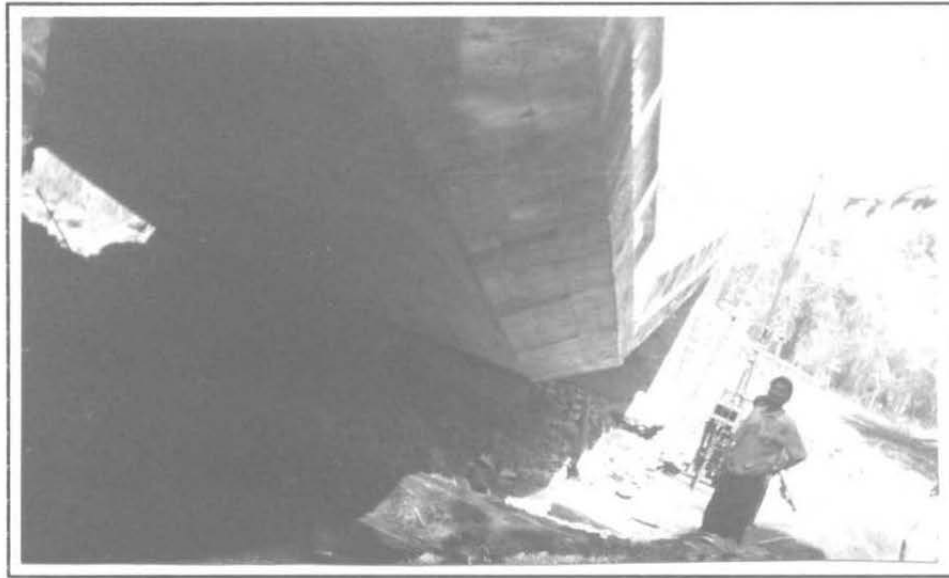
Photograph 1 View showing the collapse of pier

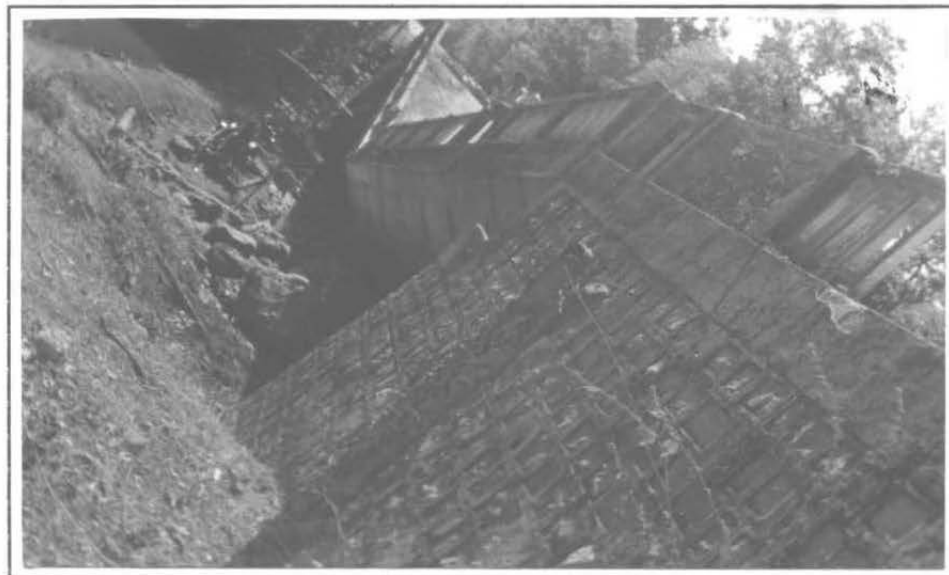
Photograph 2 Showing no damage signs in abutment and wings

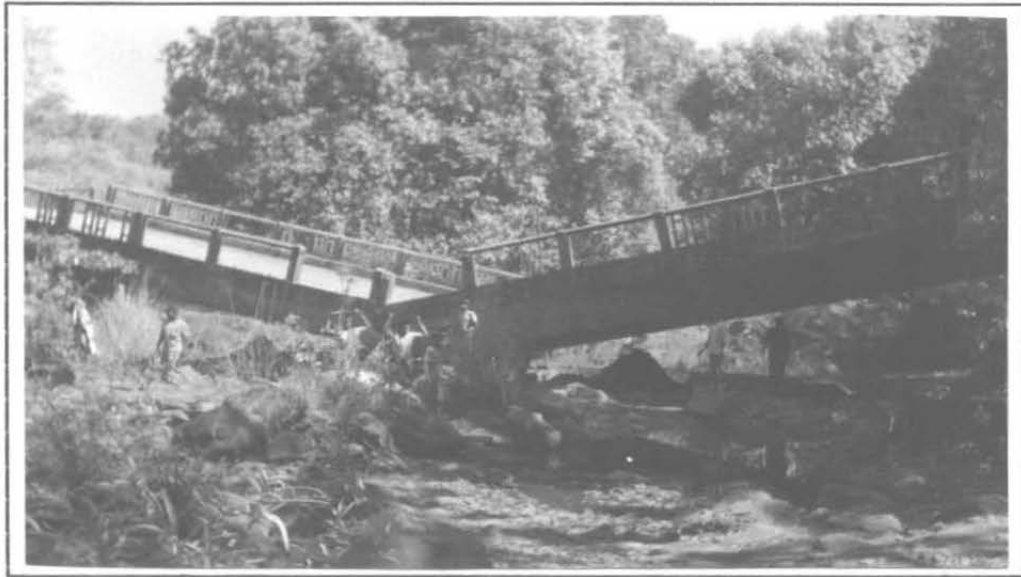
Photograph 3 View showing deck slab resting on bed level with no damage signs

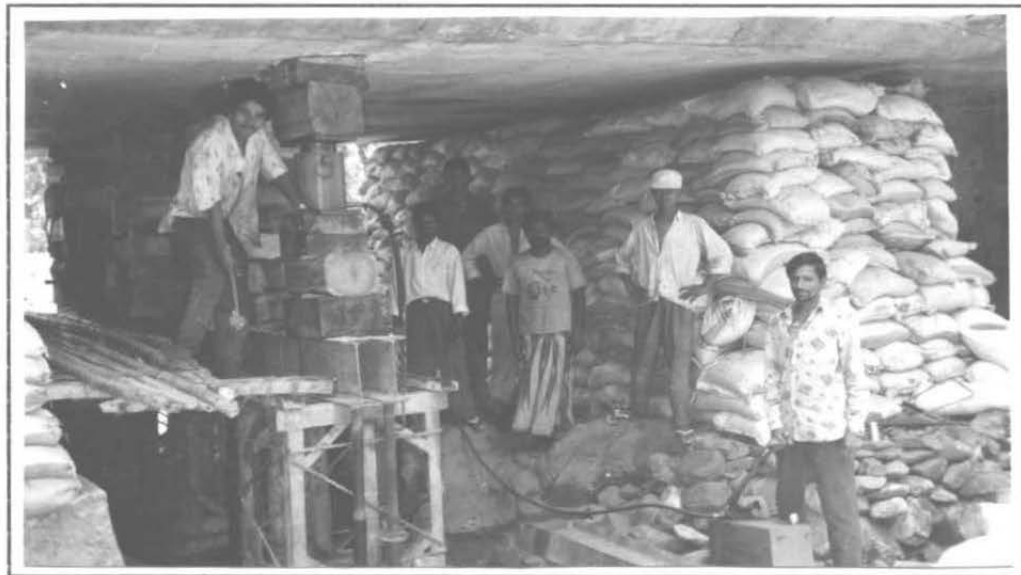
Photograph 4 View showing procedure of restoration
