Thissavros Hydropower Plant Managing Geotechnical Problems in the Construction

THISSAVROS HYDROPOWER PLANT MANAGING GEOTECHNICAL PROBLEMS IN THE CONSTRUCTION

ABSTRACT

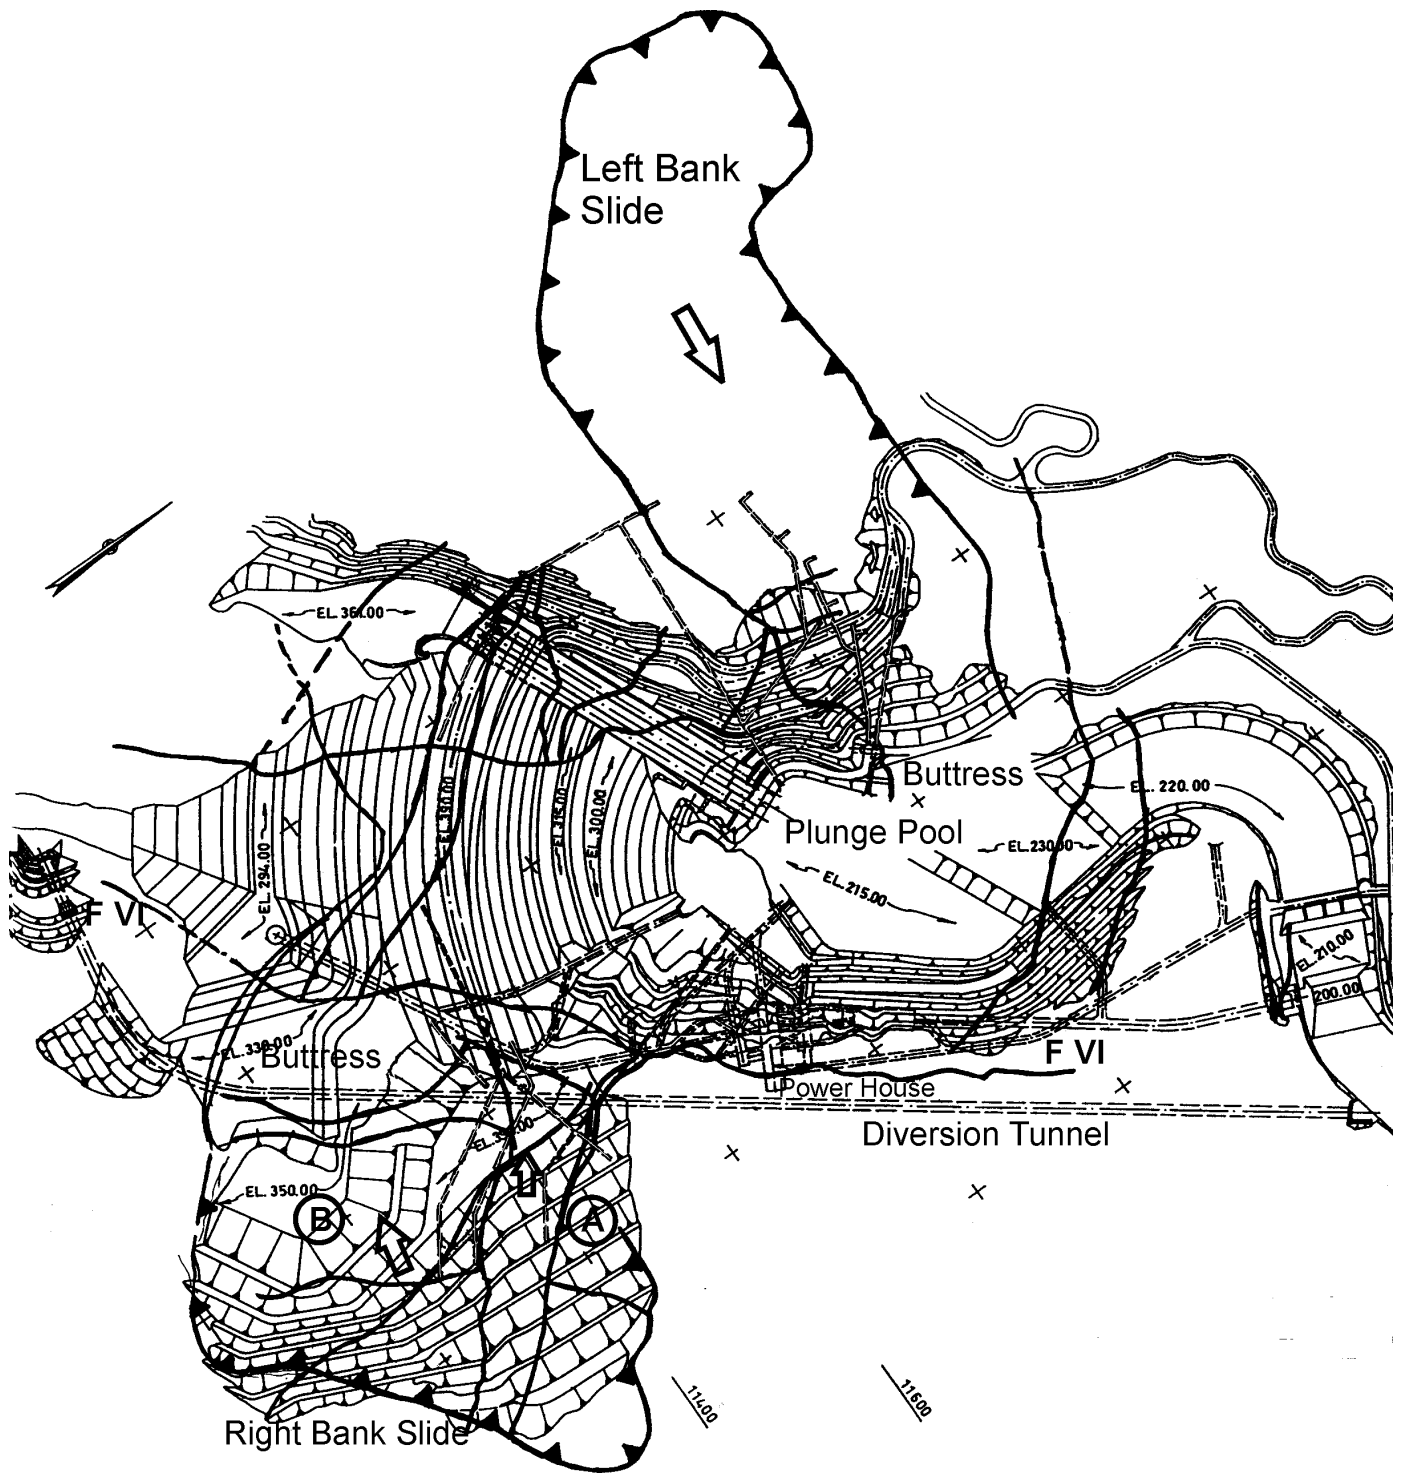
Figure 1. Dam site and landslides. Heavy lines mark faults. Coordinate grid on 200 m spacing

Two significant areas of instability developed at the site (see Fig. 1); these are discussed further below.

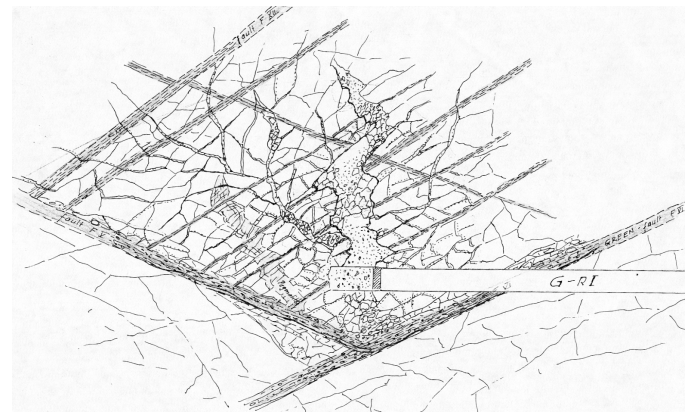
Figure 3. Collapse of grouting gallery in Segment A of landslide

At the base of Segment A, the rock mass of very poor quality is wedged between Faults V and VI. The rock is partially weathered to the point of becoming friable, partially decomposed, and only about 25% of the pieces retain their original strength. Internal deformation of the sliding rock is indicated by irregular

orientation of the foliation planes. When the lower right-bank grouting tunnel entered this zone, a major collapse occurred that also affected the intermediate grouting tunnel, located 40 m higher in the slope (Fig. 3). In consequence of this collapse, the material in the center of the wedge deteriorated even more. The poor quality rock near the center and base of the sliding wedge did not permit systematic Lugeon testing but the limited number of tests gave a notable permeability for the slide mass, on the order of 10^{-5} m/s, but lower than for the adjacent in-situ rock. According to grain size distribution, the permeability of the soils produced by alteration of the gneiss was estimated to range from 10^{-4} to 10^{-3} m/s but presumably core drilling did not recover representative samples from the soils. Fines appear to have been lost.

Remedial measures for the right bank included major excavation and stripping to unload the head of the unstable mass, toe buttressing and drainage. Unloading the head of the landslide in Segment A by excavation of 1.65 million m^3 , combined with subhorizontal drain holes that dropped the groundwater levels by 10m, stopped the initial movements in 1988. However, preparatory excavation for the power intake caused the slide to accelerate again to a rate of 17 mm/day in early 1989. This time, 0.9 million m^3 were removed at the head of Segment B, and a toe buttress placed between El. 280 and 420 m definitely stopped the displacements of the slide mass. The final volume of excavation for unloading arrived at 2.6 million m^3 .

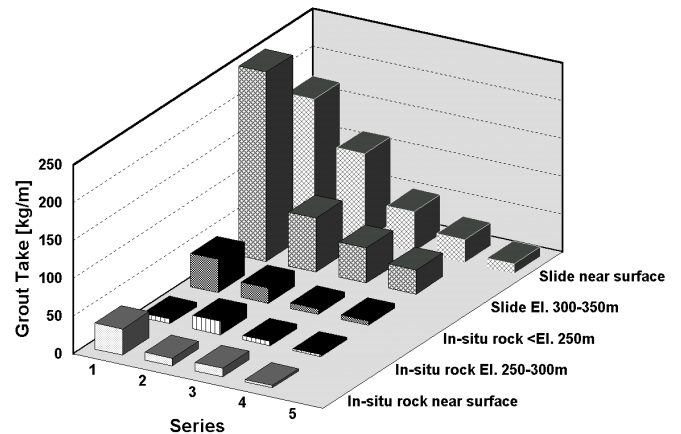
decomposed material. Initially, traditional slurries with water/cement ratios of 2 and 1 by weight and addition of 1 to 2% bentonite were applied. However, the large takes indicated an uncontrolled reach and, therefore, slurries with a ratio of only 0.6 were used in the event that high takes were experienced. With such dense slurry, the initial treatment of the collapse absorbed 20 tonnes of cement. Grout take averaged about 250 kg/m in the primary series and dropped progressively to only 13 kg/m in the final series (see Fig. 4). In comparison, the primary series in in-situ rock absorbed less than 70 kg/m on average. Grout pressures ranged from 1 bar at the top to 15 bar at the lower fringe of the curtain. According to Lugeon tests at the end of the construction works the permeability in Segment A had reduced to 10^{-6} m/s. Considering that compaction grouting had been done at quite low pressures, this result is satisfactory. The ample quantity of grout found in the cores of the check holes conveyed an even more favorable impression of the success of the work.

Figure 4. Development of grout takes on the right bank

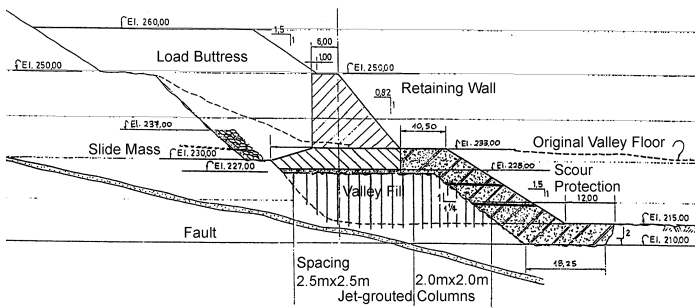
Option 4 would have required a substantial increase of the tailwater dam height and, therefore, was eliminated. The three remaining options envisaged excavation through the toe of the landslide to place the buttress fill or the RCC on in-situ rock beneath the failure plane. This excavation would have to be done in a hit-and-miss pattern, with immediate back filling of excavated strips, in order to avoid excessive unloading of the toe of the slide. With the intention to save time and excavation in the valley floor, a tied-back diaphragm wall had been proposed as an alternative but was rejected because of concerns in respect of the long term permanence of the anchors. Eventually the solution adopted was to leave the old river channel fill in place, stabilizing it with jet-grouted columns, spaced on a grid of 2 to 2.5m (see Fig. 6). Although jet grouting did not show much effect on the ground surface, an excavation to shallow depth exposed solid columns of about 1 m diameter. Removal of the river channel fill in front of the stabilized soils then proceeded without problem. A toe load berm, protected on the plunge pool side by a retaining wall, was placed above the stabilized soil deposit. During this stage of construction, it was helpful that the contractor operated two tube wells for site supply that were drawing groundwater from the confined aquifer beneath the slide. During the construction of the toe buttress, the slide still moved 15 mm.

Figure 6. Section through toe buttress at left bank

At each of the three levels of grouting galleries, a branch parallel to the flank of the slide mass serves as drainage gallery (at about elevations 350, 290 and 240 m, see Fig. 5). The hydro-geologically complex and compartmentalized nature required an additional branch at the intermediate level and two further separate galleries at about el. 260 m and 240 m.

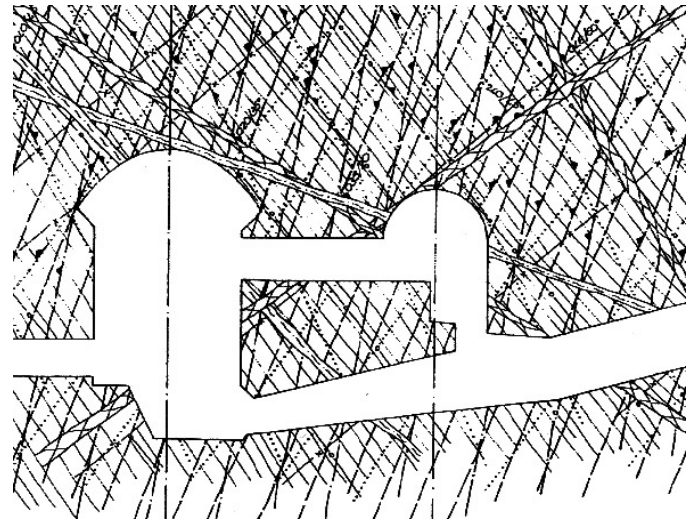
The toe buttressing of the left bank landslide changed the situation in the plunge pool and required modifying the layout of the power house (see Figures 1 and 7). In consequence of the modification, the axis of the cavern lies parallel to the foliation of the gneiss but fortunately the foliation planes were undulated, with the orientation of the poles scattering by about 40° . The foliation, joints, faults and shears created a hazard of wedge failures in the crown and the sidewalls of the caverns (see Fig. 9). But, irrespective of the adverse rock mass fabric, wedge analysis

Figure 9. Generator and transformer caverns, pattern of rock mass discontinuities

concurrent with the excavation achieved safe support with little overbreak. An innovative design provided for cast in place crane beams which, before the main benching work started, were anchored to the walls and connected to the cavern roof concrete liner. The beams supported a construction gantry used for installation of rockbolts and shotcrete for roof and wall support and for concrete works. These crane beams were later incorporated into the main crane support. Table 3 describes the support installed in the power cavern.

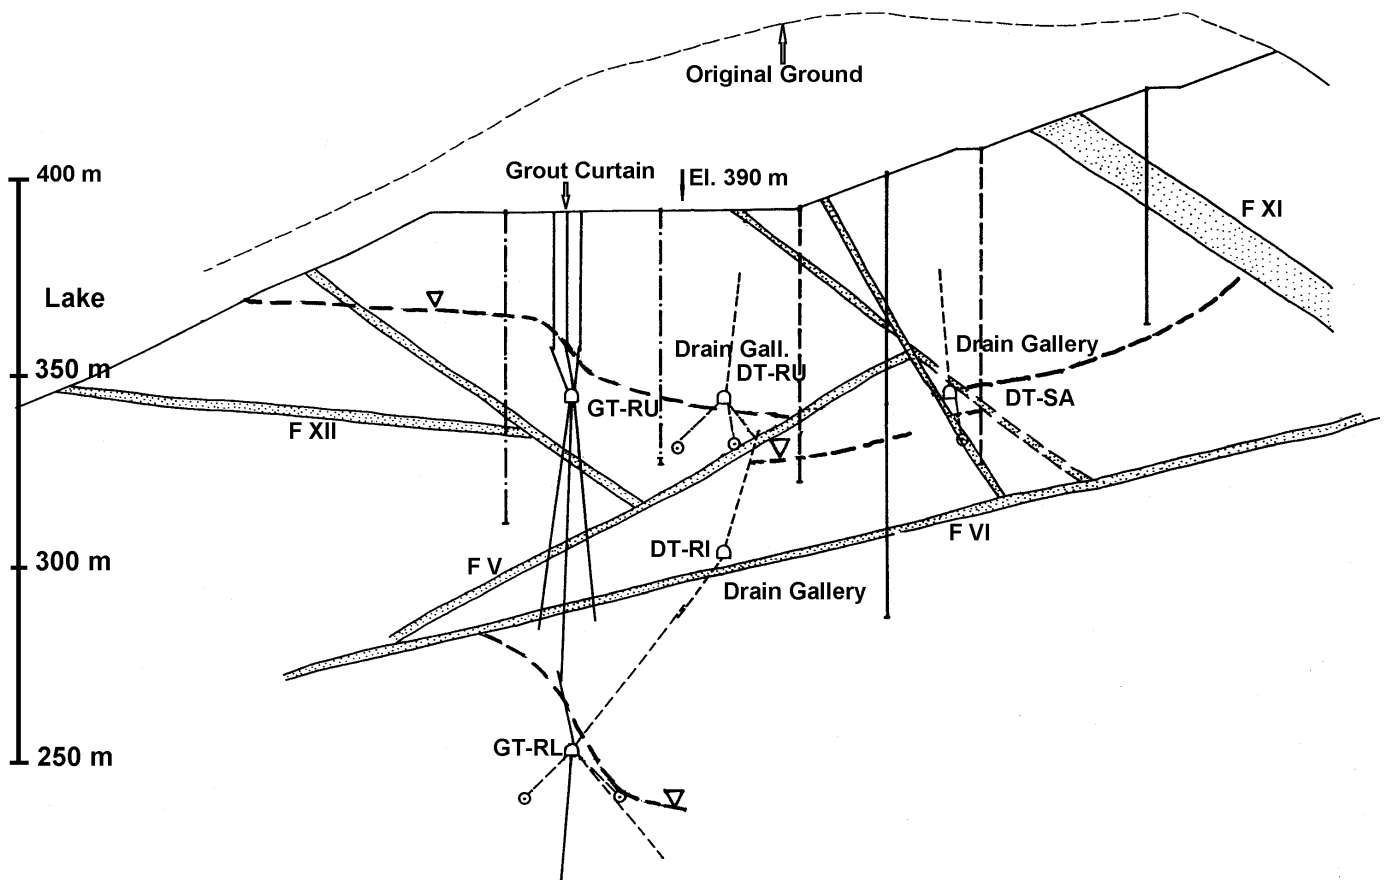
The grout curtain in the left abutment only absorbs 25% of the reservoir head but this effect suffices to permit controlling the uplift at the left bank slide with modest drainage flows. Reservoir filling increased the discharge of the drainage system from 1 l/s to 6 l/s.

Figure 11. Section across grout curtain and drainage system with piezometers. Heavy dashed lines mark groundwater tables
