Performance of Improved Ground During the 2001 Nisqually Earthquake

Elizabeth A. Hausler
University of California, Berkeley, California

Mark Koelling
Hayward Baker, Tukwila, Washington

PERFORMANCE OF IMPROVED GROUND DURING THE 2001 NISQUALLY EARTHQUAKE

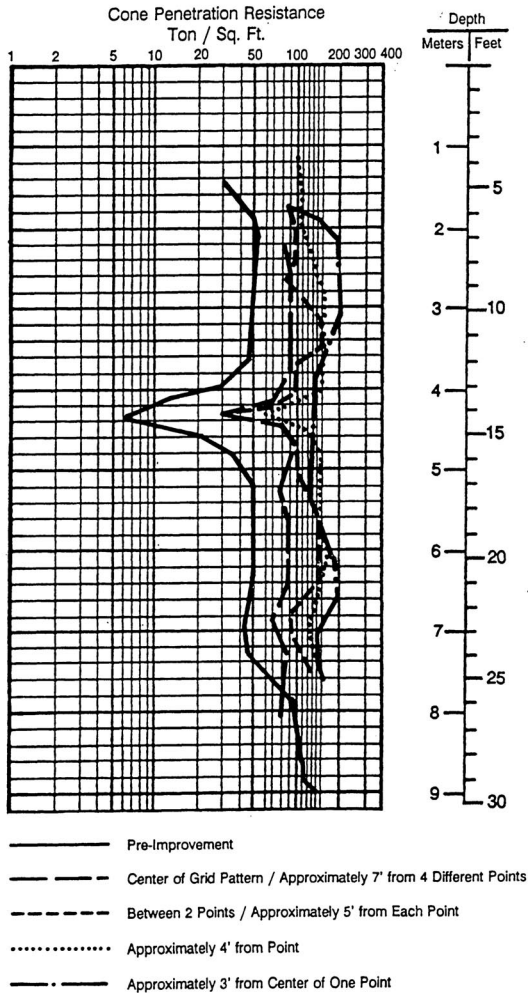
Figure 1 shows Dutch Cone Penetration Test results before and

after ground improvement. Pre-improvement tip resistances range between 2870 and 4790 kPa (30 and 50 tsf) in the upper 7 m (23 ft). SPT N values in the loose to medium dense sands ranged from 5 to 15 blows per foot. A 30 to 60 cm (1 to 2 ft) thick layer of silty sand (24% passing the No. 200 sieve) was encountered at a depth of approximately 4.3 m (14 ft) in this profile. During drilling, existing grade was at elevation 1.2 m (4 ft) and groundwater was located at approximately 1.5 m (5 ft) below ground surface.

Fig. 1. Dutch cone penetration test results, before and after ground improvement (Campbell and Koelling, 1993)

Results from Dutch cone penetration tests (CPTs) before and after improvement are shown in Fig. 1. After improvement, q_c

was as high as 19,150 kPa (200 tsf; $N > 55$ blows/ft) at the center of the column, between 14,360 and 19,150 kPa (150 to 200 tsf; $N = 40 - 55$ blows/ft) within one column radius of the stone column, from 9,570 and 14,360 (100 to 150 tsf; $N = 28$ to 40 blows/ft) within one column diameter, and from 7,660 and 9,570 kPa (80 to 100 tsf; $N = 23 - 28$ blows/ft) diagonally in between the stone columns. Thus the improvement criterion was satisfied at all locations and depths, except for the 30 to 60 cm silty sand seam at 4.3 m (14 ft) below ground surface.

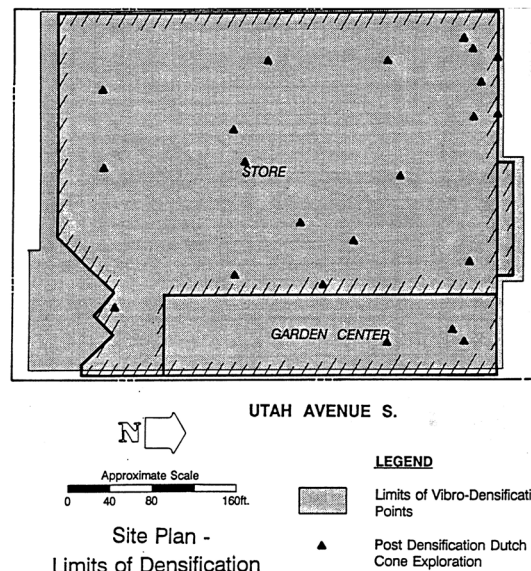
Vibro-replacement stone columns were installed in a square pattern with 3 m (10 ft) grid spacing. After grading the site with 60 cm (2 ft) of loose granular fill, the improved depth was 8.1 m (26.5 ft). The bottom feed method was used in the lower 4.6 m (15 ft), switching to top feed in the upper 3 m (10 ft). The stone column diameter was about 90 cm. The improved zone included a 3 m (10 ft) wide area beyond the building footprint on three sides. On the east side along the Garden Center, the improved zone stopped short of the building footprint because of the presence of utilities along S. Utah St, as shown in Fig. 2.

Fig. 2. Site plan and limits of densification (Campbell and Koelling, 1993)

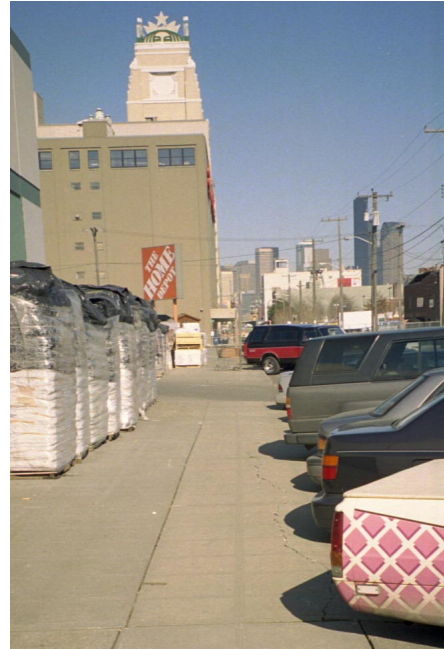
A 10 to 15mm wide crack (Fig. 3) in the sidewalk propagating north-south along the east side of the garden center was caused by the earthquake. The crack was approximately 19 m long and located outside the improved zone in the area where the extent of ground improvement was limited by the presence of utilities. Tension cracks and a large hump ran north-south along S. Utah St. Another 10 to 20 mm wide crack appeared on the sidewalk along the east side of the street, along the utility pole line, running for a distance of about 50 m.

Fig. 3. Crack in sidewalk along east side of Garden Center, looking north, outside improved zone

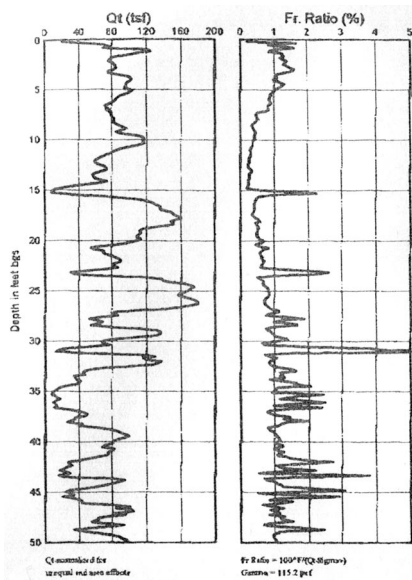
The lower unit consists of fine-grained alluvium from about 14.8 to 24 m (48.5 to 79 ft) below ground surface, with layers of very soft silt and elastic silt with variable sand content. Occasional fine gravel was encountered from about 23 to 24 m (75 to 79 ft), organic matter at about 18 m (60 ft), and shell fragments at about 21 m (70 ft). Glacially consolidated sediments exist from 24 to 29.7 m (79 to 97.5 ft) and hard siltstone at 30 m (100 ft). Groundwater was encountered at about 2.9 m (9.5 ft), although estimates vary from 2.1 to 3 m (7 to 10 ft) below ground surface. CPT results prior to improvement are shown in Fig. 4.

Fig. 4. Cone penetration testing before ground improvement (GeoEngineers, Inc., 2000)

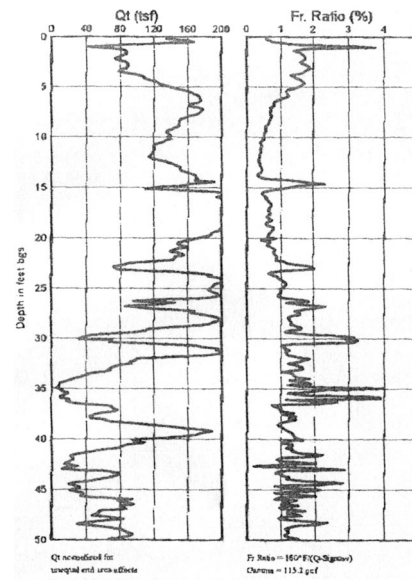
stone columns were installed along the perimeter of the building (along the grade beam) and under the hangar door at 2.4 m (8 ft) spacing. The stone columns were not intended to be load bearing. The stone columns were used to improve the soil and reduce the potential for liquefaction-induced settlement. Most stone columns extend to a depth of 12 m (40 ft), however some were obstructed and terminated at shallower depths. All stone columns extended to at least 6 m (20 ft). Post-improvement cone penetration results are shown in Fig. 5.

Fig. 5. Cone penetration testing after ground improvement (GeoEngineers, Inc., 2000)

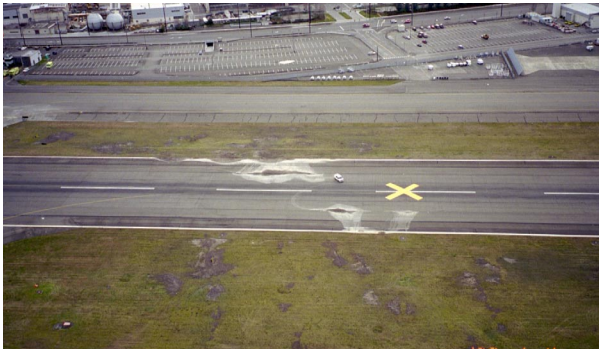
Evidence of liquefaction in the form of sand ejecta was present in the nearby runways and grassy areas of Boeing Field (Fig. 6). In an adjacent structure founded on unimproved ground, hairline

cracks were found in the tilt-up panel walls.

Fig. 6. Liquefaction ejecta in runway and sink holes in adjacent field, King County International Airport

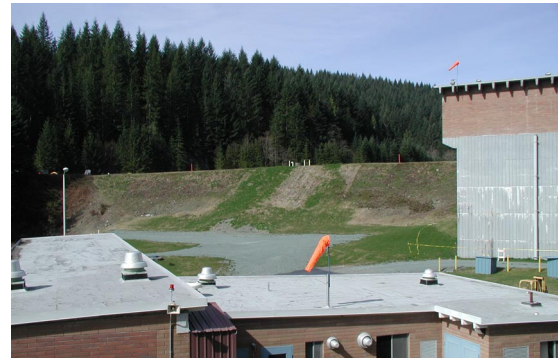
Fig. 7. Lake Chaplain South Dam, toe area to the west (left) of the inlet tower improved with vibro-replacement stone columns

Because of the potential for slumping due to liquefaction in the soils below the dam and the resultant loss of freeboard that could be caused by an earthquake, the toe of the dam was improved with vibro-replacement stone columns. The improved area begins to the left of the inlet tower (see Fig. 7) and extends to the west (left). The improved zone is approximately 52 m (170 ft) long by 15 m (50 ft) wide. The width of improvement was limited by the presence of the toe drain for the dam on the north side and a 1.8 m (72 inch) diameter concrete pipeline along the south side.
