## Geo-Engineering Problems in the Spillway Foundations and Their Treatment at Guhai Reservoir Project in Gujarat, India

# Geo-Engineering Problems in the Spillway Foundations and Their Treatment at Guhai Reservoir Project in Gujarat, India

**SYNOPSIS:** During the initial stage of construction of a 23 m high composite dam across the Guhai river, the downstream dipping sedimentary rock sequence of conglomerate, sandstone and shale resting unconformably over quartzite and schist was encountered as a surprise during the excavation of the foundation. Besides, an 8 to 8.5 m wide major fault zone along with three minor faults running across the dam axis were also noticed. Extensive subsurface investigations to study the nature and characteristics of sedimentary rocks, fault zones, etc. met with in the foundations were undertaken concurrently with the construction activity. As a result, the construction schedule was greatly affected.

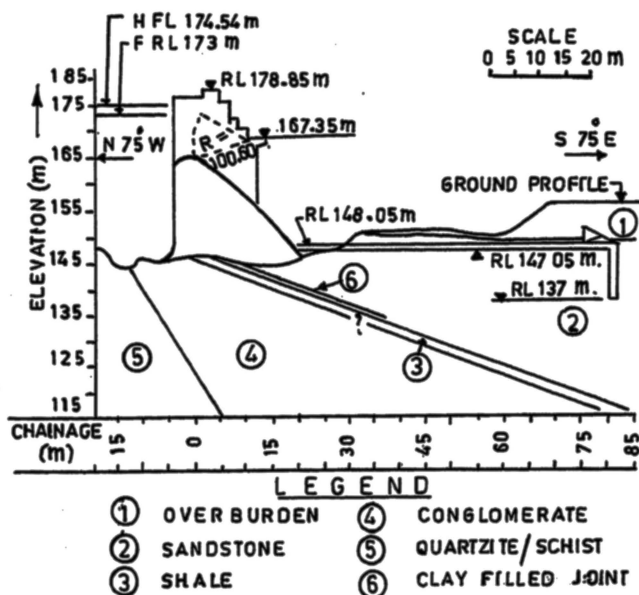
FIG.1: GEOLOGICAL CROSS SECTION

The spillway with a non overflow section on the right side has been located hugging the right bank. At the dam site, igneous, metamorphic and sedimentary rocks are met with. The rocks encountered in the masonry dam foundations are quartzite and schist of Delhi System intruded by quartz porphyry of post Delhi age. During the initial stage of construction, when the foundations of the spillway were being excavated an unanticipated sedimentary rock sequence was observed which lies unconformably over quartzites and schists. The unconformity is marked by the presence of conglomerate (Fig. 1). The description of rock types is given hereunder.

Conglomerate marks the unconformity between metamorphics below and sedimentaries above. Conglomerate seems to have been deposited over the pre-eroded surface of quartzite and schist. It mainly consists of rounded pebbles and gravels of quartzite and at times of quartz having 25 to 40 cm size. The matrix is siliceous. Thin ferruginous coating is seen along the boundaries of pebbles and gravels. The matrix of conglomerate is somewhat weakened in the close proximity of the faults. Pebbles are sharply cut along the sets of joints developed sympathetic to the faults. At the foundation level and even below it, conglomerate is fresh and hard. The thickness of conglomerate amplifies towards the downstream being more than 45 m at 70 m downstream as compared to 15 m at the dam axis.

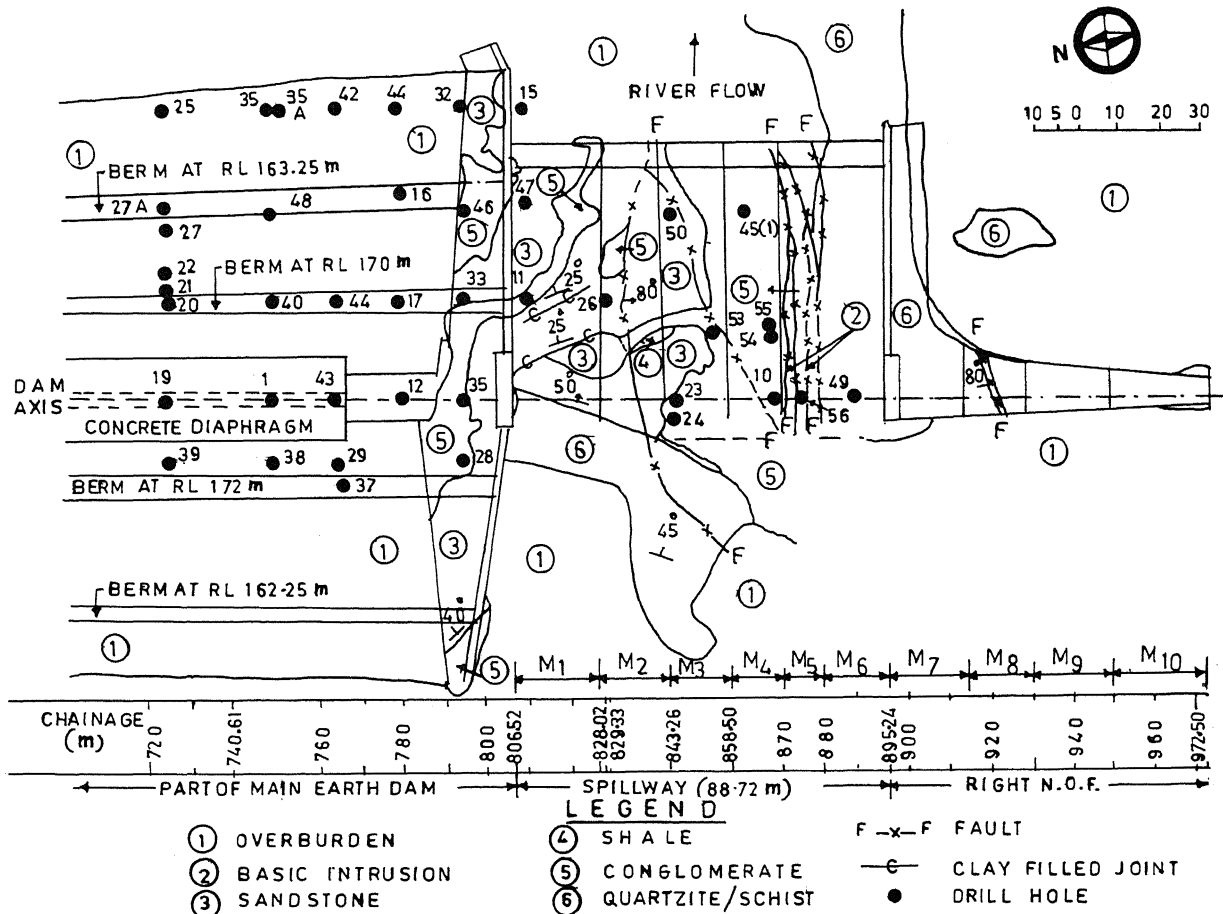
FIG. 2 GEOLOGICAL MAP OF MASONRY DAM

to assess its nature, characteristics, extent, etc. more so because of conglomerate as it is normally known for its pervious and incompetent nature. Extensive subsurface exploration was, therefore, undertaken concurrently with the construction activities (Fig. 2). The exploration revealed the following.

- (i) Thin clay beds associated with sandstone and at the interface of conglomerate and sandstone having low downstream dip of 25°.
- (ii) Occurrence of conglomerate which was apprehended for its weak and pervious nature.
- (iii) One major and three minor faults running across the dam axis with steep to vertical dips (Table 2).
- (iv) Discovery of palaeo river channel occupied by 30 to 33 m thick sand between Ch. 630 and 730 m (Fig. 3).

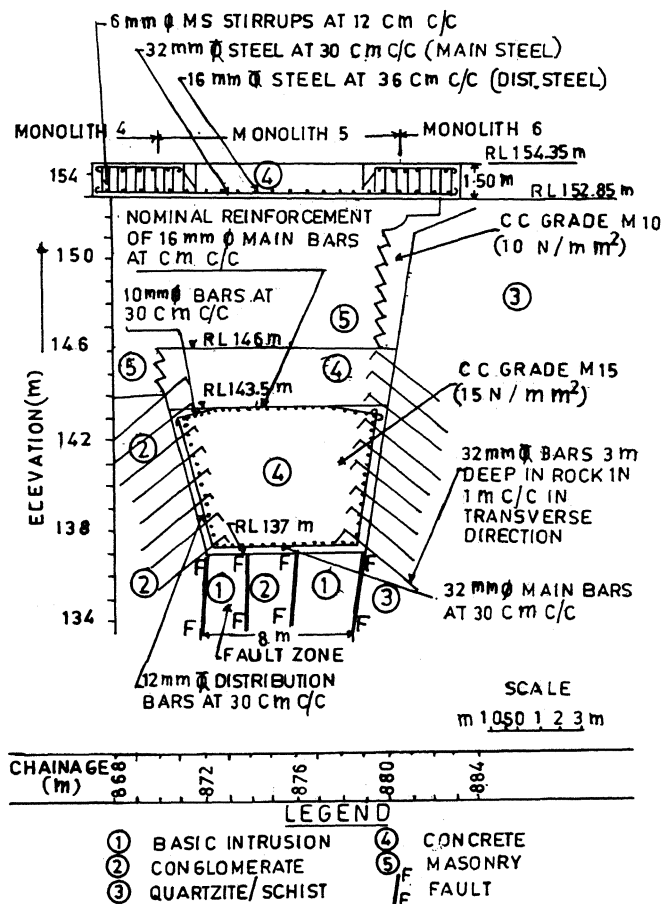
(b) Fault zone encountered in monolith 5 being a major one, elaborate treatment was considered imperative. Because of an 8 to 8.5 m wide fault zone traversing across the dam axis, a separate monolith had been provided. By adopting the Shasta formula for the plug treatment, the depth of excavation worked out to 6 m from the general foundation level at RL 143.5 m. Accordingly, the fault zone material was excavated down to RL 137 m where it was revealed that the clayey gauge was the decomposed product of basic intrusive along the fault zone. The excavated trench has been plugged with M 15 (15 N/mm<sup>2</sup>) strength concrete. To transfer the load to the competent shoulders, arch shaped concrete has been done. Hammock reinforcement of 32 mm diameter deformed bars placed at 30 cm both ways has been provided to take care against any settlement. This has been extended upto RL 143.5 m. Above this and upto RL 146 m concreting is done (Fig. 4).

Considering these points, R.C.C. slab beam above the fault zone in monolith 5 had been designed and constructed. This raft is 1.5 m thick and provided between RL 152.85 and 154.35 m and has been extended by 2.75 m on either side of the monoliths 4 and 6, thereby affording an adequate bearing to the raft on either side of monolith 5. All the three monoliths have been combined to reduce the load intensity on the foundation rocks (Fig. 4 and 5).

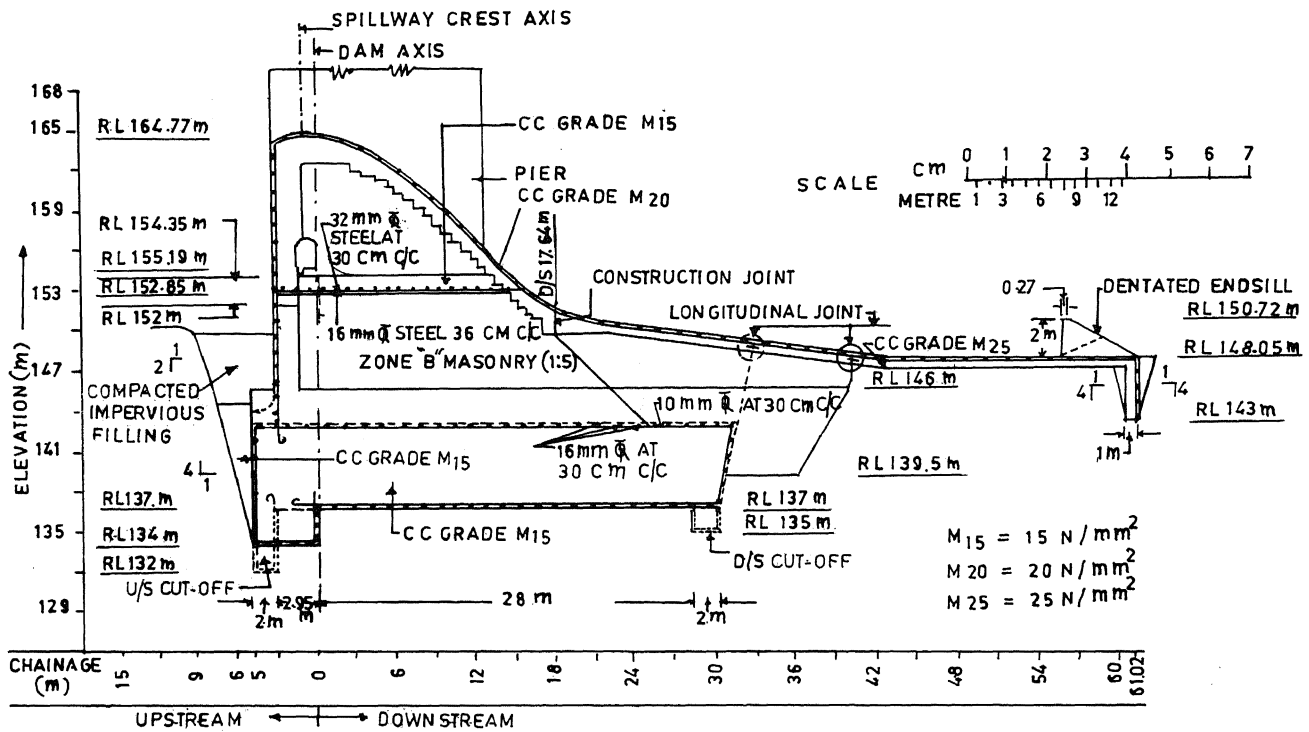
FIG. 5 SECTION OF FAULT ZONE TREATMENT IN MONOLITH 5

Plasticity index of the gauge material was more than 15 hence piping is not apprehended. However, to have adequate path of percolation through the fault zone, a 5 m wide upstream cut-off to a depth of 3 m (RL 134 m) below the bed of the trench has been provided. To achieve the desired path of percolation, the plug treatment was extended upto 36 m downstream. The bottom of the trench from 30 to 36 m downstream was kept at RL 139.5 m to avoid dewatering problem (Fig. 5).
