Case History Illustrating the Challenges of Foundation Design and Construction in Karst Terrain

CASE HISTORY ILLUSTRATING THE CHALLENGES OF FOUNDATION DESIGN AND CONSTRUCTION IN KARST TERRAIN

This paper discusses the challenges associated with design and construction of foundation systems for a Corporate Campus located in Chester County, Pennsylvania that is underlain by Karst terrain. A comprehensive subsurface investigation was implemented to develop adequate foundation systems and related site work precautions. Because there was evidence of sinkhole activity prior to any construction work, and the subsoils revealed some variability from a consistency/density standpoint, the selected foundation system design included a combination of soil improvement using compaction grouting for shallow foundations and deep drilled-pier foundations. After construction activities began, several occurrences of solution activity were documented and repaired. During construction of drilled-pier foundations at one of the structure locations, a significant number of voids and discontinuities in the rock were encountered. The impact of these discontinuities and voids was dramatic to the effort and ti

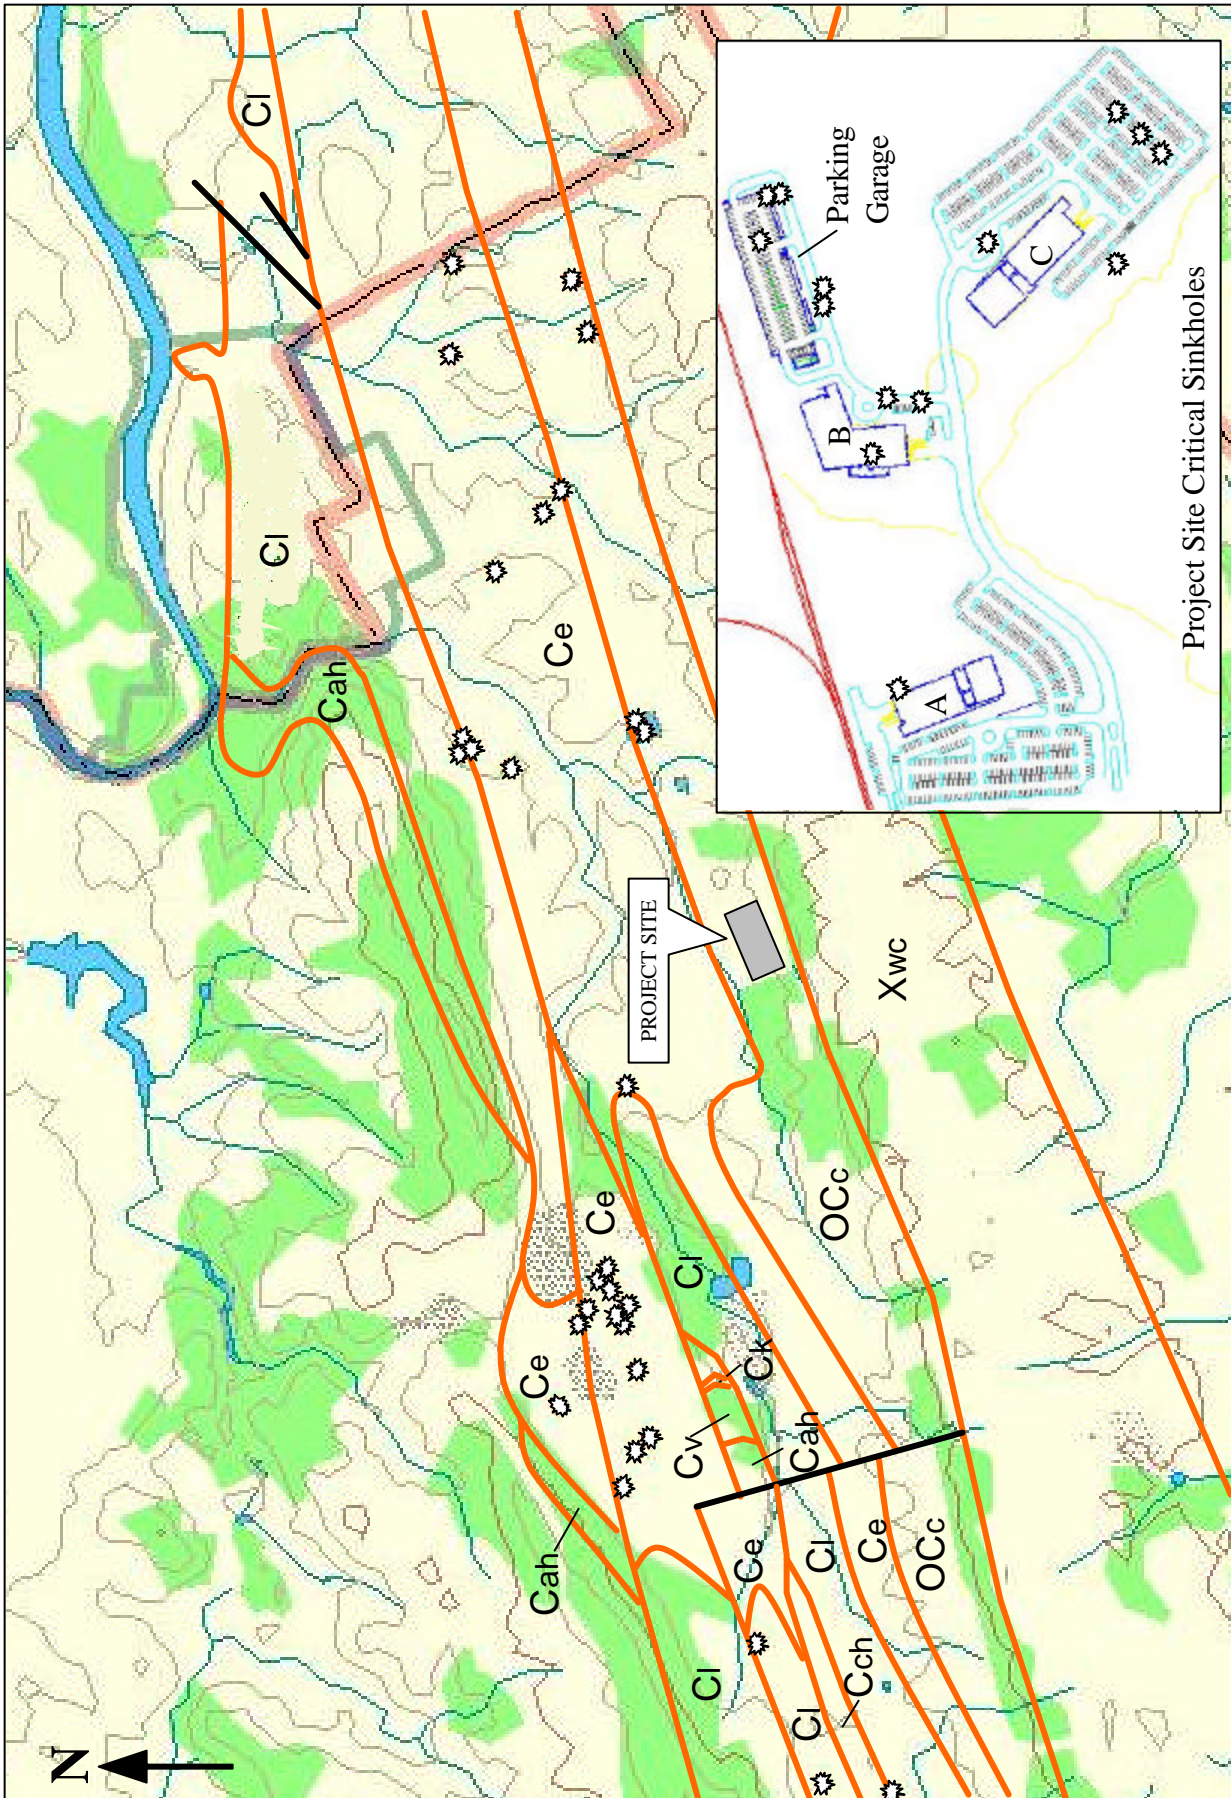
Fig. 1. Sinkhole Location Map

Figure 1 presents the location of sinkholes as reported by the Pennsylvania Geologic Survey as well as critical sinkholes observed onsite. Of note is the trend of sinkhole activity observed in this area. The drawings clearly show a southwest to northeast trend of sinkhole activity through the project site that generally follows the strike of the formation.

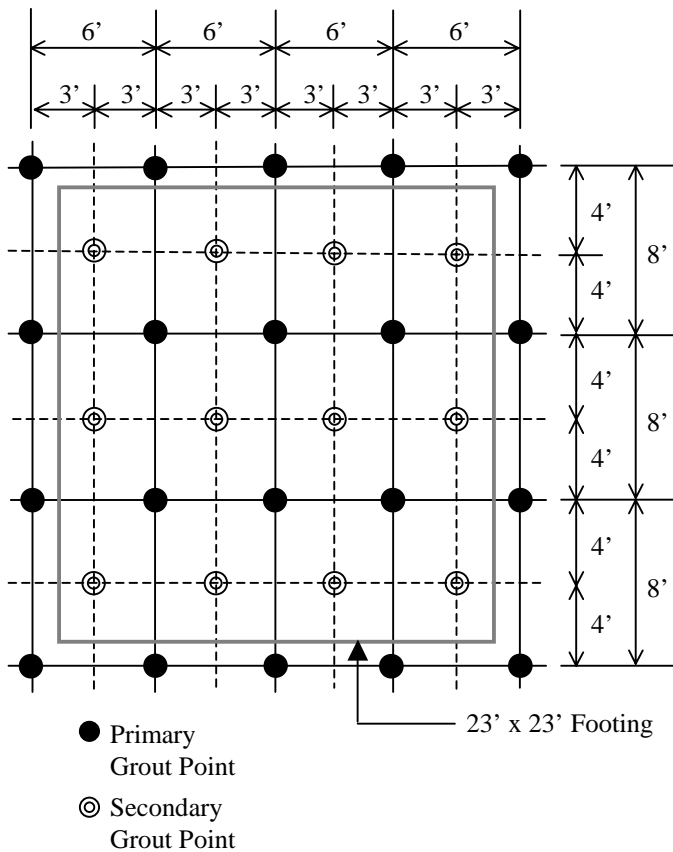
Fig. 2. Typical Compaction Grouting Layout.

A typical grouting layout consists of a series of primary, secondary, tertiary, and if necessary a fourth series of grout points over the treatment area. Grouting operations began after the building pad was constructed and a layer of stone was placed over the pad as a working surface. Typically, the compaction grouting operations were conducted in a grid pattern over an area that generally extended over the spread footing location and approximately 10 percent beyond the footing limits. Figure 2, located on the following page, presents a typical grouting layout.

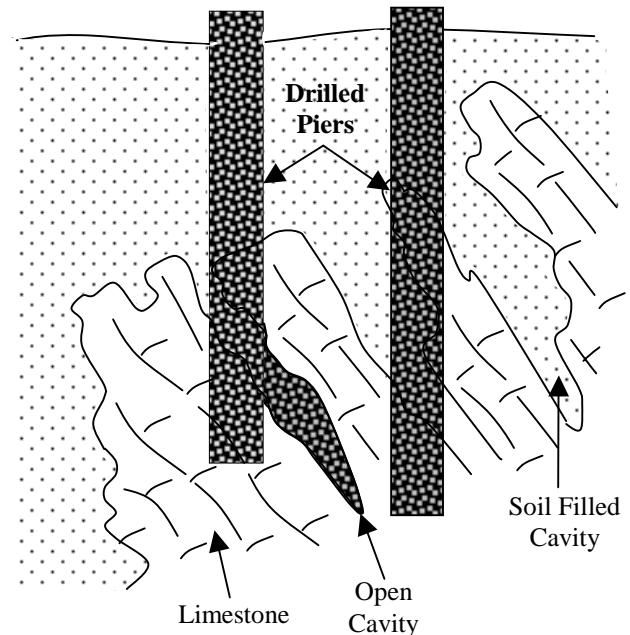
Fig. 3. Sketch of a Typical Cross-Section in Karst Terrain.

The selected foundation system for this building was drilled piers founded in limestone bedrock. At the very early stages of construction, the impact of the pinnacled, fractured and uneven nature of the bedrock became apparent to the Contractor, Construction Manager and our field inspection personnel. The pier construction schedule, while aggressive, was set for completion of the drilled piers within 35 days. Figure 3 depicts a general cross-section image of the subsurface conditions typical of the limestone bedrock.

Because the conditions of the bedrock were so variable, our geotechnical project engineer was on-call throughout drilled pier construction to assist the full-time field construction crew and inspect the variable rock socket conditions and re-design socket lengths based on the integrity of the rock. In an effort to better predict the depth and competency of the rock at some pier locations, we recommended that air track drilling equipment be used. At many pier locations, a series of four to six rock probes were advanced around the perimeter of the pier location and were advanced into rock a distance of at least twice the design socket length. Additional test borings were also drilled at several locations to augment existing data and allow for correlations with the air-track probes. Using this information together with the test boring data from the geotechnical investigation, we were able to correlate and predict necessary changes in socket lengths and pier diameters. Throughout the process, we worked with the Construction Manager and Contractor to re-design some piers to allow socket lengths to be reduced and adjusted by verifying increased rock capacities and/or increasing pier diameters. At a few column locations, typically where required drilled pier lengths were minimal (i.e. total length on the order of three feet as indicated in Table 2), spread footings were designed to replace the originally proposed drilled piers.

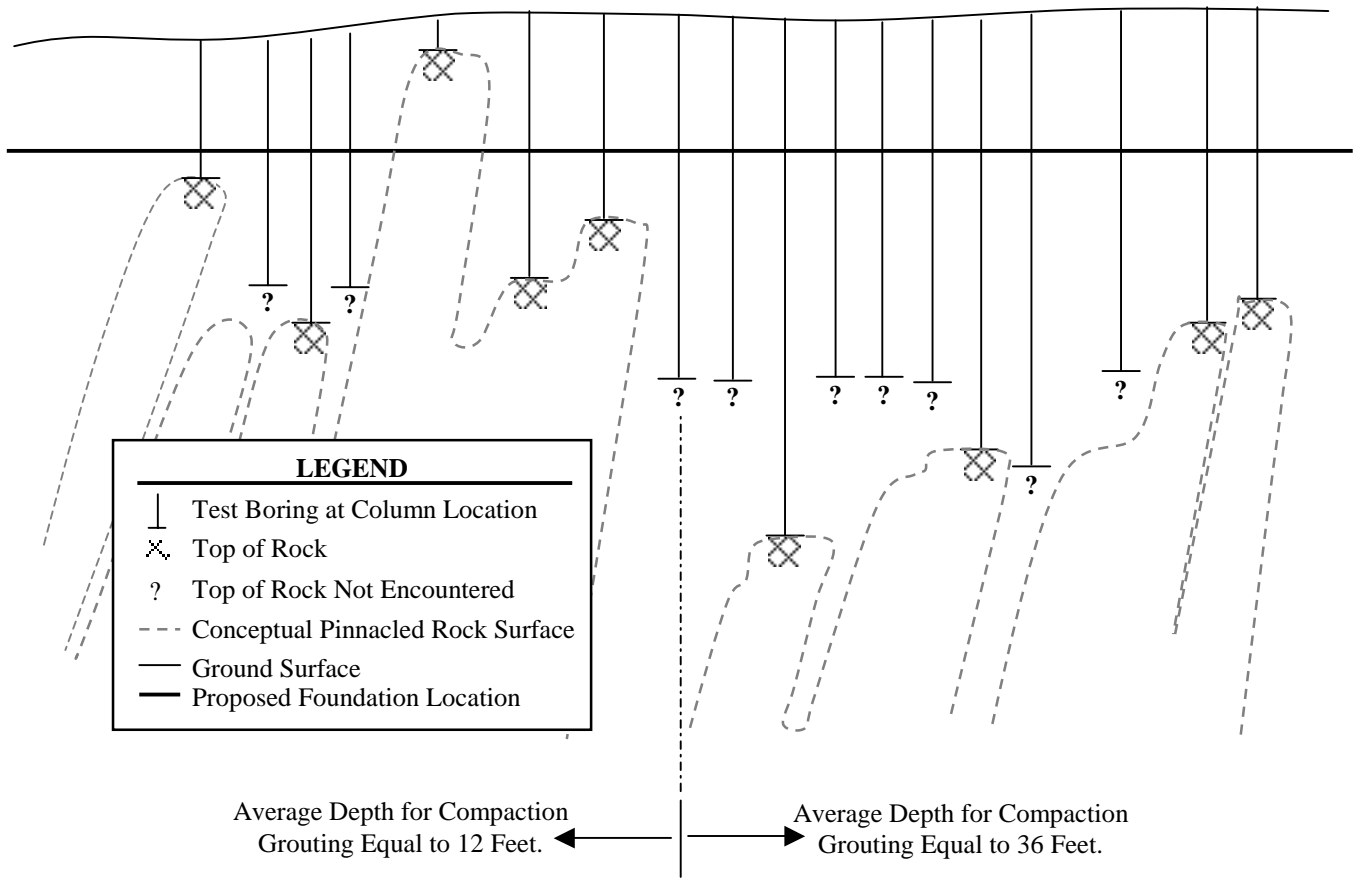
Fig. 4. Longitudinal Cross-Section of Subsurface Conditions Along One Column Line of the Parking Structure.

The design of the compaction grouting program was further modified to ensure coverage of areas where solution activity may be more prevalent. The initial compaction grouting design focused on areas where "very soft" to "soft" soil zones were encountered. The depth of the grouting zones varied as the depth to bedrock and soft zones varied. Because the initial test boring program did not provide for coverage at each individual column location, a series of supplementary test borings were advanced after the site was cut to subgrade level to fill data gaps. Figure 4, located on the following page, presents a typical longitudinal cross section of the building along a column line. As depicted in

this figure, the depth to rock was quite variable.

At several locations within this building, the depth to bedrock was not reached within the depth of the borings and these areas were suspected as being deep solution "throats" that were choked with soft to very soft saturated fine-grained overburden soils. In these areas, we attempted a phased approach to the grouting program in attempts to confine then improve these soft, deep-seated zones. Generally, the approach was to essentially "curtain off" the deep zones with a compaction grouting ring and cap above the zone, in a manner similar to the on-going grouting program as described for Building A. The theory was to confine these areas and then grout within the confined zone to displace and improve the zone. While the practice seemed sound and the implementation proceeded without incident, there was no time or budget to perform confirmation test borings to monitor ground improvements.
