RECENT DAMAGING EARTHQUAKES IN JAPAN, 2003-2008

Robert Kayen, Ph.D. P.E.

ABSTRACT

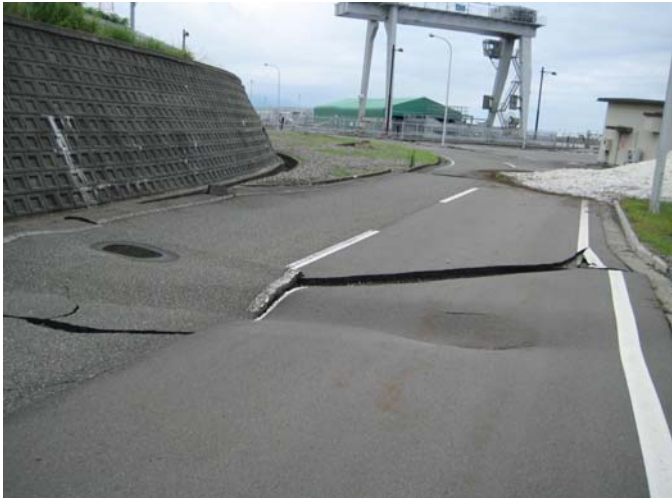
Figure 5: Damaged road at the nuclear power plant (Kayen et al. 2007).

Structural and road damage that was observed was related to problems with foundation soils, including liquefaction (Figure 5), embankment failure, settlement and distress of footings, and a landslide. Joints of piping resting on isolated footings and expansion joints in covered pathways failed, and underground pipes supplying fire retardant to reactors broke because of the relative movement between soils and the foundations. In a two-story steel building used for plant administration, drop-ceilings fell and windows broke. Access through doors was impaired by ground settlements of up to 40 cm. The plant was closed after the earthquake and is currently undergoing inspections prior to restarting.

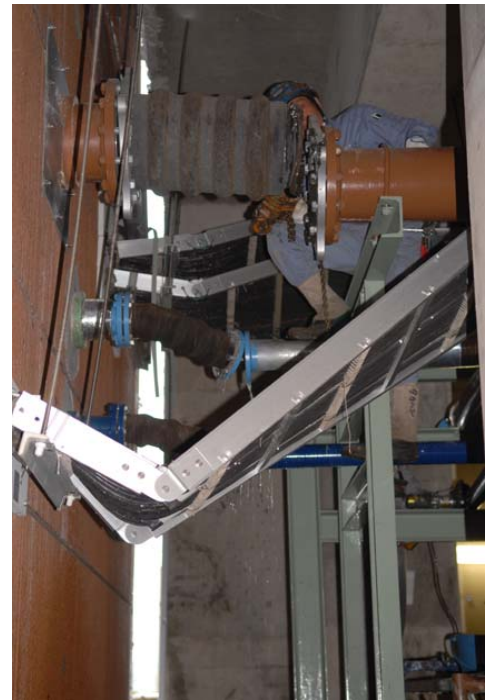
Fig. 6: Kashiwazaki Wastewater Treatment Plan on the south side of Sabaishi River near its outlet to the Sea of Japan (Google Earth map site RK9 RK9 N 37.38748 E 138.56587) Pipe breaks due to separation of two halves of building (Photo taken on 7/21/07).

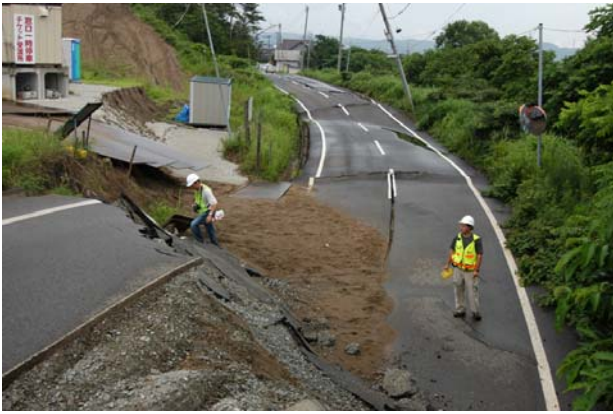
Figure 7: Lateral Spread on North side of Kai-Un Bridge area of the Sabaishi River (Google Earth map site RK6, N 37.39343 E 138.58555, 7/19/2007).

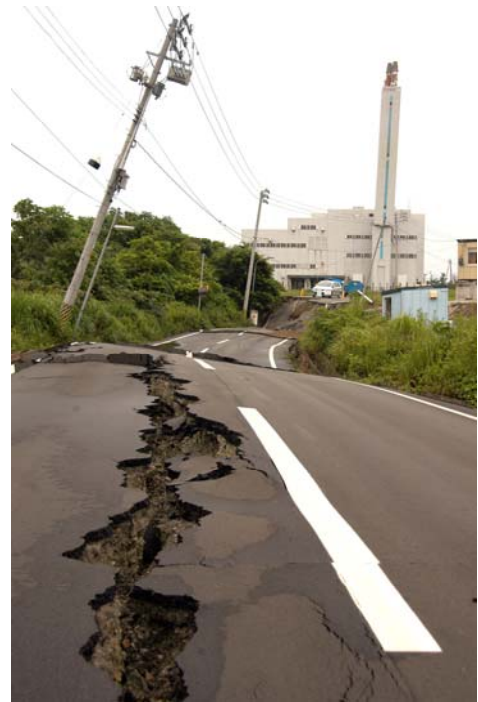
Figure 8: Failure of reinforced concrete stack and a large liquefaction-induced lateral spread on the north side of the Sabaishi River (Google Earth map site SP31, N 37.3939° E 138.5840°).

The most striking damage to the transportation network was caused by large landslides destroying sections of roads (Fig. 18). In one location, both lanes of a busy regional highway were moved down slope by about 10 m as a result of a deep-seated slope movement. The road was re-opened less than seven days following the earthquake, which is a testament to the excellent Japanese post-earthquake response, and an illustration of the importance of deploying reconnaissance teams soon after earthquakes to record perishable data. A large lateral spread affected a road near the Kashiwazaki municipal waste incinerator, forming a headscarp with a vertical offset of 2.5 meters that transected the road. The pavement was heavily damaged for a length of over 200 meters in the lateral spread (Figure 8).

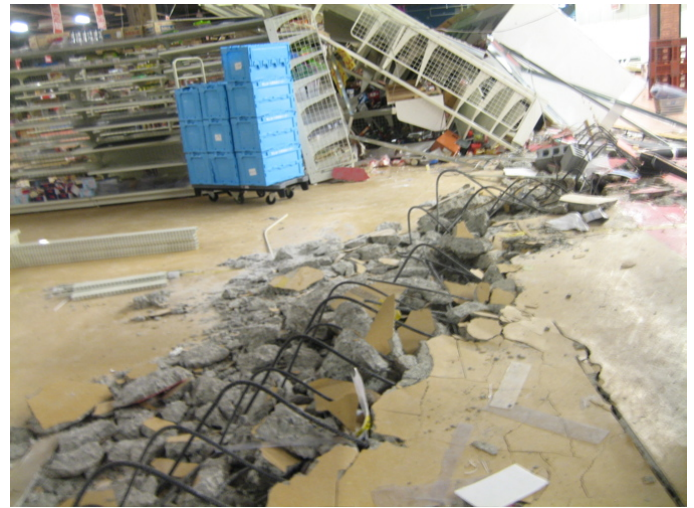
A long, coast-parallel, surficial unit of dune sand extends within and north of the city. This deposit was the source of numerous liquefaction failures, particularly along the edge of the modern flood plain (Figure 9). The sand was typically very soft under foot, and may have been reworked in areas by the ancient, meandering Sabaishi and U Rivers. At one site liquefaction settled ground was observed around the foundation pile cap of a large high-voltage power transmission tower leading from the nuclear power plant. Though the soil pulled away from the cap, the pile cap and tower had no indication of deformation (Figure 10)

Figure 9: Liquefaction and lateral downslope movement of underlying soil buckled the floor slab of a large warehouse store. (Google Earth map site RK41, N37.41468 E138.60840, 7/22/2007).

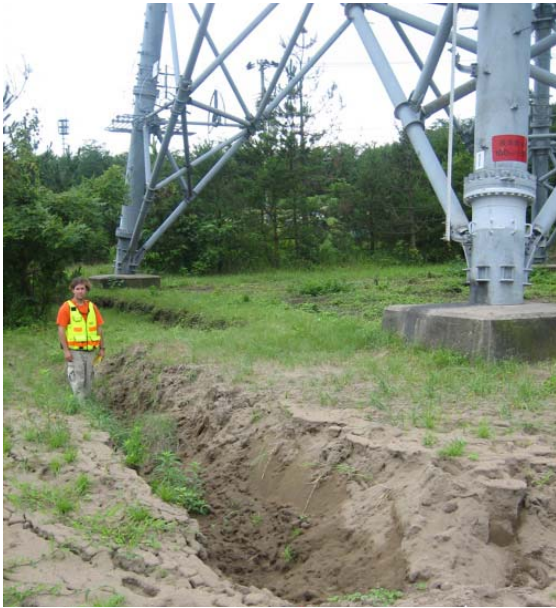
Figure 10: Settlement of ground adjacent to the grade beam between footings of a high voltage transmission line tower (Google Earth map site RK40 - N 37.41633 E138.60792, 7/22/2007).

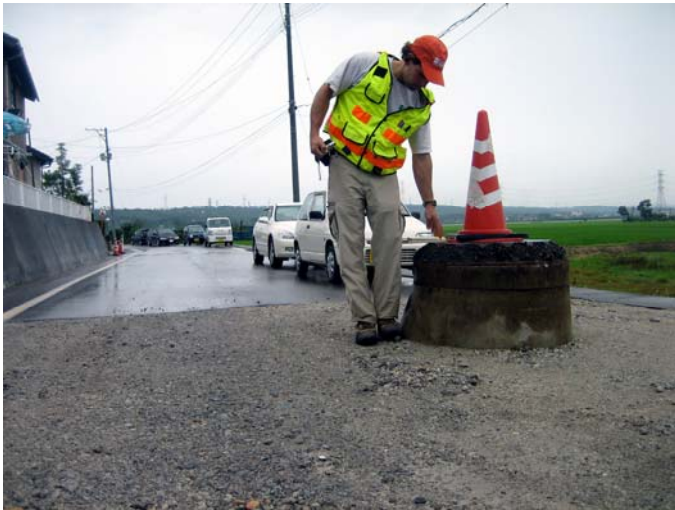
Sandy fill deposits used for backfill for the wastewater and storm water drain network performed poorly throughout the epicentral region causing hundreds of separated and uplifted manholes that incapacitated the drains and impeded traffic (Figure 11). Ports and harbors suffered only moderate levels of settlement and liquefaction-related lateral spreading.

Figure 11: Uplifted manholes from storm-water drains impeded traffic and compromised rainfall drainage throughout Kashiwazaki City and the surrounding villages.

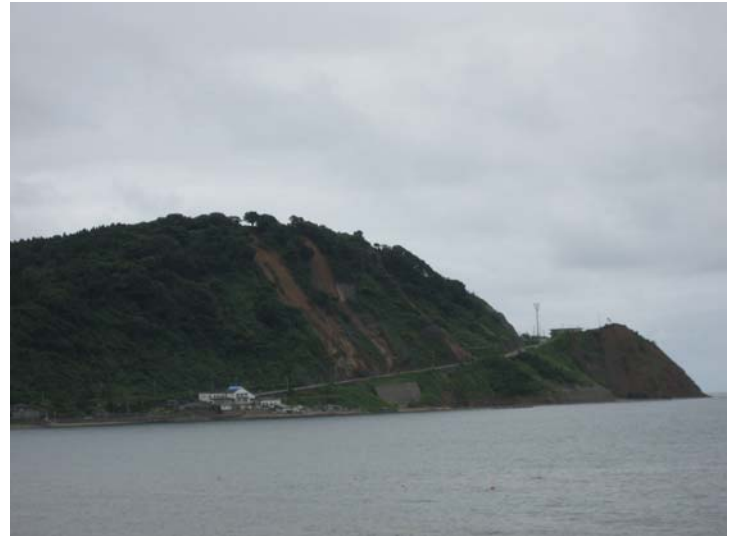
Landslides caused by the earthquake consisted of shallow translational slides, debris slumps, and deep-seated rotational slides. In general, landslide activity was focused near the coast, with many steep (50° +) slopes experiencing shallow landsliding of overlying colluvial debris and residual soils (Fig. 12).

Figure 12: Coastal landslides on Highway 352 north of Kashiwazaki-Kariwa Nuclear Power Plant at road closure south of Route 373 (Google Earth map site RK34; N37.48455° E138.62435°; Photo taken 7/22/07).

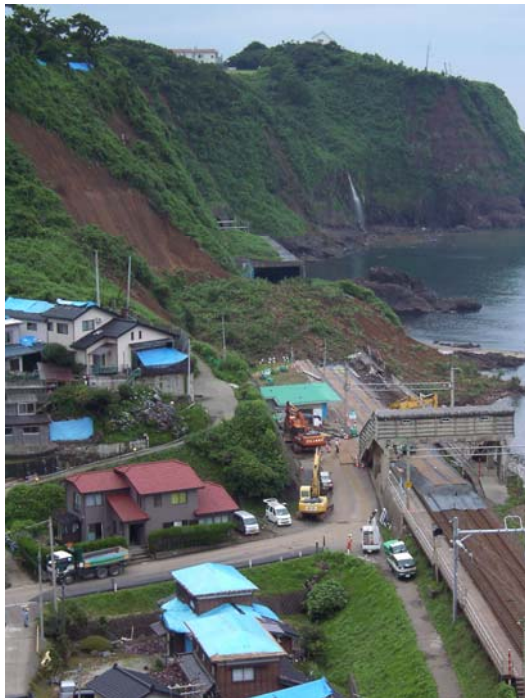
Figure 13: Landslide at the Oumigawa Train Station on the Shinetsu Line (Google Earth map site RK20/YT16/SA9; N37.34490° E138.48435°, 7/21/07)

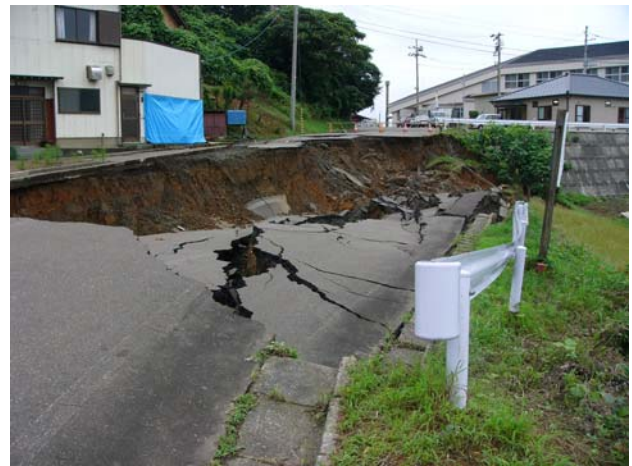
Embankment failures were typical in road fills both along the coast, and were also observed at three sites located further inland (Fig. 14). Embankments underwent from 10 cm to in excess of one meter of vertical displacement, extending between 10 and to 60 meters in length. Three embankment failures required full closures of roads, and/or protection with tarps to reduce rainfall infiltration and the associated potential for additional movement. Among these was a 15-meter high, 97.5-meter wide, earth-fill dam located to the east of the region, where cracking through the midpoint of the crest was observed. The water level at the time was well below the crest. At a water supply dam located southwest from the city of Kashiwazaki, cracking of the crest was also observed along with minor concrete cracking and spalling on the upstream side. Here, the reservoir water level was within several meters of the dam crest at the time of observation.

Figure 14: Road embankment failure off Route 8 on the way to Kasashima (Site YT18; N 37.33325 ° E 138.46500°; Photo taken 7/21/07)

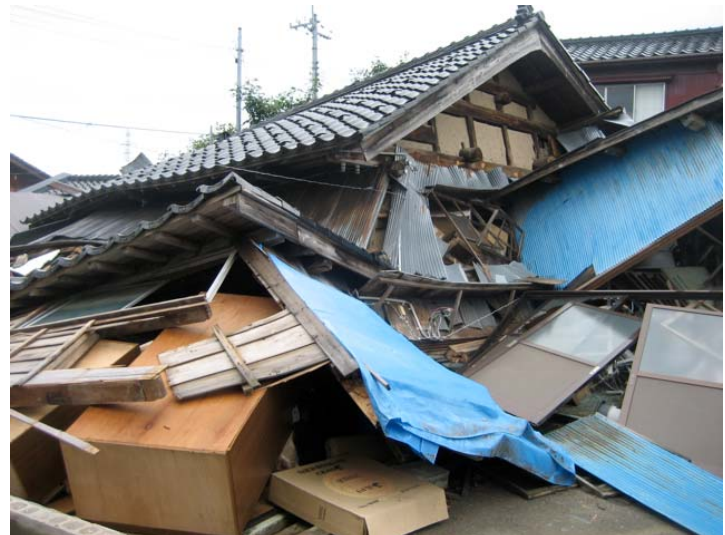
The earthquake caused the collapse of nearly eleven hundred houses in the Niigata prefecture in Japan. Damage to one-to-three story wood buildings was observed along the 30-kilometer long coastal region between Hatsusaki, to the south, and Shiya, to the north. Damage extended inland to western Nagaoka, 12 kilometers west of the coast. The city of Kashiwazaki reported the highest number of collapses in the region. The structures that collapsed were almost exclusively wooden structures and unreinforced masonry fences. Preliminary estimates of collapse rate were between 5 and 7% for buildings and houses in the vicinity of the K-NET instrument in Kashiwazaki. A large fraction of the houses affected were of old-style heavy clay-tile kawara roofs with soil walls (Figure 15). Soft story collapses occurred in buildings with open businesses on the ground floor. The business arcade of Higashi-Honcho Dori was particularly hard hit.

Figure 15: Typical collapse of a heavy kawara-tile roofed home supported by the weak & brittle tsuchi-kabe (“soil wall”) construction technique and wooden post and lintel frame.

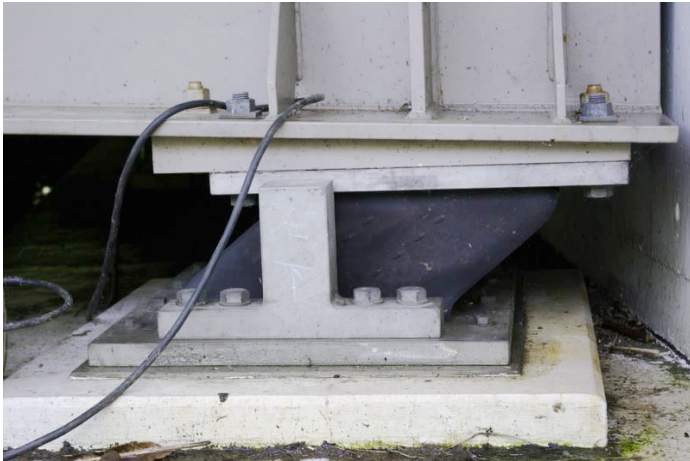
Damage to bridges crossing the Sabaishi River (north of Kashiwazaki) and the U river to (south of Kashiwazaki) was caused by permanent deformation of embankments that run parallel to the rivers and preserved in bridge bearings (Fig. 16). Lateral and vertical deformations of embankments ranging from a few centimeters to about a meter were observed. Embankments cracked at their crests and, in instances, sand boils flowed upward through these cracks indicating liquefaction. Larger ground deformation, and more damage to bridges was observed along the Sabaishi River compared with the U River.

Figure 16: Strained bearing (site SA18, N37.39041° E138.59052°; 7/21/2007)

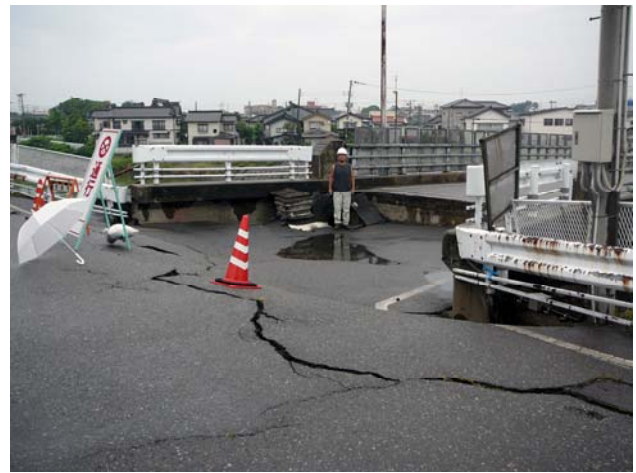
Vertical offsets at bridge approaches caused by soil settlement ranged from 5 cm to a meter (Fig. 17). Asphalt or gravel fill was placed to permit cars to cross bridges. Utility lines attached to bridges where approaches settled were damaged. Settlement of approaches was observed at bridges crossing the Sabaishi and U rivers and bridges along the Hokoriku Expressway.

Figure 17: Settlement of approach fill to bridges along the Sabaishi, here, and U Rivers created critical transportation hazards immediately following the earthquake.

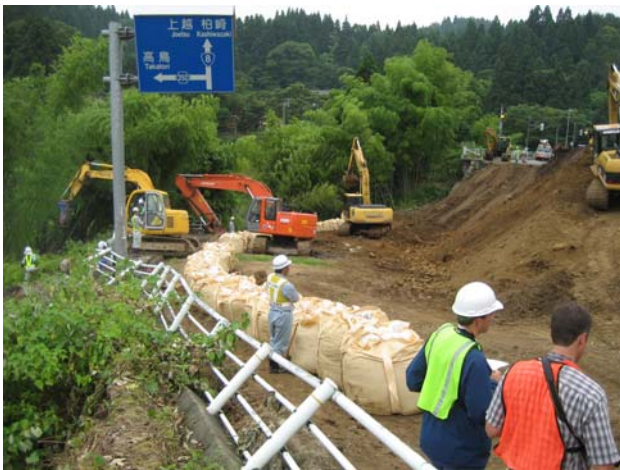
Figure 18: The Ozumi Senbon Landslide (Site RK1; E37.41422° N138.71347°)

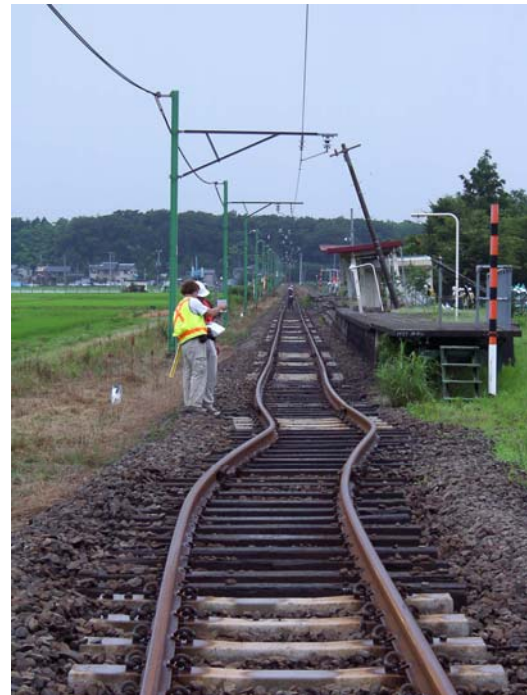
Figure 19: Lateral deformation of train tracks at Arahama Station (Site RK13; N37.40555° E138.60197°, 7/21/07)

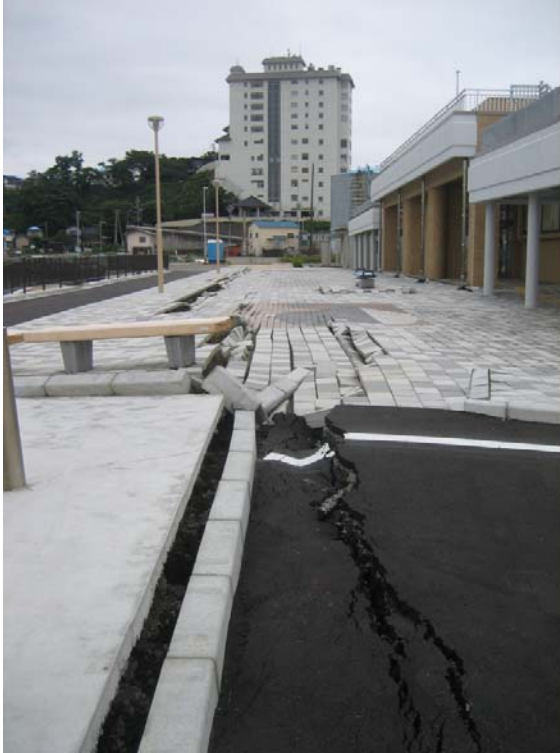
the ground and waterfront earth retention structures (Figure 20). The westernmost section of the Port of Kashiwazaki was subjected to the effects of widespread liquefaction, lateral spreading and settlement exceeding 30 cm in many areas and a pronounced graben formed between a port building and the waterfront quay wall. A pile supported structure performed very well, but two pedestrian-accessible roof areas on either side of the main structure were distressed by ground settlement and lateral spreading.

Figure 20: Kashiwazaki Harbor – Liquefaction induced lateral spreading and settlement of soil beneath a harbor-front caisson resulted in rotation toward the harbor and lateral displacement of the soil behind it (Site RK25, N37.36713 E138.53210, 7/20/2007).

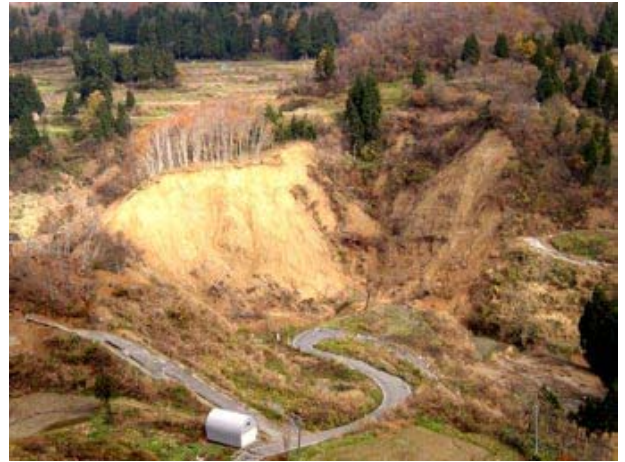
Figure 24: North-facing valley wall with extensive translational soil sliding into valley bottom, Yamakoshi epicentral area (photo: K. Kelson).

The most widespread type of observed failure consisted of translational slip of the regolith and highly weathered bedrock materials on very steep slopes flanking floodplains and along incised river and creek channels. This type of failure generally involves the upper 1.5-3 m of soil, and slip appears generally to be concentrated along the interface between significant root growth and underlying highly weathered bedrock. Examples of this type of failure are shown in Figure 24.

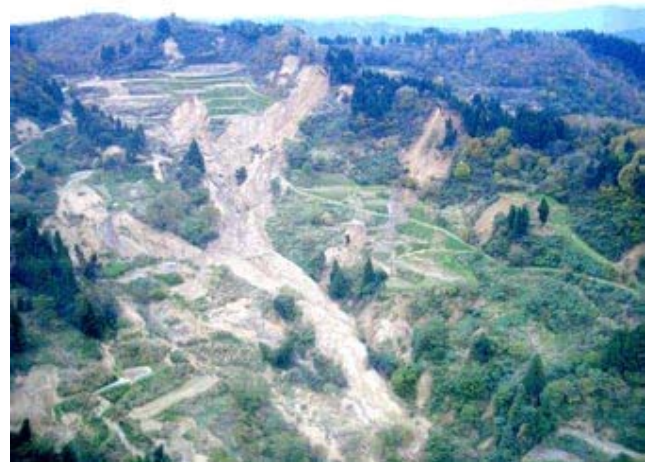
Figure 25: Typical debris flow, exhibiting a narrow path and long runout.

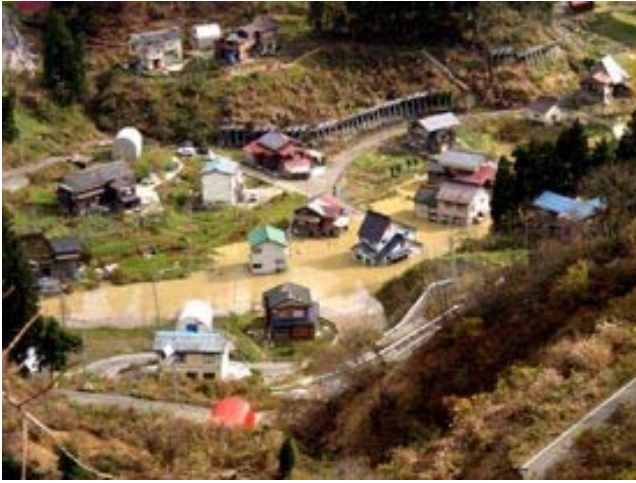
several cases, massive debris flows blocked natural drainage courses, forming landslide dams. These events have already resulted in the flooding of villages and infrastructure (Figure 26), and there is potential for large sudden floods to initiate if the landslide dams are breached in an uncontrolled manner.

Figure 26: Inundation of homes upstream of landslide dam (photo:K. Kelson).

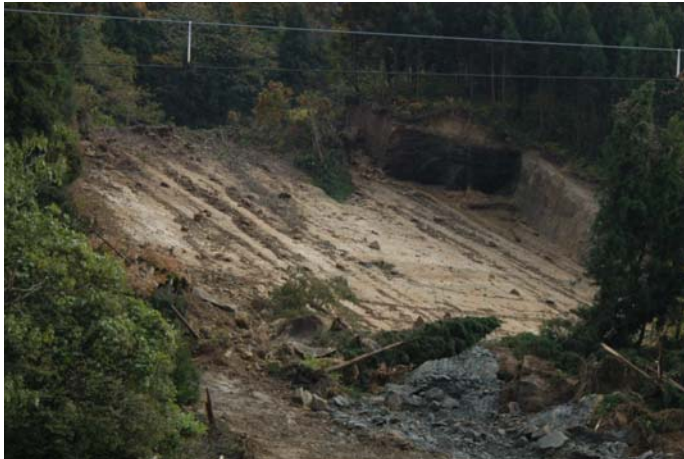
Figure 27: Block slide formed by bedding plane (sliding surface) and two sets of vertical joint release surfaces (photo: R. Kayen).

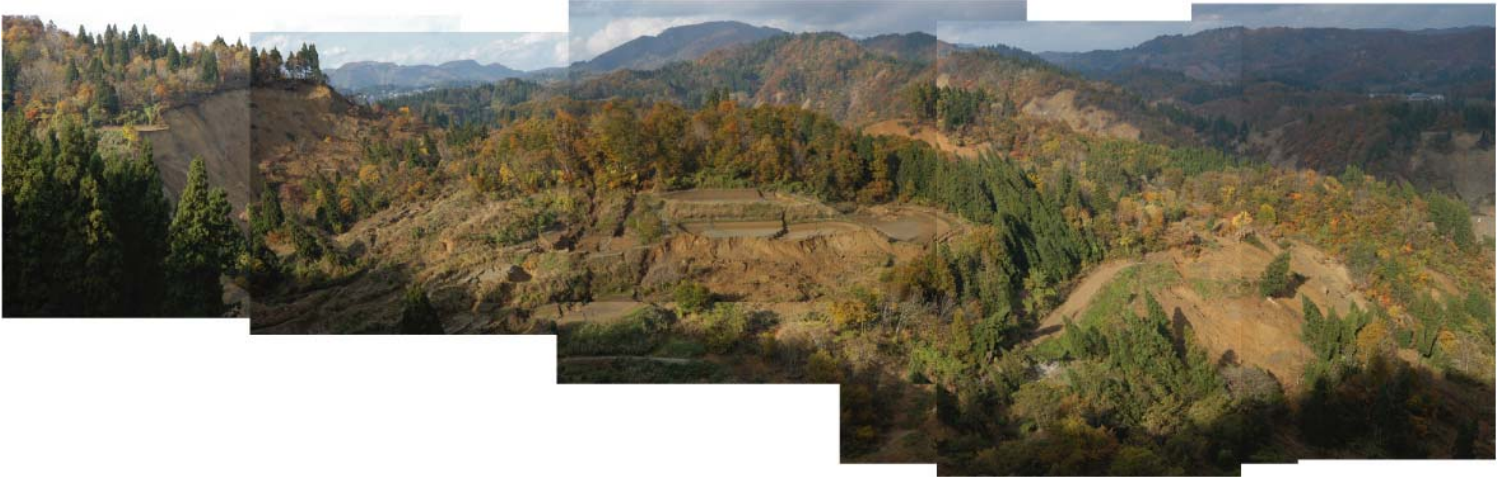
Figure 28: Deep rotational slump, indicated by a block of back-rotated trees and agricultural land, beneath an approximately 30m-50m foot high headscarp (photo mosaic: R. Kayen).

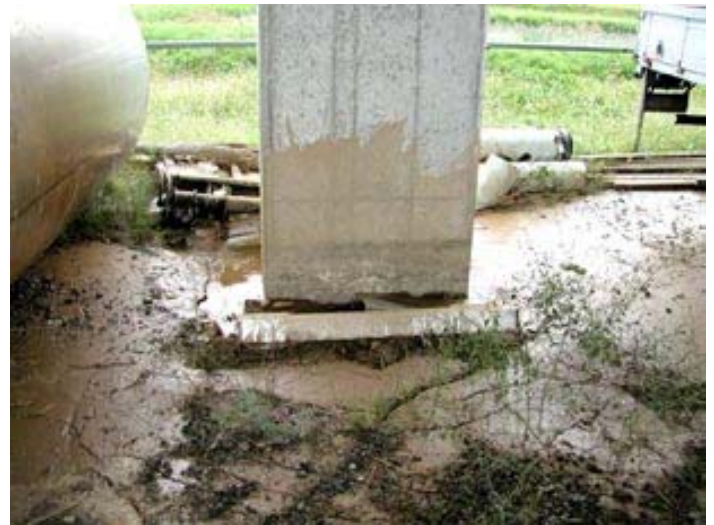
Figure 29: Sand boils at the derailing site of the Johetsu Shinkansen (Oct. 25) (photo: K. Kiyono).

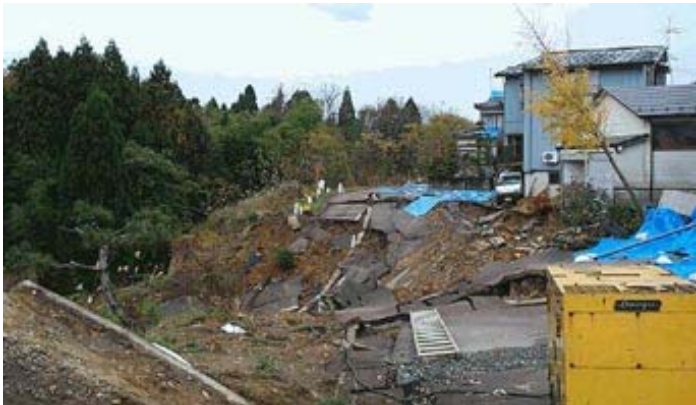
Figure 30: Failure of hillside fill in Takamachi residential area (photo: E. Rathje).

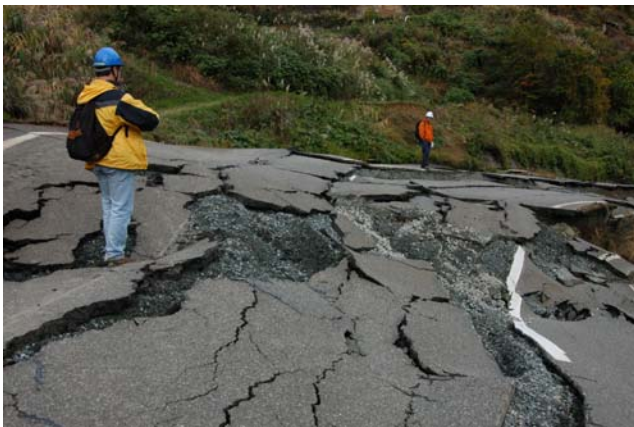
Figure 31: Typical damage to road in Uonoma Hills. (photo: R. Kayen).

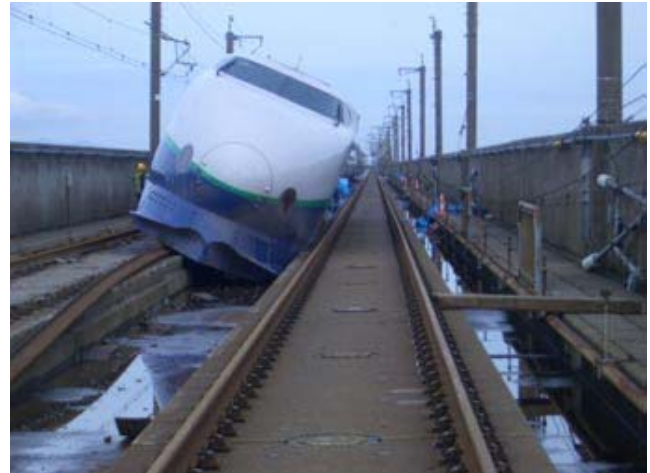
Figure 32: Derailed Shinkansen (Oct. 31) (photo: C. Scawthorn).

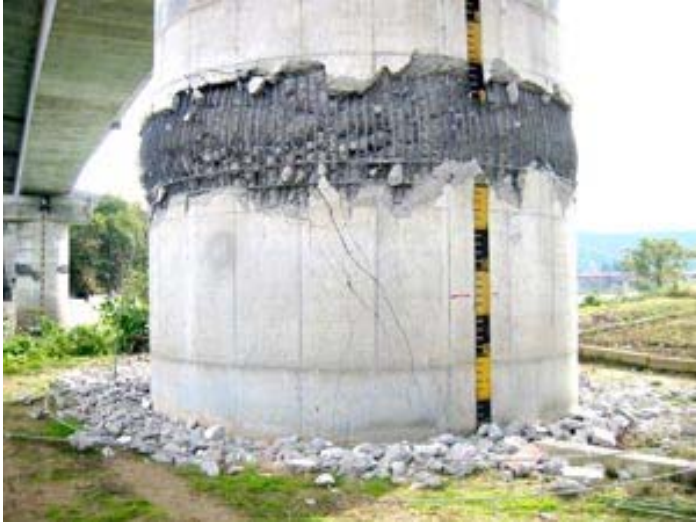
Figure 33: Damaged piers of Joetsu Shinkansen Wanazu Bridge (Nov. 1) (photo: S. Ashford).

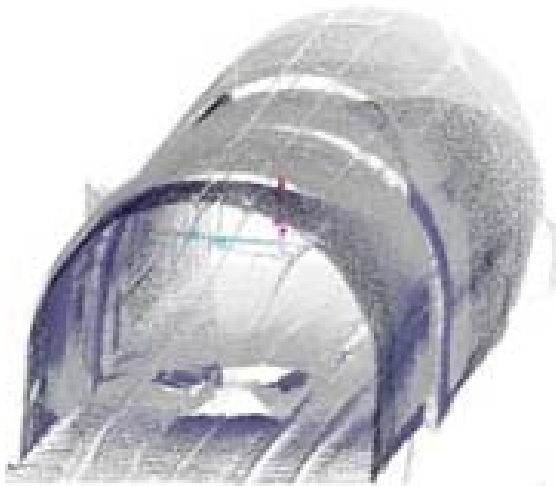
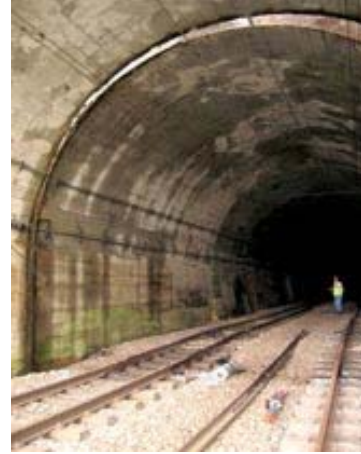
Figure 35: Photograph (below) and LiDAR image (above) of damage to the Juetsu Railroad portal at Kita-Horinouchi from the portal entrance. Lateral displacement of the portal in the photo is visible and measurable in the LiDAR scan. (: R. Kayen)

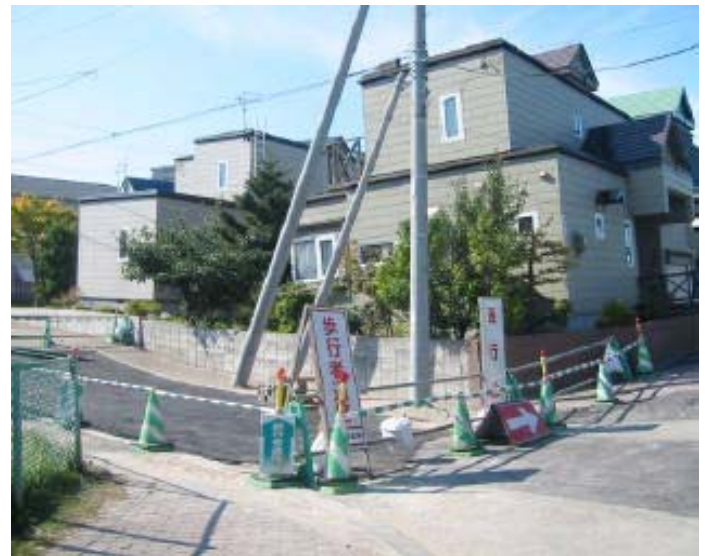
Figure 39: Damage to houses in Utsukushigaoka suburb of southern Sapporo from liquefaction induced settlement.

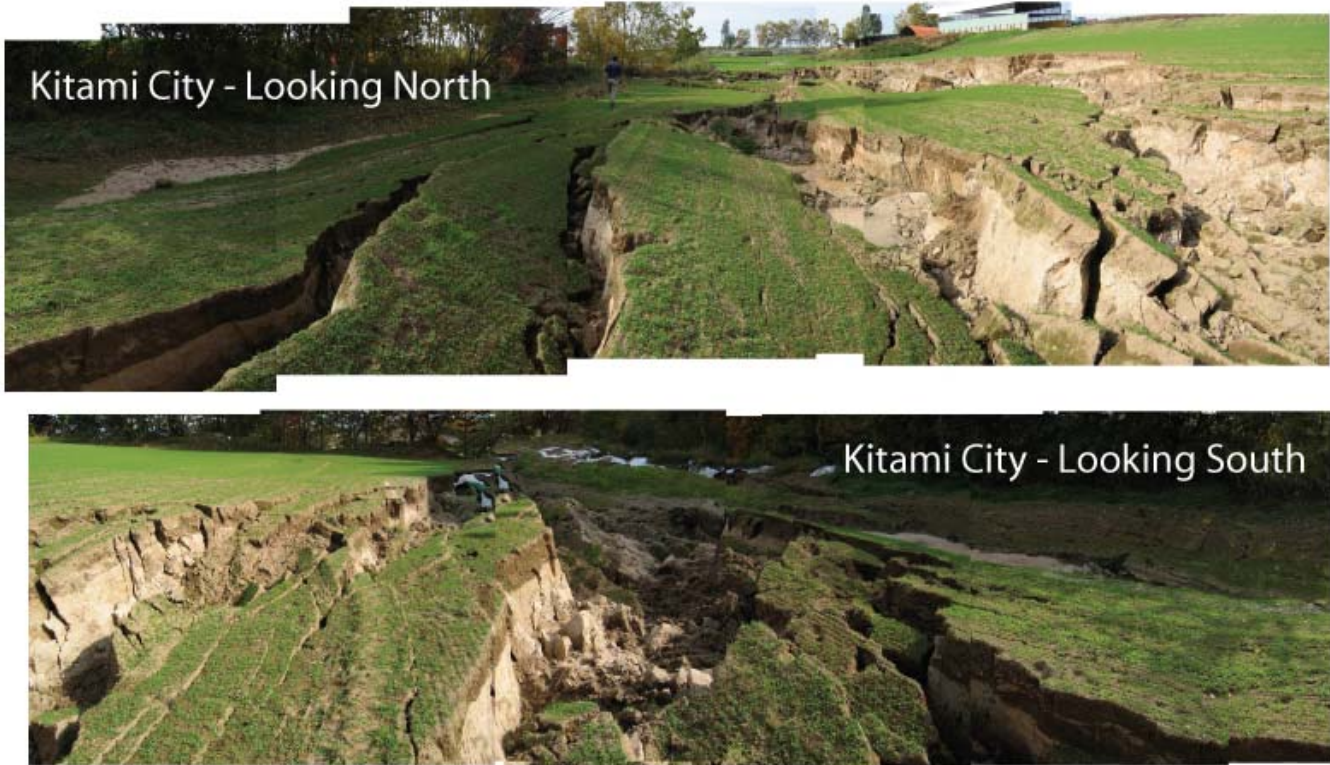
Figure 40: Flow failure in a farm field near Kitami City, where 5,000 to 10,000 m³ of volcanic ash fill soil was expelled from a single site as a result of liquefaction (Photo Mosaic: R. Kayen).

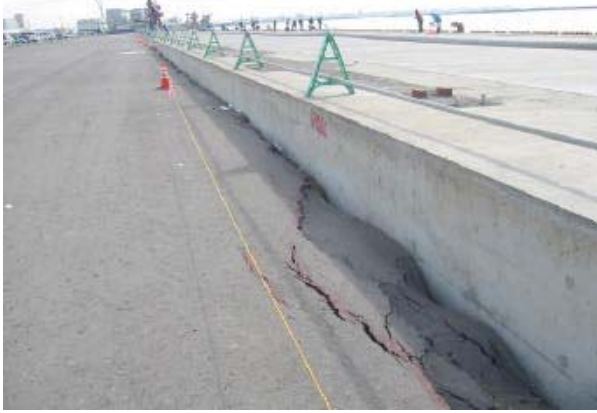
Figure 41. Lateral movement of 10 cm and settlements of 100 cm were observed at Pier 4 of the Port of Kushiro, causing its closure. Piers 1 through 3 suffered minor damage and were quickly reopened.

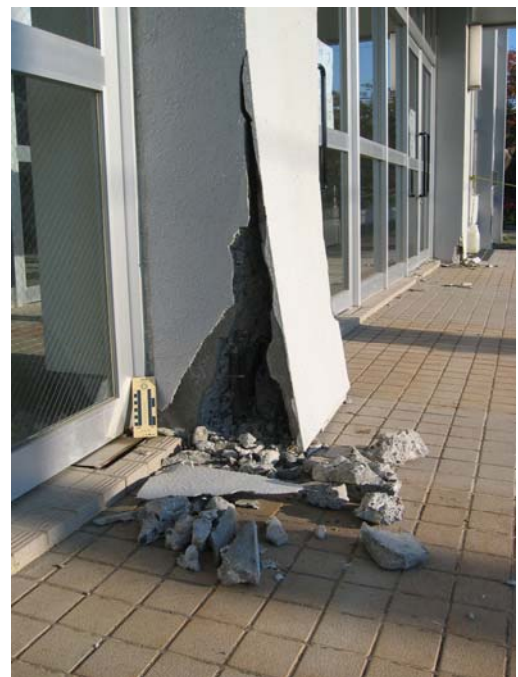
Figure 42. Damage to Urakawa Elementary School.

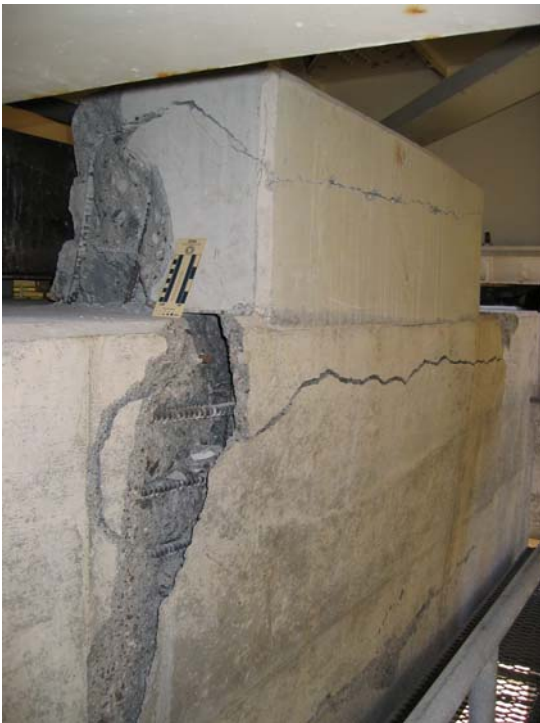
Figure 43. Damaged shear key from the Shizukawa Bridge near Tomakomai City.

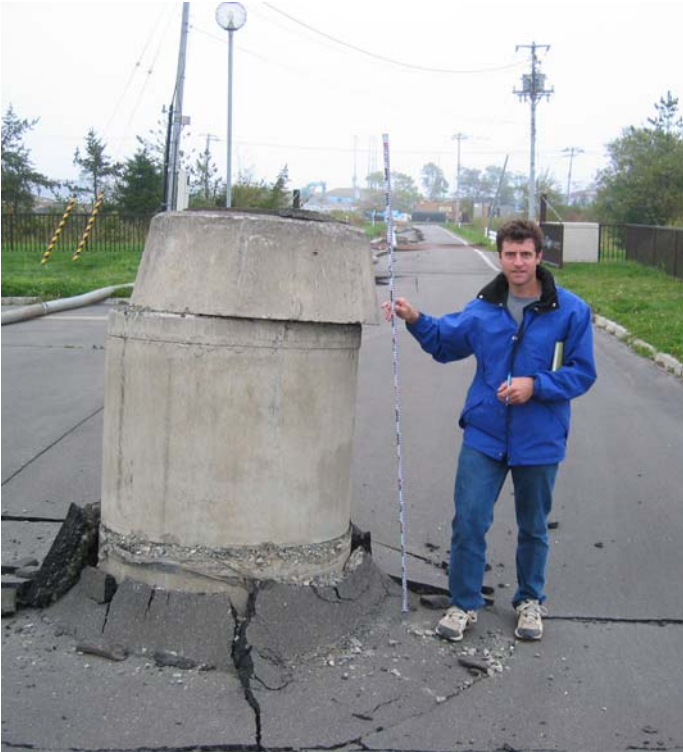
Figure 44. Uplifted manhole near a sewage treatment facility in Otsu town, near the Tokachi river.
