Diagnosis of Structural Damage and Movement Due to More Than One Cause

G. E. Barnes

SYNOPSIS: A structural and ground investigation was carried out on a domestic property at Leigh, Lancashire, England. The settlement of the property was measured and showed a complex pattern of movement which was separated into: (i) an overall tilt towards the east; (ii) an outward tilt of the northern and southern ends; and (iii) severe tilting and cracking at the northern end. Following detailed investigation separate causes were assigned to each of these movements as: (i) preferential longwall mining to the east of the site; (ii) eccentric loading at the northern and southern ends; and (iii) moisture removal from the stiff clay beneath the northern end by the roots of a nearby tree. Details of the settlement of the property, soil conditions and mining situation are presented together with appraisal and analysis of the separated movements.

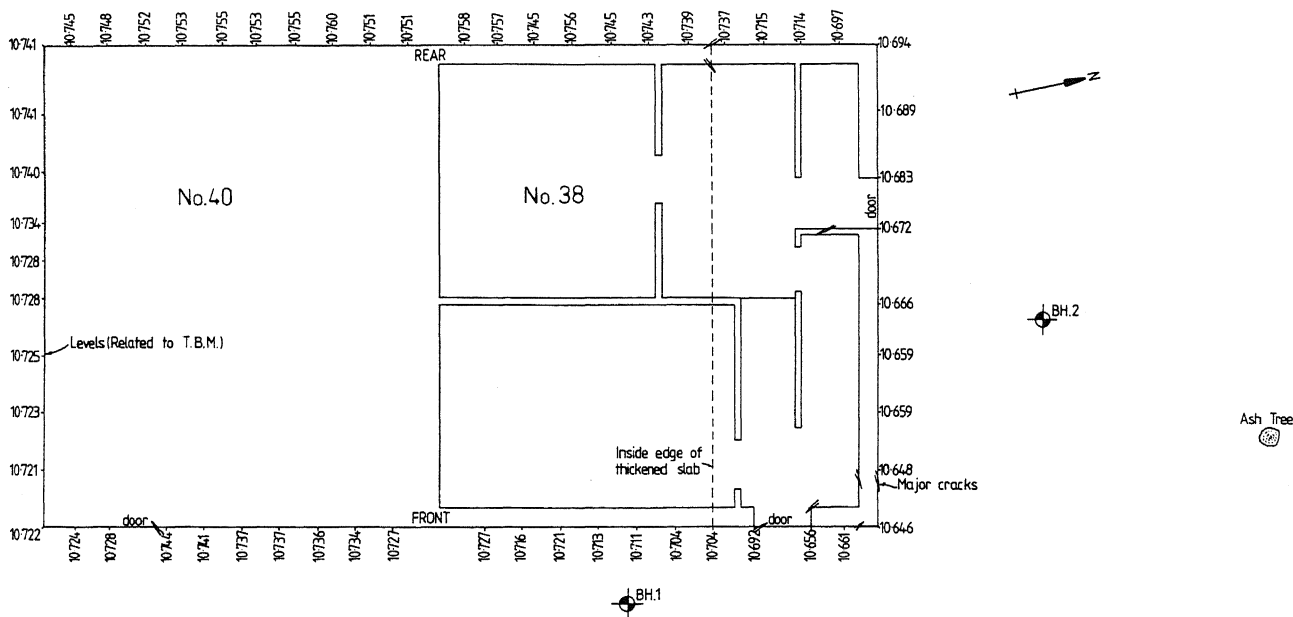
FIGURE 1 : Site Layout

A single fairly mature tree of the Ash family existed about 6m to the north of the front corner of the gable end of No. 38. Pits excavated at the gable end proved thick fresh roots (up to 15mm diameter) and numerous fine roots within the silty clay underneath the foundation. Open fissures in the clay were also observed. Tree roots or open fissures were not observed in pits excavated at the front and rear of the property. Thus the lateral extent of the tree root system was limited to the gable end and no further.

Evidence of the removal of moisture from the clay strata was obtained from comparison of the moisture contents from Boreholes 1 and 2 sunk outside and within the tree root extent, see Figure 1. Average moisture contents are given in Table 1 and show lower values near the tree. It can be seen that the differences are small and could be within the variation to be expected for a natural soil, especially one of glacial origin. Nevertheless, it is also shown that if these are to be considered reductions in moisture content then the change in (vertical) thickness of each layer

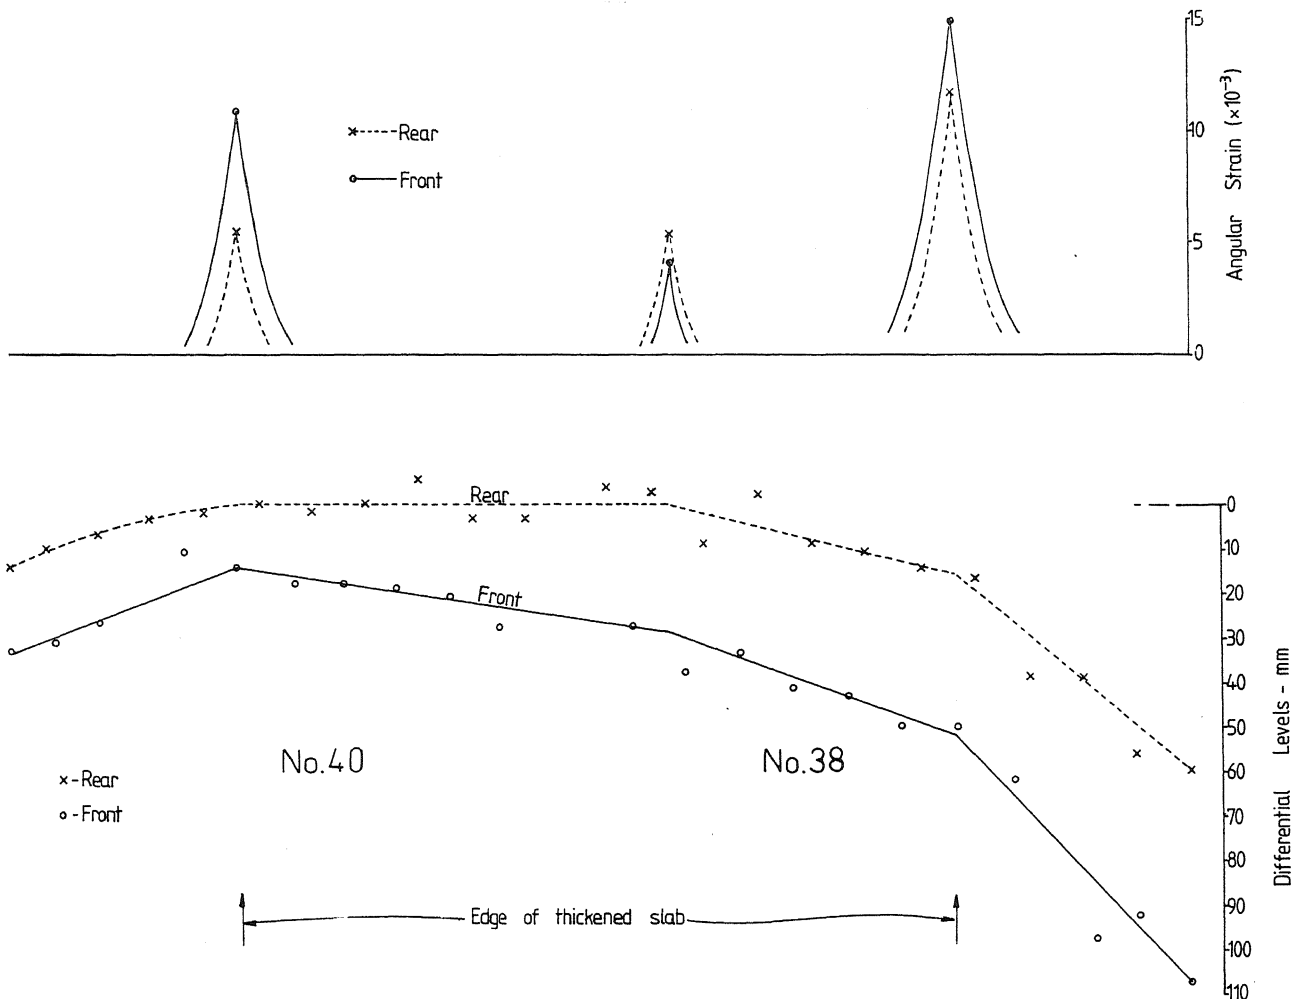
FIGURE 2 Differential Shape and Angular Strain

By levelling along a brickwork course the differential shape of the property could be ascertained. From an inspection of surrounding houses it appears reasonable to assume this property was built horizontally and the measurements obtained reflect differential settlements. Obviously total settlement measurements were not available but these would be estimated to be small, apart, of course, from the mining subsidence. The measurements are given on Figure 1 and the profile along the front and rear are plotted on Figure 2. From these profiles it was considered that there were three quite distinct types of movement, namely

- (i) an overall tilt of about 20mm across the building towards the east, about 1 in 400,
- (ii) a local tilt or rotation parallel to the gable end of No. 40 (southern end) of about 15 - 20mm over the 2.6m wide thickened raft portion (and presumably also at the northern end), about 1 in 150, and
- (iii) a differential settlement in a northerly direction across No. 38 of about 60mm at the rear and about 90mm at the front

With an average value for soil layers 1 and 2 of $0.25m^2/MN$ a rotation of about 0.005 is obtained which compares reasonably well with the measured rotation of 0.006. Eccentric loading is, therefore, considered to be the cause of the rotation at the gable end of No. 40 and consequently must be part of the rotation at No. 38.

The overall hogging ratio at the rear and front of the property (No. 38) is calculated as 30 and 34 ($\times 10^{-4}$), respectively, which is far in excess of the critical value and obviously represents very severe cracking, as found. Ignoring the effect of the tree, i.e. solely due to eccentric load rotation, the overall hogging ratio would be 11×10^{-4} , still above critical and compatible with the observed settlement and cracking at the southern end of No. 40.

Where the settlements are non-uniform, as in this case, their effects can be better depicted by plotting the angular strain, see Figure 2.

The locations of high angular strain relate well to the zones of more severe cracking.

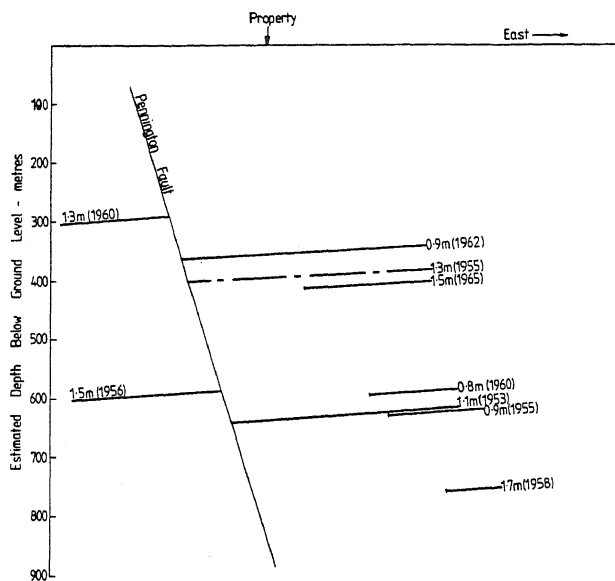
FIGURE 3 Coal Extraction After 1945

Coal extraction has been carried out beneath this area from the nineteenth century but since 1945 when the property was built most of the coal mining within the support area of the site took place by longwall working between 1953 and 1965 so a considerable amount of vertical subsidence would have occurred but movements would have virtually ceased by 1976. However, the most significant factor affecting these workings is the presence of a major geological fault, the Pennington Fault, which runs in a NNW-SSE direction, outcropping about 250m west of the site. This fault plane dips steeply at about 1 : 3 (horizontal : vertical) in an easterly direction with a fairly large throw on the eastern side of the fault. The records show that some workings were taken up to the fault but several were terminated east of the site, see Figure 3.

From the above it would be reasonable to expect that the property would retain an easterly tilt after mining ceased, and this was assigned to be the cause of the tilt observed. However, it should not be forgotten that the small differential level measured may not be a tilt but simply the out of level laying of the brickwork originally.
