International Conference on Case Histories in Geotechnical Engineering (1993) - Third International Conference on Case Histories in Geotechnical Engineering

## An Unsuccessful Urban Deep Excavation in Soft Soils

Richard Rodgers

Michael Majchrzak

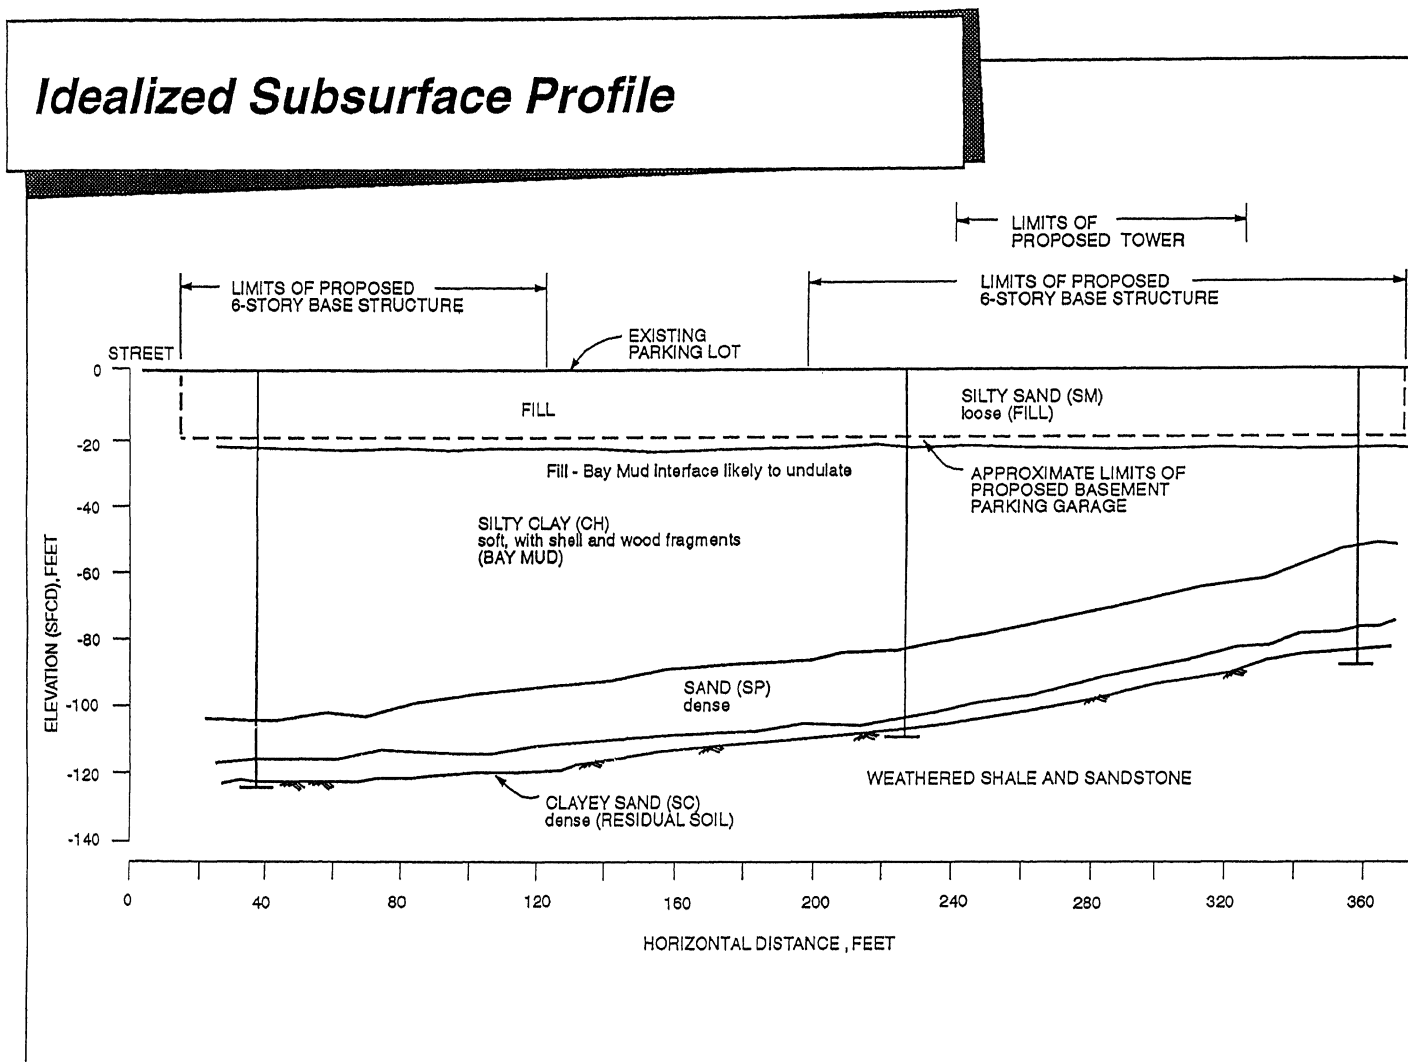
Figure 1  
Idealized Subsurface profile

The area of San Francisco in which the project is located is land reclaimed from San Francisco Bay. In the late 1800's, the waterfront areas of San Francisco were diked off from the Bay by seawalls, and sand and rubble fill was placed landward of the walls to provide developable land. The fill was generally uncompacted and, consequently, remains loose even today. At the project site the fill varies from approximately 10 to 25 feet thick, and is underlain by about 60 to 80 feet of compressible marine clay known locally as Bay Mud. Bedrock consists of interbedded weak shale and hard sandstone found at depths ranging from about 90 to 120 feet below the ground surface. Groundwater at the site fluctuates with the tide, but is generally on the order of 10 feet below the ground surface. An idealized subsurface profile is shown on Figure 1.

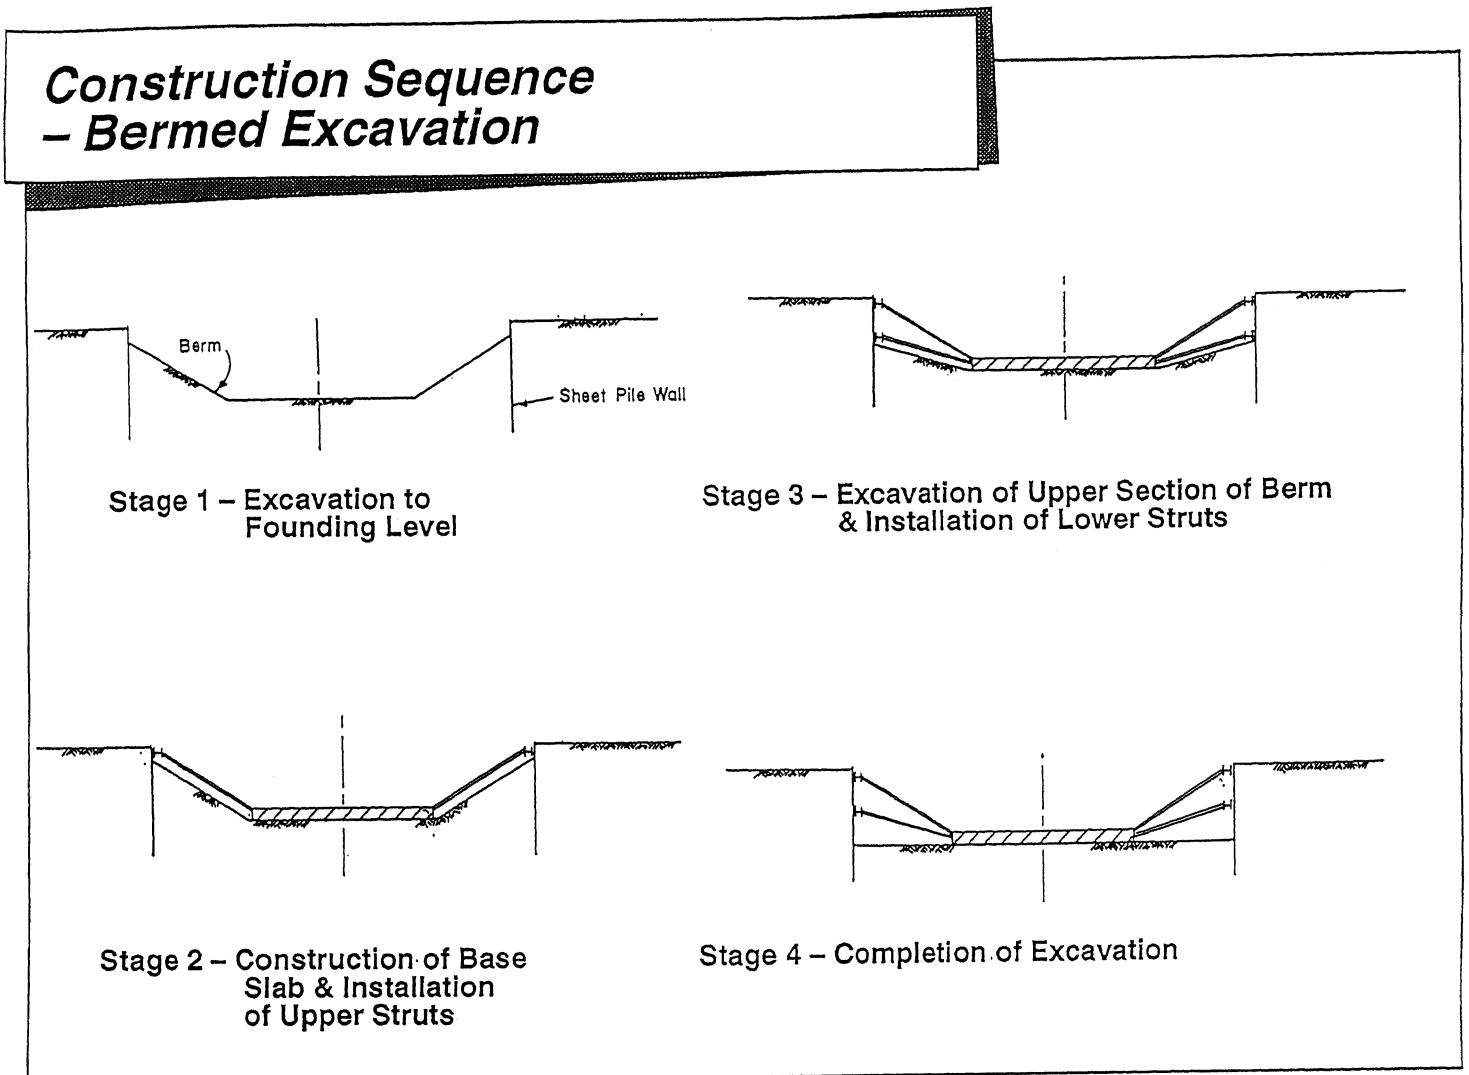
Figure 2  
Bermed Excavation Construction Sequence

1. Drive the sheet piles around the site perimeter;
2. Excavate to a depth of 6 feet to install the upper waler for shoring system and install precast concrete piles to support foundation loads;
3. Following internal dewatering, excavate a 1 to 1 (horizontal to vertical) sloped berm from the depth of 6 feet to bottom of the mat grade;
4. Construct central portion of the mat covering approximately one-half of the center of the basement;
5. Install the first row of internal braces;
6. Excavate berm to approximately 10 feet above the bottom of the mat grade and install the second row of braces; and
7. Excavate remainder of berm to reach final grade.

The excavation sequences are illustrated on Figure 2 below.
