Foundations Failures of Bridges and Geotechnical Investigations

SYNOPSIS In the present paper two cases of foundation failures due to which the complete bridge structure have failed are reported. The 93m long Palakmati high level brick masonry arch bridge on Hoshangabad - Piparia Road was constructed in year 1910. This bridge has shallow well brick masonry foundation with brick masonry wall type piers. Foundations of piers were on two circular shallow independent wells. The wells are resting on yellow soil. During floods of 1989, the pier No.3 sunk. This brought down 5 spans. Two well foundations were up-rooted. Cracks were developed in other arches also.

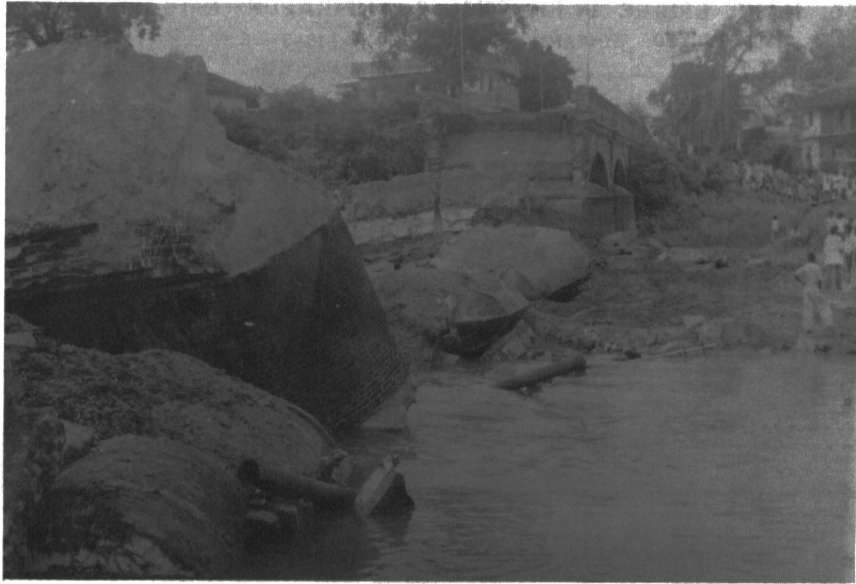
The wells were resting on yellow soil @3m below the lowest bed level. Concentration of flow is mainly in span Nos.3,4,5 & 6. During floods of 1989, there was heavy scouring at pier-3 which collapsed and the shallow well was uprooted (Photo-1). This brought down 5 spans i.e. spans 3 to 7 as there was no abutment pier. Two well foundations were uprooted. Cracks developed in other arches (Photo-2). There exists a Railway bridge @ 300m U/S on the same river has about 5.5m deep open foundation resting on similar type of foundation. No distress is observed on Railway bridge.

The investigation shows that heavy floods in this small river caused scour which extended gradually over years below founding level. The bridge did not collapse during high flood but on receding floods when a heavy tanker passed over the bridge. Pier p-3 which settled and gone way.

Photo 1 Pier No.3 from Piparia side of Palakmati Bridge.

Investigations have been done and it is found that good founding strata, yellow soil mixed with kankar is available at a depth 4m to 5m below the lowest bed level with S.B.C. of @ 30 T/Sq.m. Now a new bridge is proposed at the existing site with 5 spans of 19.2m c/c and the foundations are kept at R.L. 91.00 i.e. 5.5m below lowest bed level on yellow soil mixed with kankar.

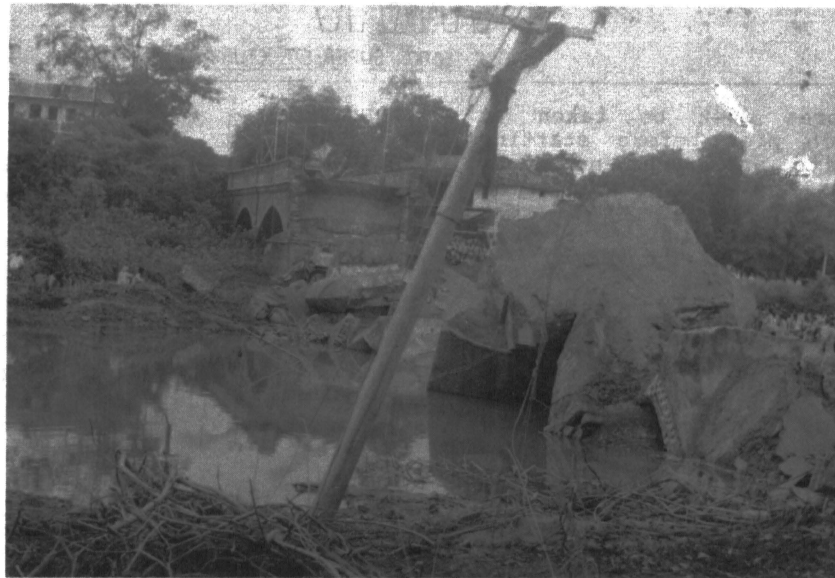
Photo 2. Showing 5 spans collapsed of Palakmati Bridge on Hoshangabad - Piparia Road.

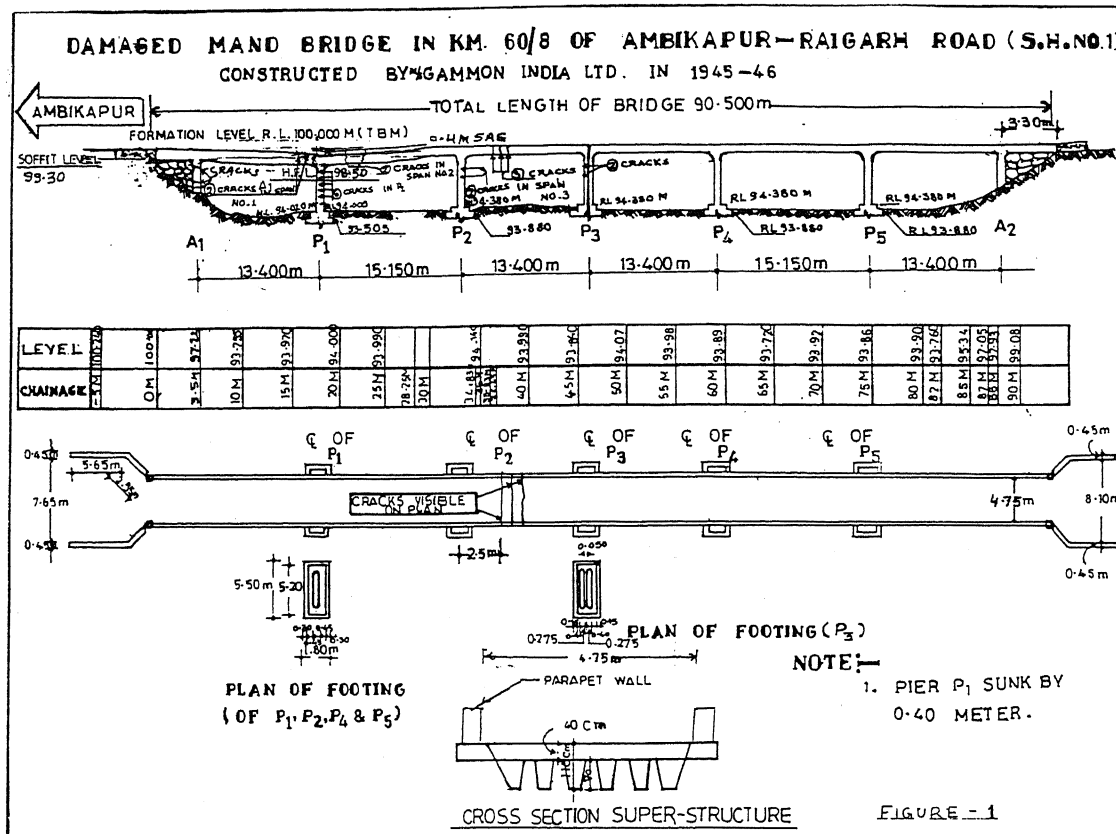
The bridge has open foundation resting on rock/hard strata. The superstructure consist of two units of R.C.C. framed structure (3.3m cantilever + 13.40m + 15.15m + 13.40m). The details are shown in fig.1. The foundations are resting at a depth 3.5m to 5m below the lowest bed level.

The river channel is flat with defined banks. The abutments are resting on high ground near banks. Pier P-1 is resting on gravel and below gravel it is only silt. The foundation of pier P-1 towards Ambikapur side sunk by about 0.4m in August 1991. Due to this abrupt settlement the abutment and all the three piers have developed through cracks below the supports. Similarly the slabs at 0.2 L. from support have developed severe cracks in all spans as shown in figure-1. The traffic on bridge has been stopped.

under pier P-1 and partly due to creation of cavity and voids in the silty strata due to flow of water with high velocity during rains. The bridge was standing due to arch action and when this arch action was broken due to unbalancing of the underlying strata, the settlement took place under pier P-1 and the failure of one unit of three spans occurred.

Detailed investigations have been done and it is found that foundation in unit-2

is also not reliable, so it is under consideration to dismantle complete bridge and provide a new bridge with 2 lane carriage way i.e. 7.5m width.
