(1984) - First International Conference on Case
Histories in Geotechnical Engineering

The Use of Limited Field Observation in Remedial Design

SYNOPSIS As a consequence of a slope failure, an investigation was carried out to determine the present and future stability of a gold tailings dam in the Orange Free State, South Africa. Recommendations were also required concerning the type of remedial measure(s) necessary in order to permit continued deposition of the tailings waste product on the dam. The field and laboratory investigation involved sampling of the tailings and foundation soils and installation of piezometers at various locations around the dam. The paper describes how, using data obtained from a limited monitoring period, evaluation of in-situ parameters enabled prediction of future phreatic surface variations under differing operating and climatic conditions.

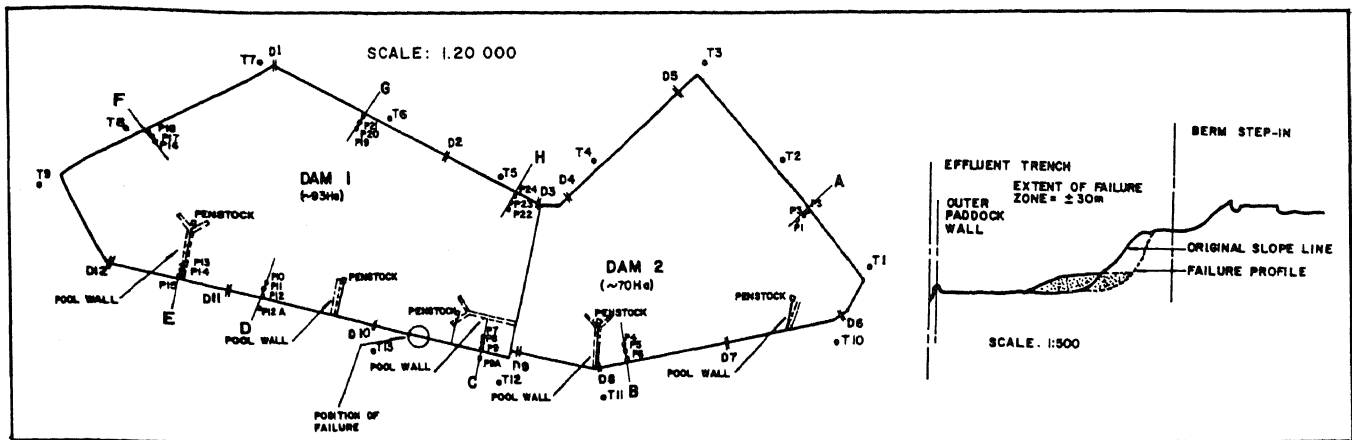
Fig. 1 (a) General Layout of Tailing Dam showing Piezometer Sections and Position of Failure; (b) Cross-Section through Failure Area. (D1-D12 Delivery points; P1-P24. Piezometer Positions; A-H Cross-sections used for stability analyses; T1-T13 Positions of Excavated Trial Pits).

Figure 1a. shows a cross-section through the failure which was located between piezometer sections C and D (Fig. 1b). The shape of the failure

re suggests a circular surface occurring mainly within the tailings material with only slight influence of the underlying aeolian sands. The extent of the failure parallel to the daywall was approximately 30 m.

- daywall slopes, constructed at high angles which had been steepened by erosion due to rainfall run-off. The average slope angles at sections C and D were 52° and 55° respectively.
- continual sliming in the area of the failure for nine days prior to failure.
- high groundwater conditions in the outer paddocks at the toe of the slope; water table being at ground level.
- evidence of seepage from the lower part of the slope.
- several days of heavy rainfall on the dam causing partial saturation and subsequent loss of apparent cohesion in the tailings material above the steady-state phreatic surface position.
- storage of large volumes of rainwater and slimes delivery water on the surface of the dam due to inadequate penstock decant capacity and poor operational procedures. The stored water was about 0.3m deep at the top of upper slope above the berm step-in.

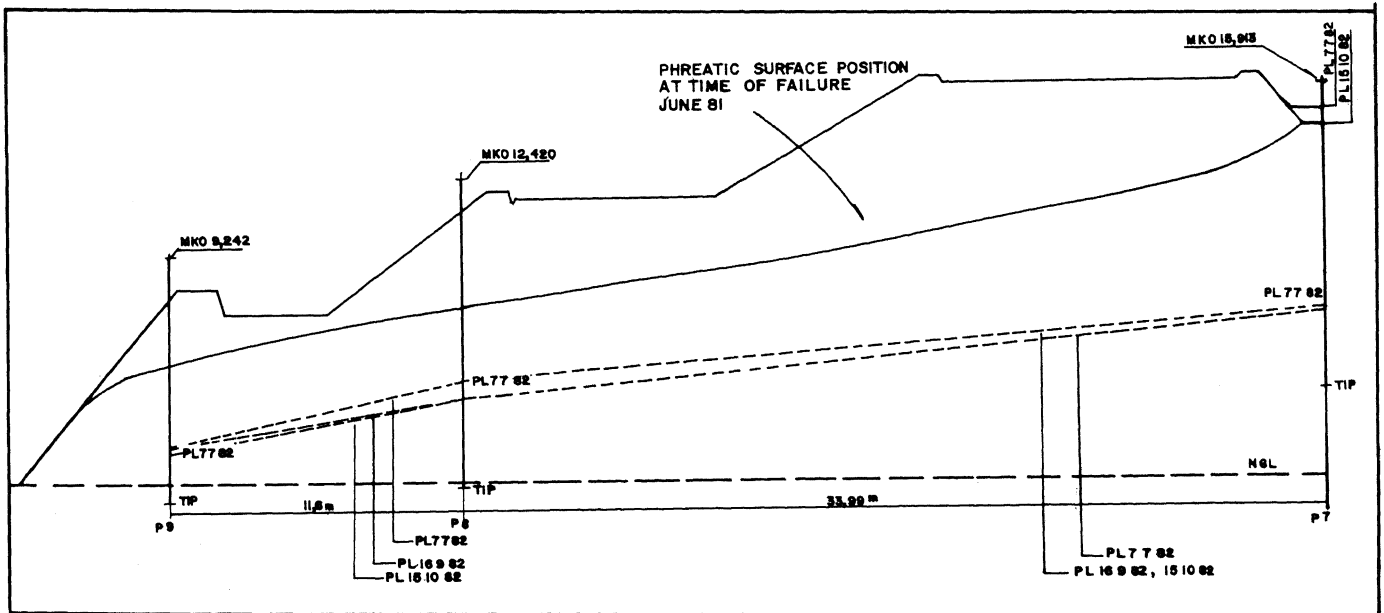
Fig. 2 Phreatic Surface Data For Cross-Section C

The results of piezometers for Section C during the dry season are shown in Fig. 2.

The calibrated program was then used to predict the phreatic surface position at the time of failure with simulation of applicable boundary conditions described earlier. The predicted surface is shown on Fig. 2 with results from post-failure monitoring for comparison. (The difference

between the pre-failure and post-failure phreatic surface positions is due to improved operating conditions instigated as a result of the failure.)

The stability of a slope is directly related to amongst other variables, the angle of the slope and the position of the phreatic surface. Present day slopes of the dam were analysed for stability using piezometer data. As shown in Fig. 2 the phreatic surface is very low which may be attributed to the underdrainage effect of the aeolian sands and the post-failure practice of decanting water from the top of the dam. The factors of safety for present slope configurations are shown in Table V. In these analyses no account was made for apparent cohesion affects resulting from partial saturation which can significantly increase the effective safety factor (McPhail, 1982).

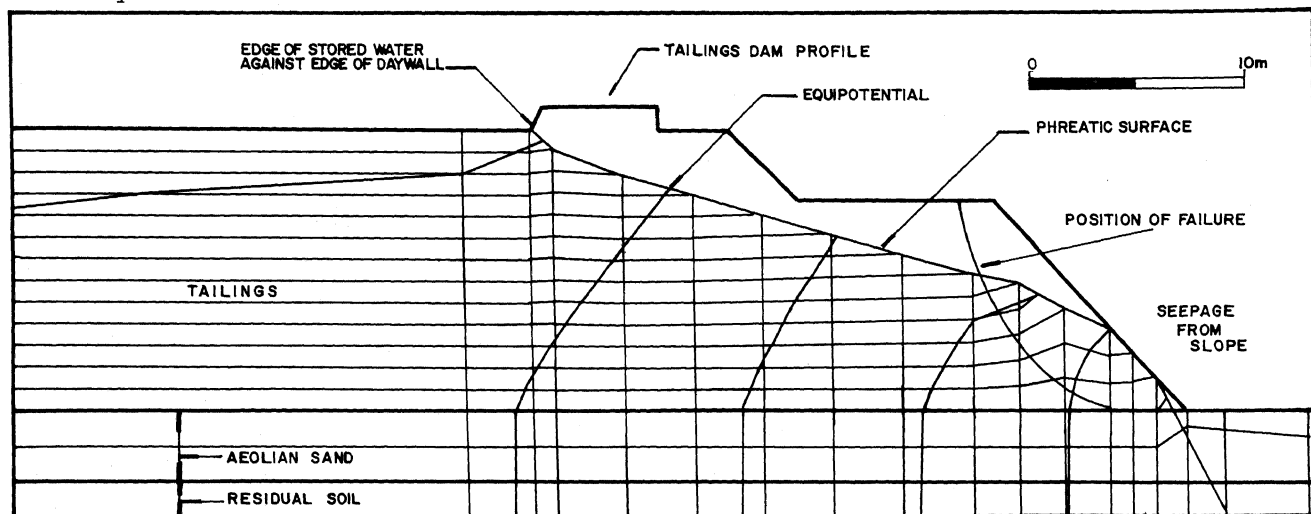
Fig. 3 Predicted Surface Position for Backanalysis of Failure

The position of the failure surface was obtained from the survey carried out by the Mine just after failure had occurred.

The backcalculated factor of safety, using the slope stability program STABL (Siegel 1975) was found to be 0,97 with a probability of failure of 68%. The analysed cross section showing position of the phreatic surface and failure surface are shown in Fig. 3. The following points were verified from the backanalysis:

- that the phreatic surface prediction was realistic albeit somewhat slightly conservative.
- that the soil parameters obtained from laboratory testing were representative of actual in-situ strengths.
- that the method of analysis could be relied upon to predict meaningful values of factor of safety and probability of failure for a slope.

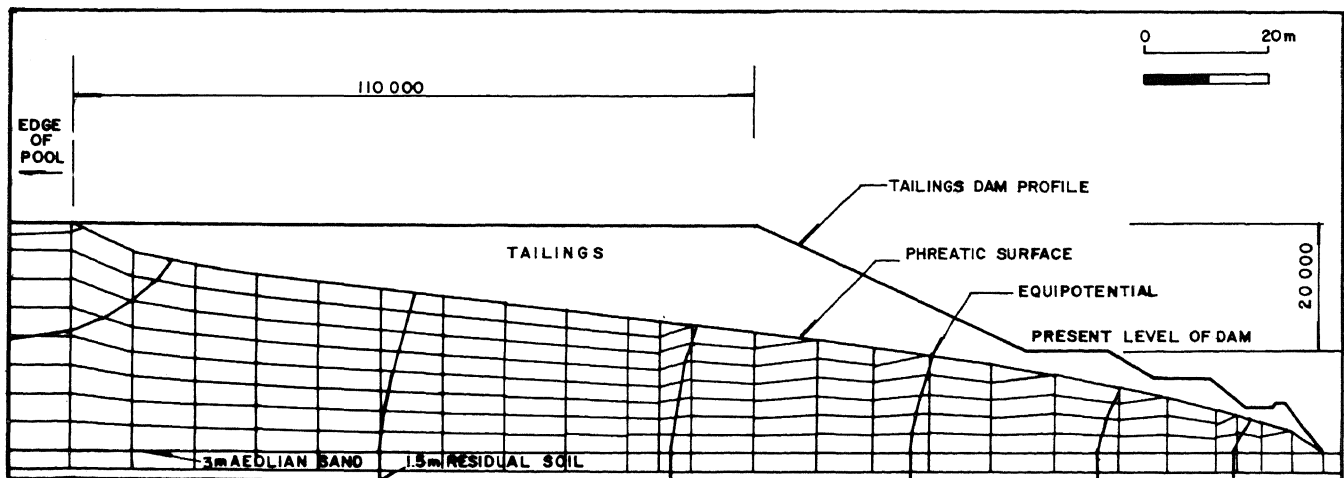
Fig. 4 Predicted Steady-State Phreatic Surface Position after 20m Rise

- 'steady-state' conditions which exist during average weather conditions and normal periods of sliming. The 'steady-state' phreatic surface for Section C after a 20m rise above present level is shown in Fig. 4.

The difference between the two conditions was modelled by allowing encroachment of the pool to the daywall slope. The distances used, i.e. 110 m from crest and 10m from crest for 'steady-state' and 'transient' conditions respectively, are considered realistic since the gold tailings material beaches at a very low gradient (+2%) and small rises in pool level can cause significant lateral movement of pool boundaries.

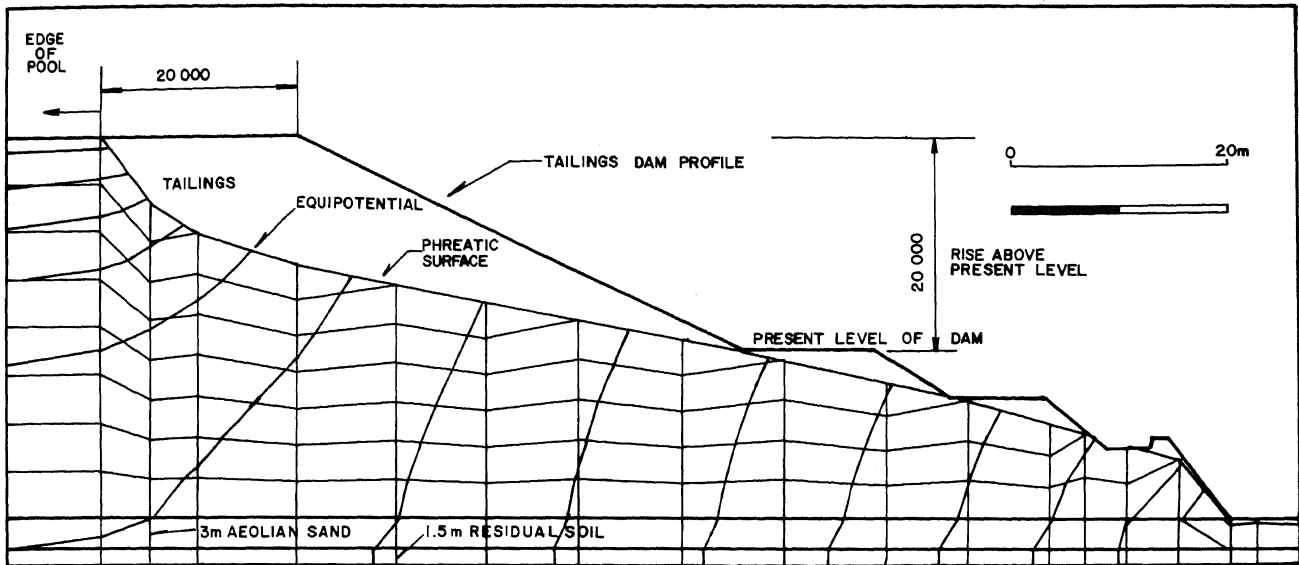
Fig. 5 Predicted Transient Phreatic Surface Position after 20m Rise

- 'transient' conditions which exist for short periods during adverse periods of deposition and rainfall. The 'transient' surface for section C after a 20m rise above present level is shown in Fig. 5.
