Distress in Hirakud Dam, Orissa, India – Possible Causes and Remedial Measures

B. Ramachandran
Madras, India

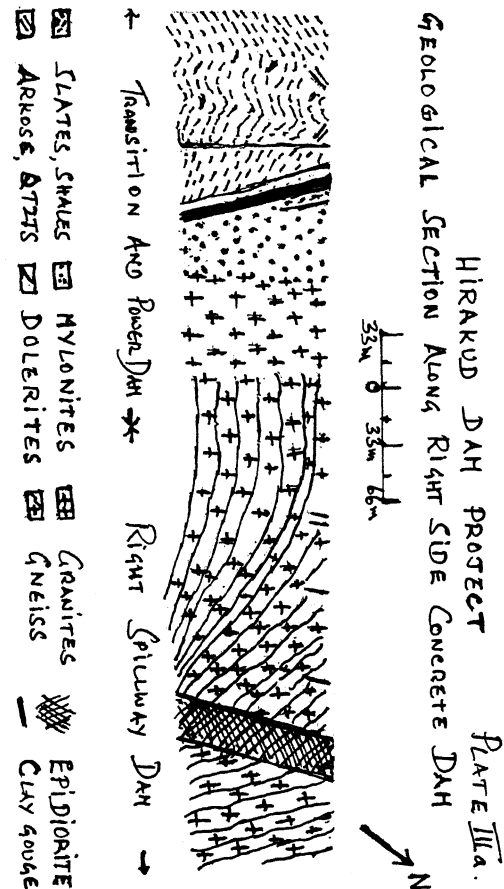
HIRAKUD DAM - RIGHT CHANNEL - PLAN

- a) Highly sheared and fractured shales and slaty rocks on the right bank in the power house and power dam, with clay gouge in the middle.
- b) Deeply weathered gneissic and granitic rocks in the right channel, with a number of shears and minor faults, parallel to the flow and normal to it, with widths ranging from a few cm to a maximum of 1m.
- c) A fractured and jointed epidiorite band 10m wide on the right channel, along a fault feature.
- d) Very deep scouring of the rocks in the main channel with perennial springs at the bottom on account of a fault parallel to the flow.
- e) Occurrence of very soft schisose pockets besides joints and minor faults within the granites on the left concrete dam. (GSM Rao, P.B.Srinivasan, N.R.N.Rao, A.Acharya & B.Ramachandran). (Plate III a)

Treatment was carried out for the above adverse foundations features by means of deep selective excavation, excavation on formula basis along joints, fractures and shears, provision of dowel bars on slopes, steel grilles over weathered zones and extensive consolidation grouting after washing and cleaning of joints and fractures. On the right side additional rows of curtain grout holes were also provided. Nearly 101 tons of cement has been injected on the right side dam foundations. (R.C.Rao).

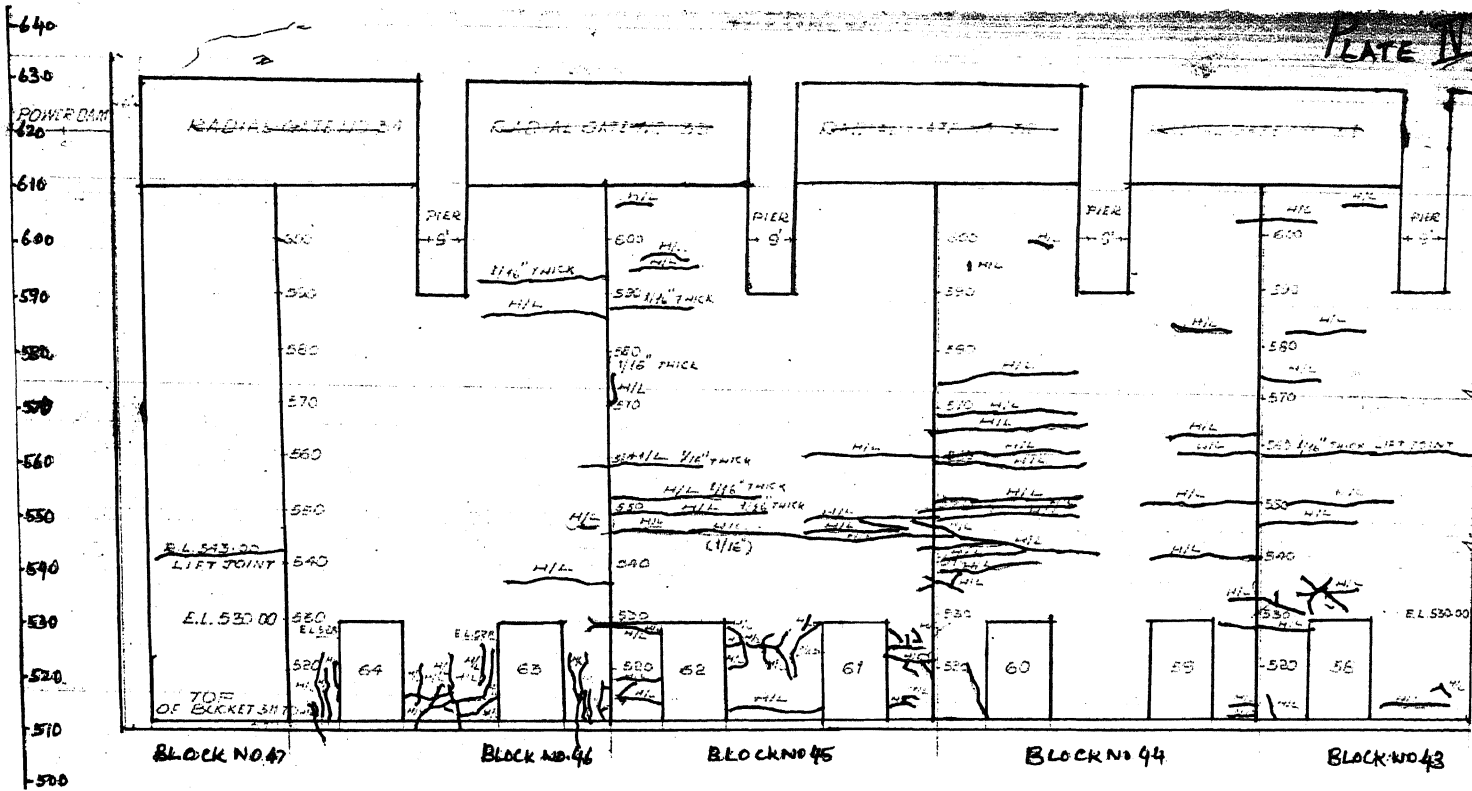
CRACKS ON D/S FACE OF THE DAM - RIGHT BANK

Immediately after the completion of the dam in 57-58 horizontal cracks appeared at the operation gallery of the right side spillway dam. The cracks were confined to the area adjoining the construction joints. Wet patches were seen in December 73 on the downstream wall of operation gallery, which was healed by grouting. In August 74, the lifting beams of gantry cranes in blocks were not moving freely, because of development of cracks nearby. The cracks are generally less than one cm wide, extending to length of 1m to 3m, sometimes upto 10m. The depth of them are in the order of 1 to 2.2m inside. Sometimes they occur in echelon in pattern.

In July 83, the engineers of the Indian Institute of Technology, Delhi reported on horizontal cracks at block No.35 on both walls, in block 37, 38 and 39 on the side walls and on the downstream side wall in blocks 41, 44 and 45; besides extensive cracking on the side walls near the entrance adit, with the buckling of angles. Besides in almost

all the sluice barrels, horizontal cracks had developed, 1 to 1.5m above the floor of the barrel. In blocks 46 and 47 vertical cracks have developed on the downstream face of the barrels walls, extending to a height of 3 to 4.5m. (Plate IV).

Remedial Measures : Ever since the development of cracks were observed, the project authorities have been opening them with chisels and jackhammers, and grouting them at pressures of 1 to 3 kg/sq.cm. with Cement and Epoxy resin. The grout appears to cover only 3 m from the crack surface. Guniting of some parts with waterproof cement has also been performed.

The latest measures consist of provision of steel sheets by international groups, the steel sheets, placed upstream of the dam extending from the river bed to the maximum water level in the non overflow and overflow sections. Steel sheets are expected to prevent further attack of the concrete and its deterioration subsequently.

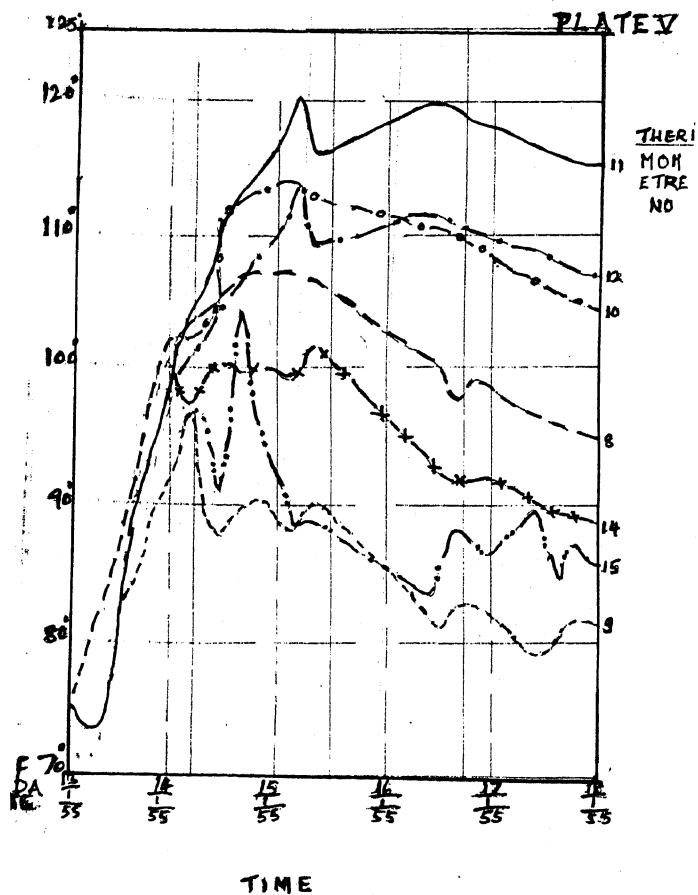
EARLY TEMP. RISE FOR EL. 525-BLOCK 4/NO

The Central Water and Power Research Station, (CWPRS), Khadakvasla, Pune, conducted static and dynamic analyses in October 78, by complete detailed stress distribution around the sluice openings. The stresses, because of normal gravity loads and water loads are not very high, though some tensile stresses are high on the downstream face of the dam. The internal pressure attributes to reduction of compression on the wall of the sluice. The compressive stress on the face of the large gate gallery is very small. These could very easily lead to cracking on account of thermal stresses, which may be in the order of 20 kg/sq.cm. Therefore, they conclude that thermal differential between the concrete and the air temperature has caused the cracking in the gate gallery and the sluice barrels. And also because of the rapid cooling of the interior concrete. (Plate V)

- a) Effect of thermal stresses in the gate gallery and undersluice barrels, because of very rapid placement of concrete in those sections, without precooling or postcooling, lack of pozzolanas and use of high alkali cement for obtainment of high strengths, as per studies conducted by the Central Water and Power Research Station Pune and Indian Institute of Technology, New Delhi.
