Geotechnical Damage Due to Bihar Earthquake of August 1988

SYNOPSIS: The Bihar-Nepal earthquake of August 21, 1988 (magnitude 6.6) caused significant loss of life and property. Besides the epicentral area, two distant places (Munger in India and Bhaktapur in Nepal) suffered significantly. This was also the case in the 1934 earthquake (magnitude 8.4) and is due to peculiar geology of the area. Geotechnical damage in the affected area includes liquefaction, cracking and subsidence of embankments, and cracks in bridge abutments and wing walls. Besides, in the hilly regions of Sikkim, landslides and rockfalls disrupted road network significantly. Extensive damage took place in the eastern Nepal also. This paper describes the geotechnical damage to the Indian areas only.

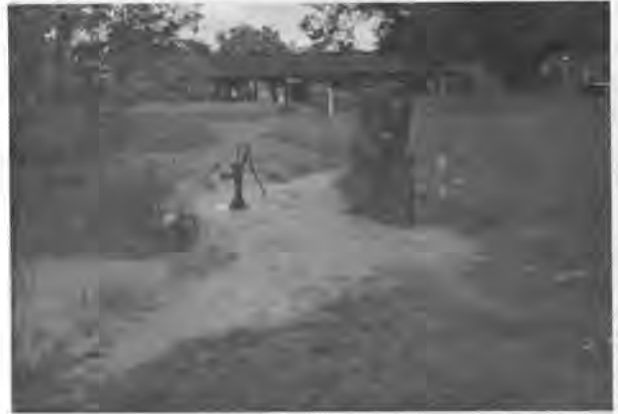
Darbhanga, was found choked with sand. A hand pump was mounted on the top cover slab of the well. The upward thrust on the pump punctured the top brick slab and a big heap of sand brought by the springing water was lying all around the well (Fig. 3). A typical sand dune due to liquefaction inside the premises of the Bihar Public Works Department rest house is seen in Fig. 4.

FIG. 3 Sand Boil, Around Hand Pump Inside the Residence of the Superintendent of Police, Darbhanga.

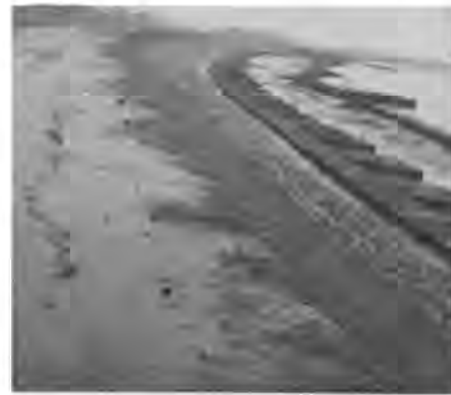
FIG. 6 Longitudinal Cracks on Top of the Bhutahi River Embankment, Zero Nose Near Laukha, Bihar.

border (Zero Nose, Laukha), is having 1:2 slope on the river side with dry brick pitching over 6 inch filter material. Slope on the other side is 1:3 without pitching. Height of the embankment varies from 10 feet to 12 feet, near Zero Nose (Fig. 5), and its top width is approximately 18 feet. The total length of this embankment is about 31 miles out of which 16 miles was damaged due to the earthquake. Subsidence and series of parallel longitudinal cracks were observed on the embankment (Fig. 6). Sand boils on the river bed were seen all along the embankment. Liquefaction in the ground at either side of the embankment possibly created differential settlement such that the base became convex upwards resulting in the development of longitudinal tension cracks on the top of the embankment.

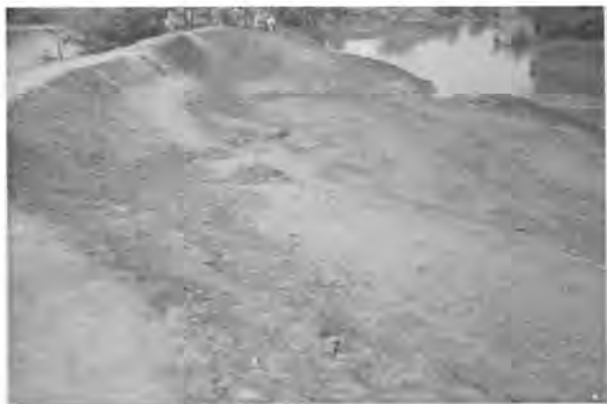
This embankment subsided very significantly at 67.0 km point (Fig. 5) near Jhanjharpur. The damaged site is about 22 miles from Darbhanga. This embankment is 18 feet wide at the top and approximately 18 feet high, having 1:2 slope on the river side and 1:3 slope on the other side with brick pitching on both the slopes. The embankment was reconstructed in August 1987 after a breach and washing away of the earlier embankment. The top of the newly constructed embankment subsided by about 8 feet (Fig. 7). The pitching on the river side slope bulged out, while on the other side it became wavy after subsidence. Longitudinal cracks on top of the embankment and sand boils brought by the liquefaction were also observed. Since construction practice in the area does not include compaction of the embankments, the embankment itself being loose and saturated underwent liquefaction resulting in large slumping.

FIG. 7 Subsided Embankment of Kamala River.

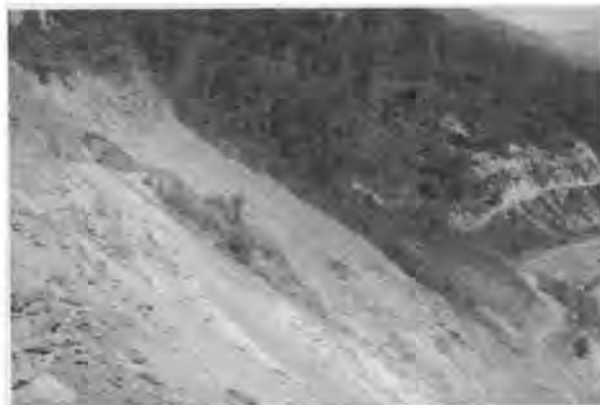
The hill slopes in Sikkim are known for their land-slides. The tremor triggered numerous land slides which was compounded by heavy rains, before and after the earthquake. The slides disrupted communications in many cases and also caused widespread damage to the roads, bridges and the other structures. An initial slip at Kumrek got aggravated due to the earthquake and washed away about 0.6 miles long state highway

FIG. 8 Kumrek Landslide, Sikkim.

(Fig. 8). Construction of a new road on a different alignment became necessary in order to restore the traffic. At Narak, initial slope failure occurred due to the earthquake which was aggravated subsequently by rains (Fig. 9). Several other land-slides have been reported to have damaged the road formations in the state. Three major bridges were damaged mainly due to rock-falls and abutting slope failures. Damage also took place to the hilly roads in Darjeeling district of the state of West Bengal.

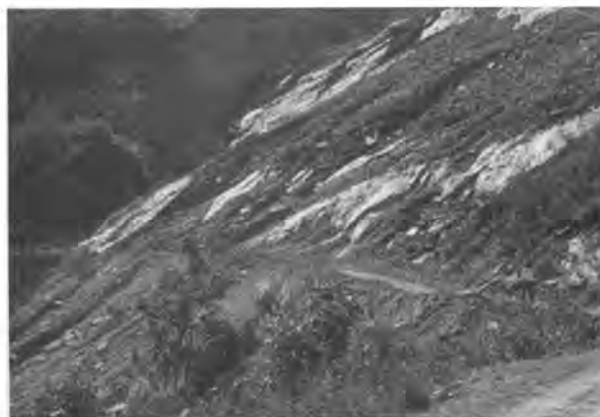
FIG. 9 Narak Landslide, Sikkim.

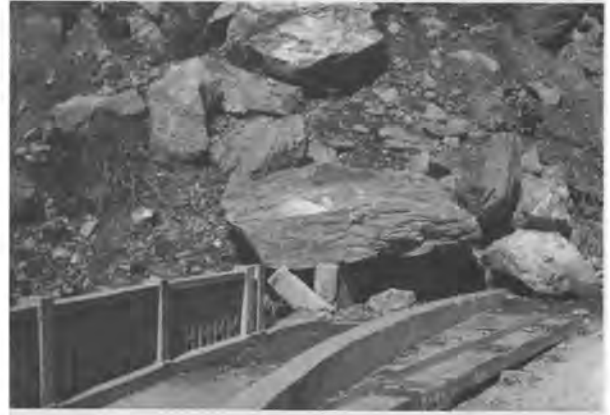
was opened for traffic immediately after removing the debris. The other end did not receive much damage and only some portions of reinforced concrete railing were affected due to the impact of rolling boulders (Fig. 12). There was no apparent damage to piers and abutments.

FIG. 12 The Damaged Railings of the Legship Bazar Bridge.

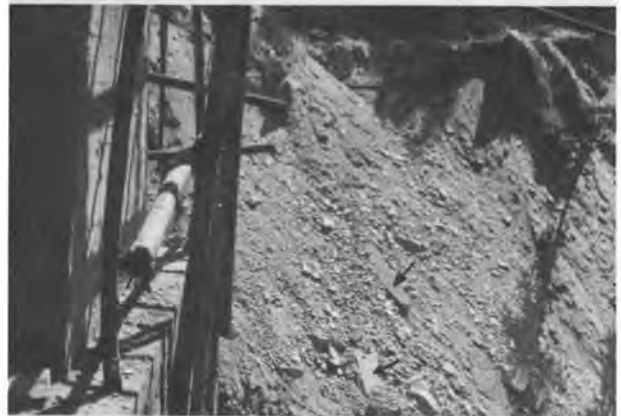
This bridge site is also located on river Kalej Khola at about two miles upstream from the Legship Bazar and is on Legship-Tashiding road. Bridge was under construction and its towers and cable anchors were complete at the time earthquake occurred. Proposed bridge is of suspension type with a span of about 450 feet. Legship end abutment cum suspension tower of reinforced concrete was situated just by the side of a high hill-cliff. During the quake, a huge soil cum boulder mass from the cliff came down and washed away the whole construction on Legship end (Fig. 13). The other end was however intact. An old suspension bridge with wooden

FIG. 13 The Landslide that Damaged the Tashiding Bridge (arrows show pieces of the suspension tower).
