Behavior of Buildings in August 21, 1988 Bihar-Nepal Earthquake

S. K. Thakkar, D. K. Paul, S. Mukerjee,
S. Bandyopadhyay, Ashwani Kumar, and
B. V. K. Lavania

Department of Earthquake Engineering, University of Roorkee,
Roorkee, India

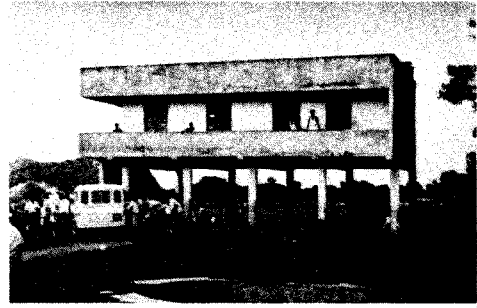
Cycle stand cum Canteen structure (Photo 7) : This is a two storey reinforced concrete structure. The bottom storey consisting of several columns framed with the beam was open and used as a cycle stand, the upper storey housed a canteen. The structure of the same design was constructed at Darbhanga and Munghyer. The structure at Darbhanga completely collapsed while the structure at Munghyer survived with the cracking of columns near the top. The structure at Munghyer received relatively less severe ground motion because of its greater distance from the epicentre as compared to Darbhanga. The soil at Munghyer was relatively firm than at Darbhanga. The lack of continuity of steel in beams and inadequate stirrup spacing seemed to be the reason of collapse of this structure at Darbhanga. No measures were taken to incorporate ductility provision in the structure.

Photo 7 Cycle stand cum canteen R.C.
structure, Munghyer.

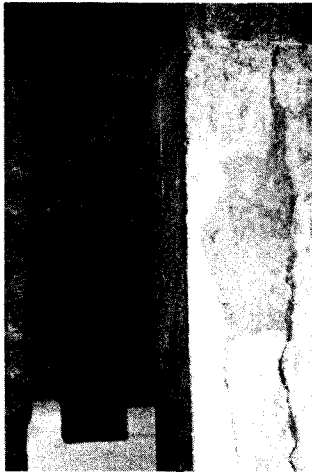
Surgical Ward building of DCHS, Darbhanga (Photo 8) : This is a three storeyed concrete structure constructed in early 70's. The following types of damages were observed :

- (i) The reinforced concrete columns developed diagonal cracks in the ground floor. In one of the columns, the rusted reinforcement was exposed due to spalling of concrete. The spacing of ties was quite apart. One of the columns had significant vertical crack in the lower portion.
- (ii) Cracks were also observed in concrete on the face of the column concealing the pipe.
- (iii) There were horizontal and diagonal cracks on the cross wall in the first and second floor.

The reasons for damage of this building were (i) poor quality of construction and poor maintenance; (ii) dampness in the building causing corrosion in reinforcement; (iii) lack of detailing of reinforcement.

Photo 3 Surgical ward, Darbhanga
(Cracks in r.c. column)

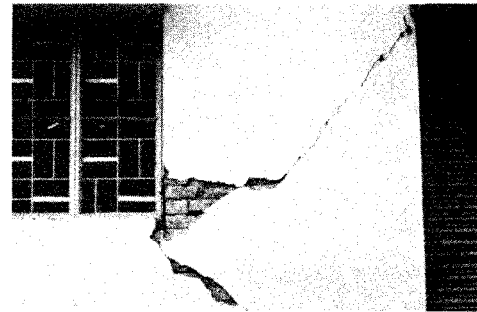
Telegraph Office, Munghyer (Photo 9) : This is a three storeyed reinforced concrete frame building constructed in 1984. The ground floor was damaged much more than the first and second floors. The walls got cracked badly between lintel and plinth. There was practically no damage to beams and columns of frame. The twelve and half centimeter thick partition walls were cracked badly. The reasons for damage was the inadequate connection detail between partition wall and the frame.

Photo 9 Telegraph Office, Munghyer
(wide spread cracks in inner walls)

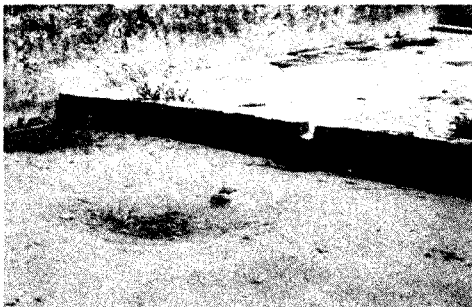
Extensive evidence of liquefaction was reported from areas near Darbhanga, Laheriasari, Madhubani and Jhanjharpur. In this belt, sand water geysers rising to a height of about 1m were reported. Sand and water vents were seen in open areas and floors of buildings cracked with water and sand oozing out of the cracks, building foundations and long boundary walls sank and cracked. The boundary walls of the Darbhanga Raj complex developed cracks at many places and so did the thick walls of the Darbhanga Jail complex. In both, Darbhanga and Laheriasarai, roads are reported to have cracked at many places with sand and water gushing out (Photo 10). In the nearby villages of Taralahi, Bishanpur and Keoragach a layer of sand was reported to have been deposited following the earthquake. Much of the tell tale evidence of liquefaction of these areas were lost due to the floods which followed the earthquake.

Photo 10 Jail Building, Darbhanga
(Circular patch of sand left over after
liquefaction)
