Structural Damage in a Populated Area due to an Active Fault

SYNOPSIS: The city of Patras was struck in August 1989 by a shallow earthquake of $M_s = 4.8$ which caused a surface rupture and serious structural damage to several buildings located in a narrow elongated zone. A detailed investigation programme was carried out including geological mapping, drilling of boreholes, in situ and laboratory testing and monitoring of horizontal and vertical movements. It was found that the surface rupture, about 1500 m long, was closely related with the reactivation of a preexisting normal fault. The structural damage of buildings was found to be limited mainly in a narrow zone 50 m wide along the fault and connected with its movements and the seismic intensity.

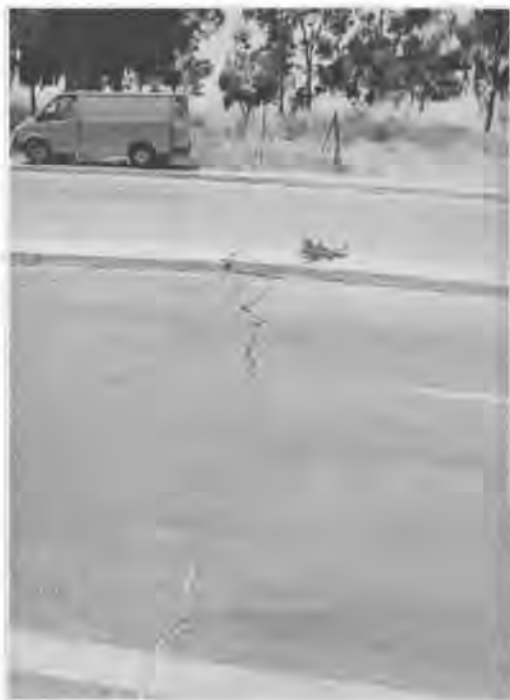
Fig. 2. Surface rupture traced on the pavement of Patras-Olympia motorway

The main part of the rupture observed was extended in free ground, causing damage in road pavements and other superficials works, (i.e. hydraulic connection tubes), whereas some part was extended to a populated area of the city of Patras and caused damage of buildings.

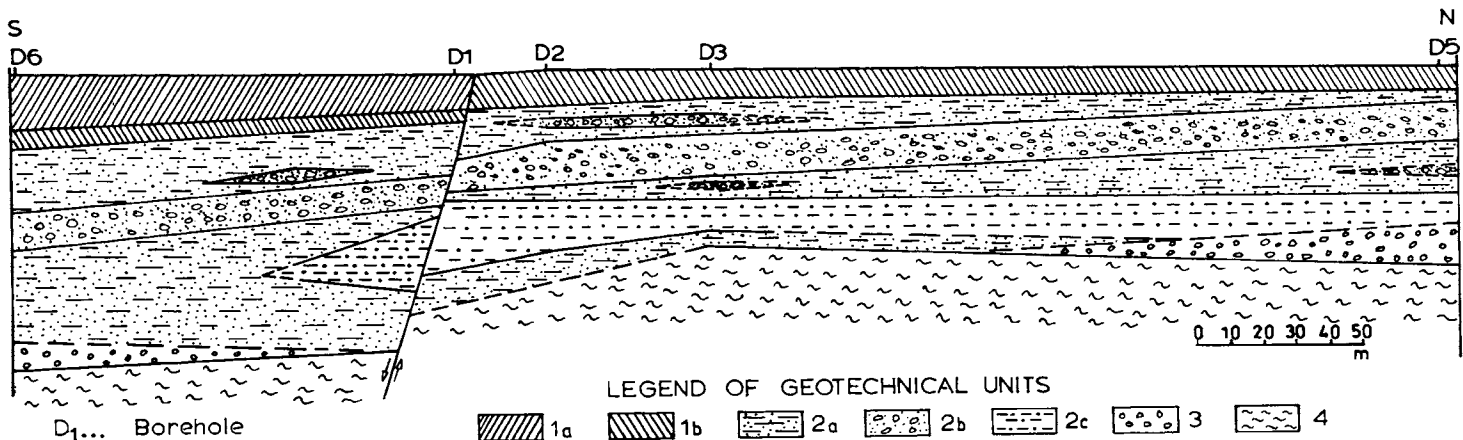
The geological section shown in Figure 4 illustrates the sequence of the geotechnical units described above and the normal fault which has caused the relative displacement of the layers (the thrust is up to about 10 metres) and the recent surface rupture. A typical geotechnical profile which includes only the upper units 1a, 1b and 2a, is shown in Figure 5. In this the results of SPT, CPT and Cross-Hole testing up to a depth of about 40 m are shown.

Fig. 4. Geological section through the boreholes D6, D1, D2, D3 and D5

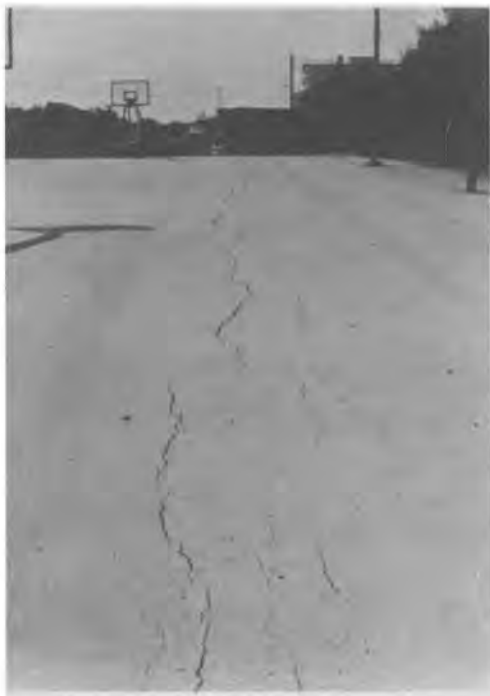
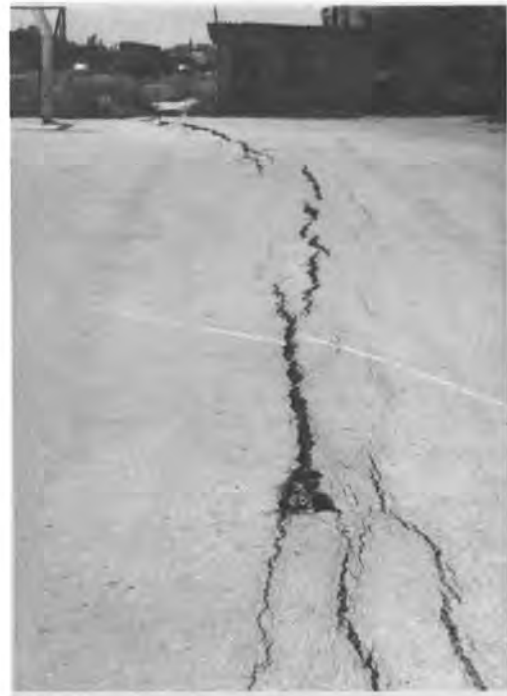
tensile cracks observed in the top soil immediately after the main shock continued to increase with time. This is well illustrated in Figures 6a and 6b which show an athletic playground with a flexible asphaltic surface. A few days after the main shock the horizontal displacement was about 1 cm and the vertical one less than 5 mm, (Figure 6a), whereas four months later the displacements were increased to about 3 cm and 2 cm respectively (Figure 6b).

Fig. 6. Increase of the surface rupture aperture with time in an athletic playground

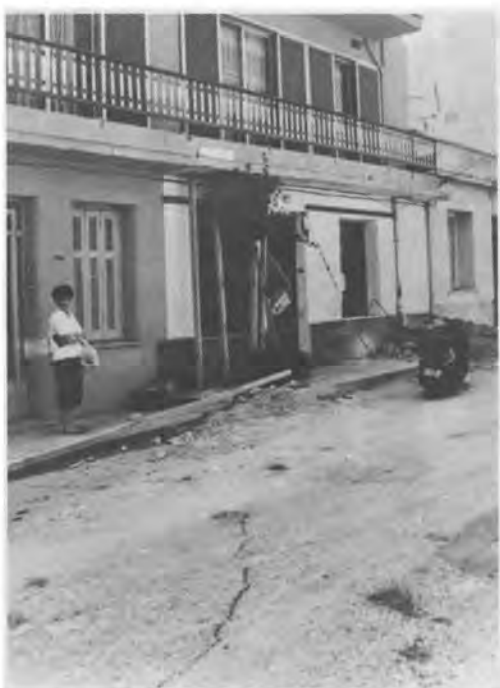
The damage of buildings was closely related with the surface rupture, whereas the discontinuity of the ground resulted in an unavoidable break in certain parts of the structures along the fault trace. Such damage of a two-storey building is shown in Figure 7, where the broad rupture in front of the building has caused the rupture of the walls. In all these cases the buildings situated directly on the surface rupture had increased the rigidity of the local ground and the ruptures are much smaller than these on the free ground surface. This effect has also been pointed out by Wang et al. (1981).

Fig. 7. Structural damage of a two-storey building located on the surface rupture

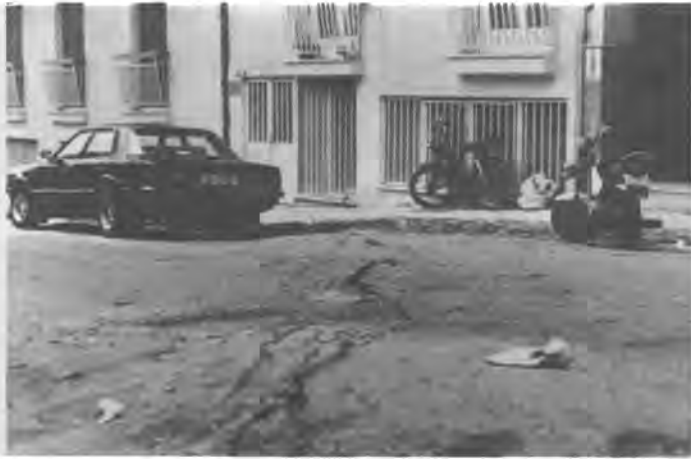
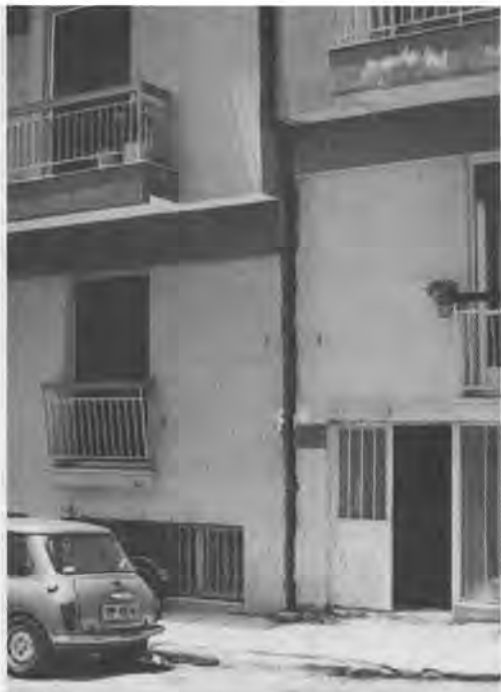
As shown in Figure 8a, the surface rupture crossed the interface of two six-storey buildings which suffered severe damage, (site of borehole D1), and caused relative movement in all three directions of only one of the two buildings (Figure 8b). This building was situated to the south side of the fault (downthrow region) whereas the other building was situated on the immovable north side, (upthrow region).

Fig. 8. Rupture crossing the interface of two six-storey buildings and the relative displacement

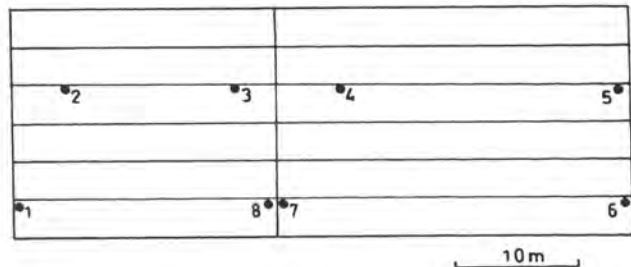
In parallel with the measurements for the microtriangulation network, eight control points were installed i.e. four points on each building (two on first floor and two on the fourth), as can be seen in Figure 9. The purpose of these control points was firstly to monitor the differential horizontal movements between the load-bearing elements of each building and secondly to determine the relative movements between the two buildings. These control points are referenced to stations 3, 4 and 5 which have been considered as stable. Comparison between the three phases of both the microtriangulation and control points networks defined the following horizontal displacements (with a significance level of 99%): (a) Between the first and second phases of the microtriangulation network there were horizontal displacements of 9 mm (Station 7), 5mm (Station 8) and 14 mm (Station 9); (b) Between the first and second

Fig. 9. Face of the two six-storey buildings with control points

phases for the control points there were horizontal displacements of 9 mm (point 1), 10 mm (point 2), 9 mm (point 3) and 4 mm (point 8) and (c) Between the first and third phases there was no displacement of the reference points of the microtriangulation network while during this period the control points were displaced by 9 mm (point 1), 11 mm (point 2), 6 mm (point 3), 5mm (point 7) and 7 mm (point 8).
