**RECONNAISSANCE REPORT OF THE MAY 28, 2009  
HONDURAS EARTHQUAKE, M 7.3**

*A team sponsored by the Earthquake Engineering Research Institute (EERI) and the Geoengineering Extreme Event Reconnaissance (GEER) Association carried out a field investigation in conjunction with Honduran colleagues from June 18-23 to document effects of the May 28 earthquake. The EERI-GEER team was invited by Mr. Marco Sandoval, Executive Director of the Comisión Ejecutiva Valle de Sula (CEVS). Mr. Sandoval sent a team of engineers to accompany the EERI-GEER team. The team included experts in structural, geotechnical engineering, as well as in disaster response and recovery. The investigators were supported by EERI: Abdeldjelil Belarbi and GEER: Ronaldo Luna and Kermit Applegate, all from Missouri S&T, Rolla. The CEVS team consisted of Humberto Calderon, Osvaldo Rivera, and Luis Alonso Lopez. Observations of other individuals who visited the earthquake-affected region have also been incorporated in this report. This material is based upon work supported by the National Science Foundation through the GeoEnvironmental Engineering and GeoHazards Mitigation Program under Grant No. CMMI-0825734. Any opinions

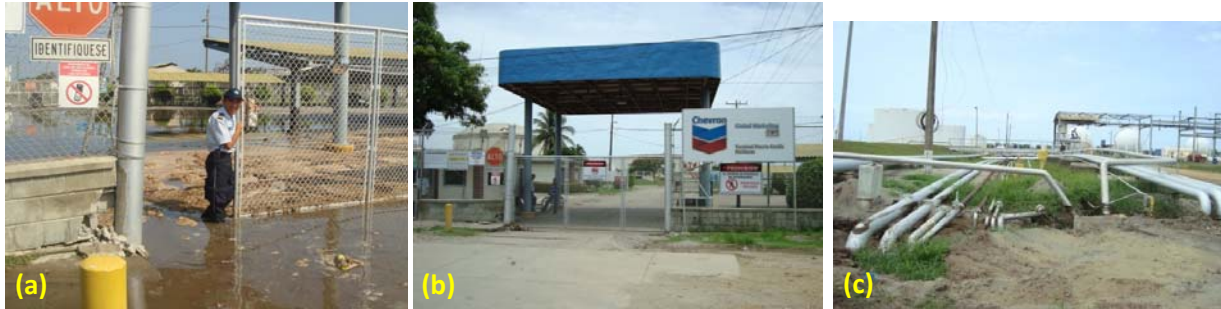
Of particular interest was the damage encountered at the Chevron Terminal in Puerto Cortés. This area was built on sandy fill. Liquefaction sand boils were wide spread throughout the terminal within tanks, pipe racks and small buildings (see Figure 3). Damage to tanks was not evident,

Figure 3 – Chevron Terminal remains closed as of 06/28/2009.

- (a) Note inundation due to wide spread liquefaction [05/28/2009 N15.848287, W87.958041],
- (b) Same entrance location 3-weeks later [06/20/2009 12:40PM, N15.848287, W87.958041], and
- (c) Multiple pipeline deformation and breaks [06/20/2009 1:24PM, N15.849177, W87.959274]

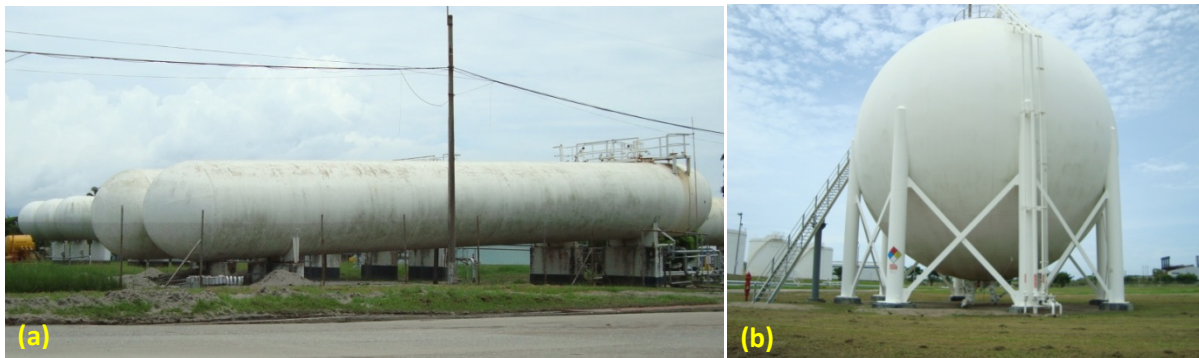
except a pressurized vessel that settled more than 2 ft on one side tilting the entire tank, which was supported on shallow foundations (see Figure 4). Small structures supported on shallow foundations were damaged, such as the laboratory and office buildings (see Figure 5). Safety inspection requirements and repairs of tanks and pipeline systems will take more time.

Figure 4 – (a) Tanks supported on shallow foundations sank and tilted, notice sand boil piled up next to foundation on left [6/20/2009, 1:12PM, 15.851061, -87.956882], and (b) those supported on piles performed well [06/20/2009, 1:16 PM, N15.851226, W87.958534].

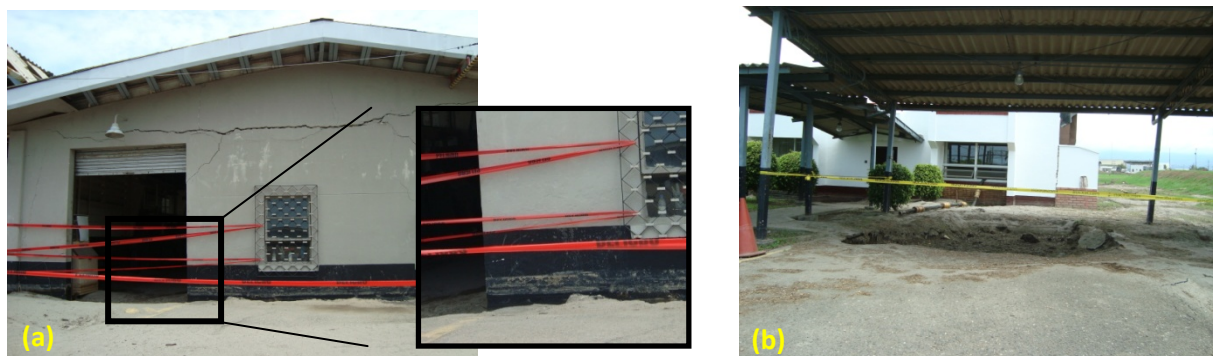
Figure 5 – (a) Buildings and small structures sank up to 3 ft and were flooded with liquefied sand [06/20/2009, 1:08 PM, N15.849851, W87.95793], and (b) vehicles sank into sand boils, see carport automobile was already extracted [06/20/2009, 1:25 PM, N15.848216, W87.958604].

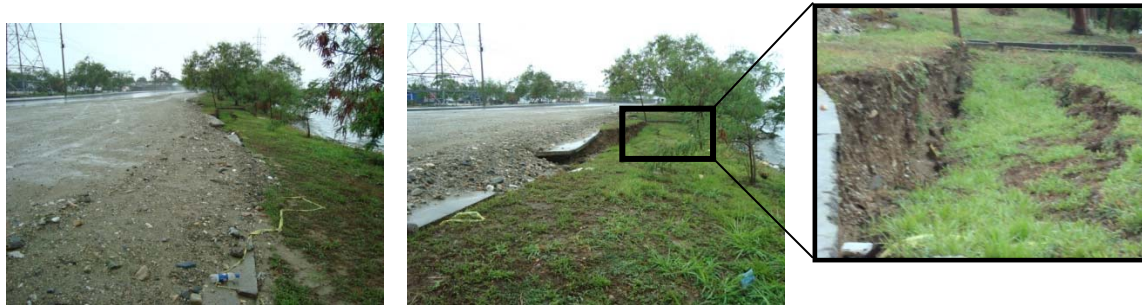
and neighbors were able to excavate the drains. A recently build roadway embankment that contains a major utility on the south side of the city was seriously affected by lateral spreading. (Figure6)

Figure 6 – Temporary repair of roadway embankment, due to lateral spreading [06/20/2009, 1:25 PM, N15.848216, W87.958604].

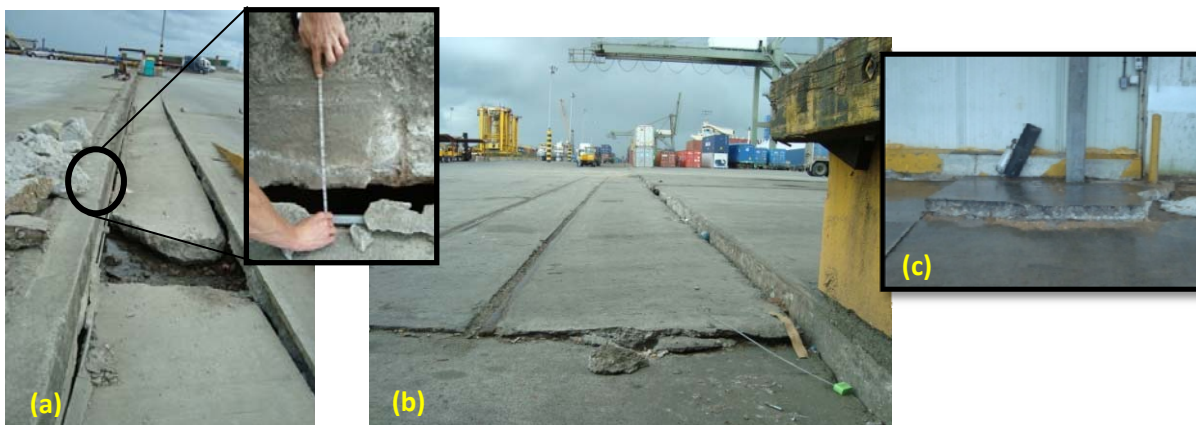
Earthquake damage at the most important port in Honduras was localized even though it remains in operation. Most of the damage was concerning movement of slabs and wharfs causing joints to move in the vertical and horizontal directions. In some cases the slabs collapsed due to the loss of subgrade support (Fig 7a and 7b). It was reported that some of the pile

supported wharfs moved upwards by several inches. Some foundations appeared to have moved upward, but this differential movement is all relative to the surrounding ground subsidence, which needs to be confirmed by precision survey (Fig. 7c). Fuel tanks supported on concrete mats experienced large deformations due to widespread liquefaction and surface rupture of fill materials, see Figure 7(d).

(a) Up to 0.46m at the main dock [06/20/2009, 3:37PM, N15.843718, W87.951739],  
 (b) 0.2m near port warehouses [06/20/2009, 3:49PM, N15.8424, W87.94941], and  
 (c) Relative foundation displacement up to 0.15m [06/20/2009, 4:00PM, N15.841912, W87.941644].

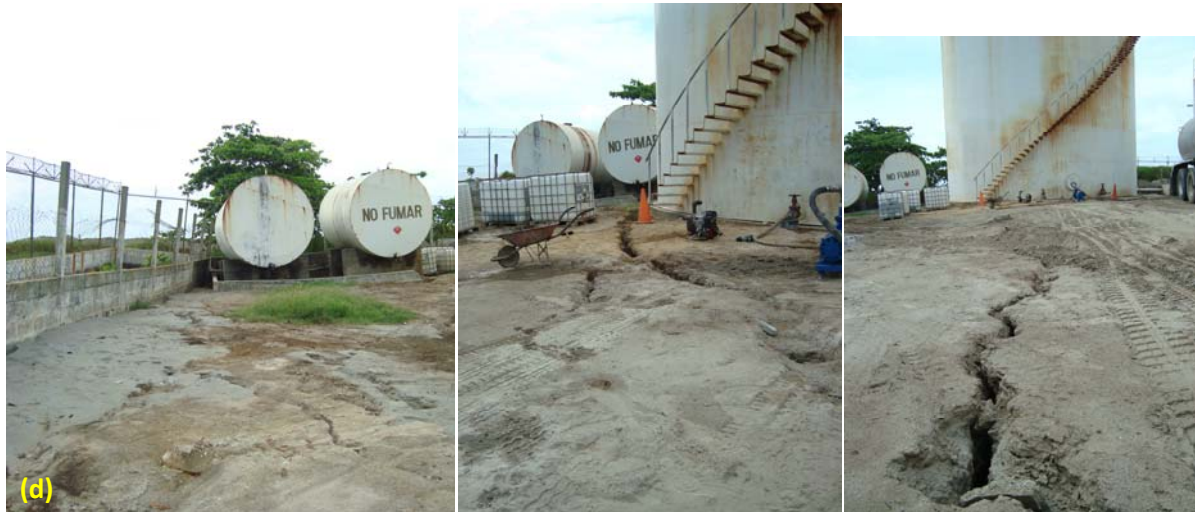
(d) Three view of fuel tanks and multiple ground fissures due to wide spread liquefaction  
 [06/20/2009, 3:12PM, N15.846936, W87.963225]

Figure 7 – Liquefaction induced deformations at Puerto Cortés – Slabs on grade and Tanks.

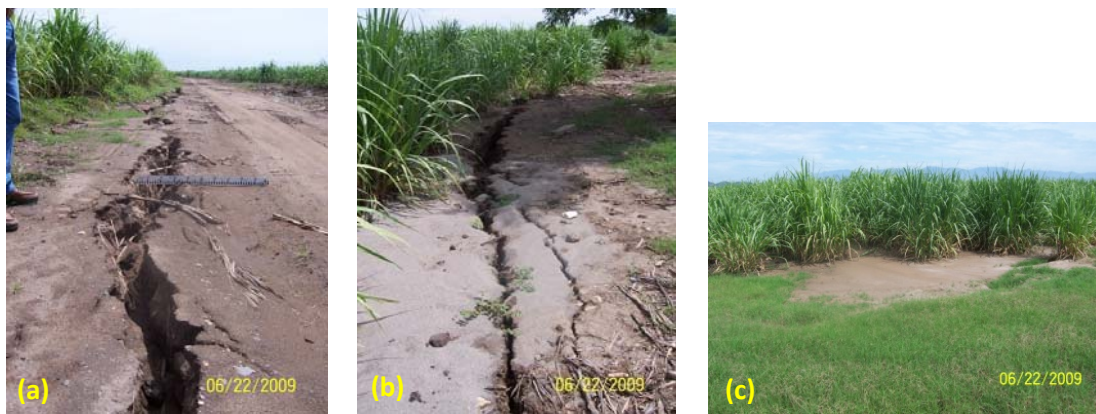
On the edge of a sugar cane plantation, about 250 meters from the river edge, long fissures opened in the direction parallel to the river (Figure 8). The crack openings ranged from 10 to 50cm with a depth of about one meter. *Allochthonous sand ejecta* were present along the length of the fissures, and sand boils were scattered amongst the sugar cane plantations.

Figure 8 – (a) Longitudinal cracks along roadways [06/22/2009, 10:03AM, N15.368726, W87.861301], (b) with sand at surface [06/22/2009, 10:10AM, N15.369316, W87.860965], (c) sandboils within plantations [06/22/2009, 10:06AM, N15.368988, W87.861209].

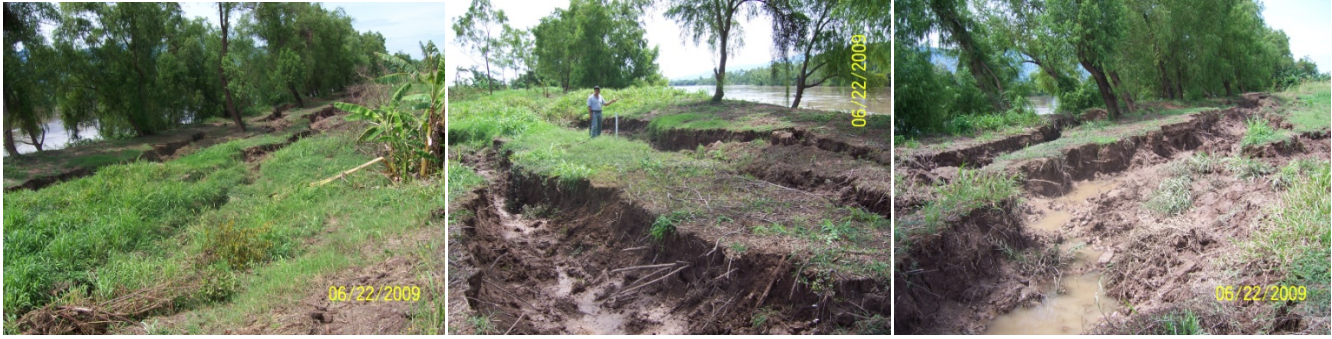
Near the edge of the Ulua River, on the unprotected zone of the levee system, extreme lateral spreading was evident. Gaping fissures up to 5 meters wide and two meters deep have indelibly altered the landscape (Figure 9). This will

have serious consequences as the rainy season approaches and the levee system is not able to keep the flood water out of the protected zones (plantations and rural residences).

Figure 9 – Multiple views of severe lateral spreading between levees and river  
[06/22/2009, 10:25AM, N15.391266, W87.845191].

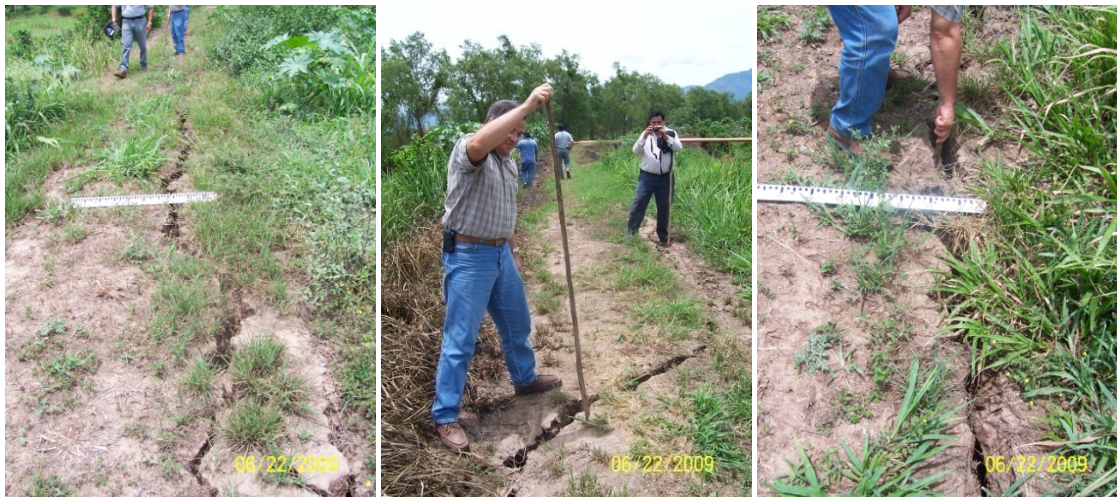
Along the crest of the levee system, a network of smaller cracks (about 5-10cm wide and several meters deep) has rendered nearly 60 km of the levee system ineffective

Figure 10 – Cracks at the crest of levees exceeding 1.5m deep  
[06/22/2009, 11:57AM, N15.344505, W87.868515].

(Figure 10). CEVS is currently undergoing an emergency earthwork operation to reinstate levee geometries to its pre-earthquake conditions.

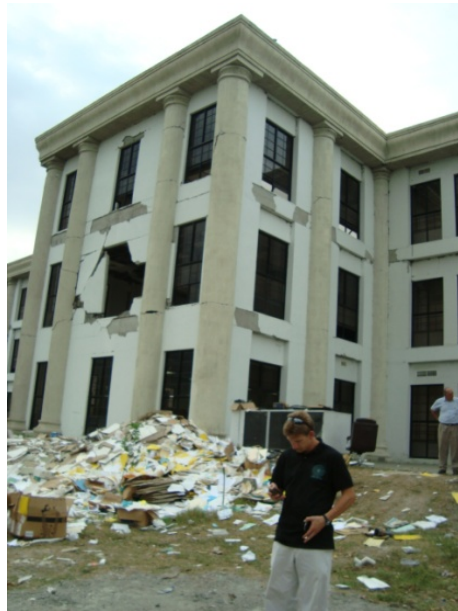
Infill walls, usually located between RC columns and beams, can suffer out-of-plane overturn due to inertial forces during an earthquake. Because infill walls are non-load-bearing elements, they tend to be thin and cannot rely on the additional shear strength that accompanies vertical compressive loads. If infill walls are not properly restrained in out-of-plane direction, walls can collapse during strong ground shaking, producing damages to inhabitants and properties. If walls on the façade of a structure collapse, the consequences could be deadly to pedestrians. Figure 11a shows a typical in-fill wall failure.

(a) Overall damage including out-of-plane failure of masonry infill wall [06/19/2009, 5:53PM, N15.472899, W88.018565].

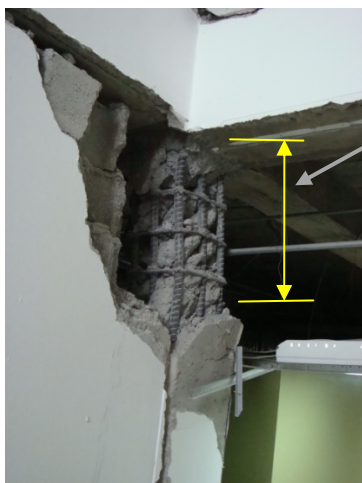
of columns. But insufficient gaps produced the same consequences. Figure 11b shows a reinforced column failed by shear. The column is constrained by masonry infill walls in perpendicular direction. Shear cracks were developed from masonry wall which led to shear failure of columns. Figure 11c shows the failure due to short column effect from a masonry infill wall. These columns had No. 3 ties spaced at 6 to 8 inches. This seems to be an inadequate detailing for seismic loading. The large spacing of lateral ties did not provide the required confinement to the core concrete.

(b) Column failure at the infill wall frame interface [06/19/2009, 5:08PM, N15.473038, W88.018103]

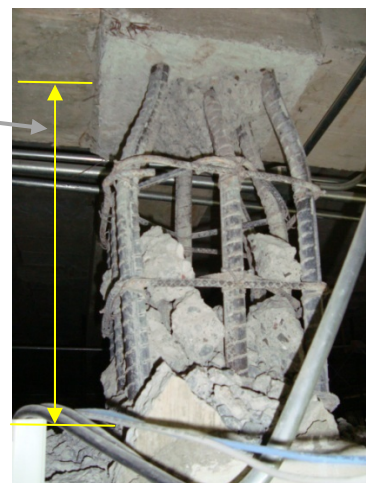
Inside the building and some locations, these frames were partially filled with masonry walls. This in turn causes the reduction in height of the column resulting in increased lateral shear during earthquakes. This is also called as short column effect. This failure mode, also called captive-column or captured-column, is very common in RC frames with infill walls. This failure happens when an infill wall is extended into a frame from the floor level up to another level to form a window, leaving a short free space in the top portion. The column in such a structure is partially restricted by the wall. This shortened column develops large shear force which may exceed the shear capacity of the column, resulting in failure. The problem is well known but is often ignored in practice. In some cases, the infill walls are separated from the column to allow flexure

(c) short column effect failure [06/19/2009, 5:31PM, N15.473346, W88.018592]

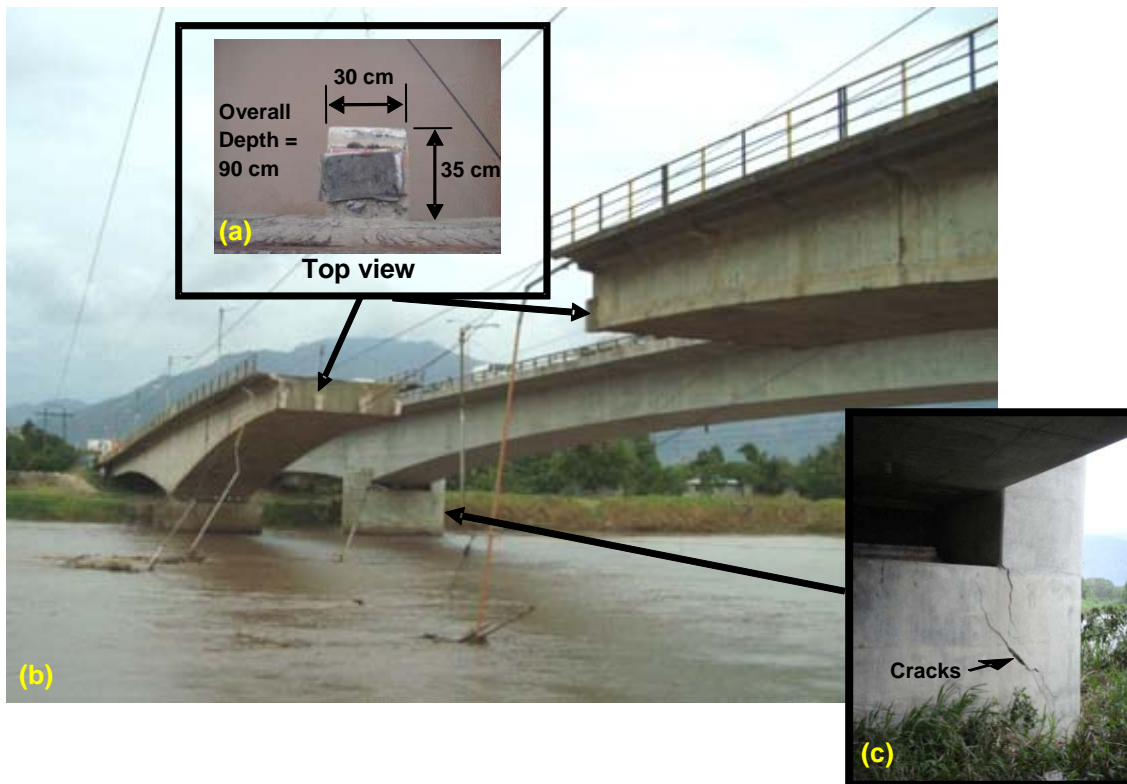
supported T-beams. All supports, including abutments, consist of steel plate bearings. Figure 12 shows the collapsed middle span and in the background the newer 2005 twin bridge built by the Japanese, which still is in service taking the traffic towards el Progreso. The bearings on the abutments moved more than 250 mm in the horizontal direction. This bridge had shear key only in the longitudinal direction to support the T-beams. This simply supported girder Type Bridge had inadequate seating and no provisions like lateral restraint to prevent unseating. The lack of redundancy in the simply supported beam also prevented formation of alternate load path which resulted in the fall of the beams and consequently the middle span.

Figure 12 – La Democracia twin-bridge with middle span collapsed.

- (a) Top view of shear key [06/19/2009, 6:45PM, N15.404139, W87.820174.],  
(b) Overall view of the twin bridge [06/19/2009, 6:45PM, N15.40478, W87.819967], and  
(c) cracking due to lateral restraint in the new bridge [06/19/2009, 6:58PM, N15.40408, W87.820615].

In contrast, the new bridge, which consists of a single monolithic concrete arched structure, has neoprene elastomeric bearings and shear keys at the supports. The shear keys suffered diagonal cracks, evidence that they engaged in keeping the bridge on its bearings during the seismic event. A transverse crack on the bridge (western

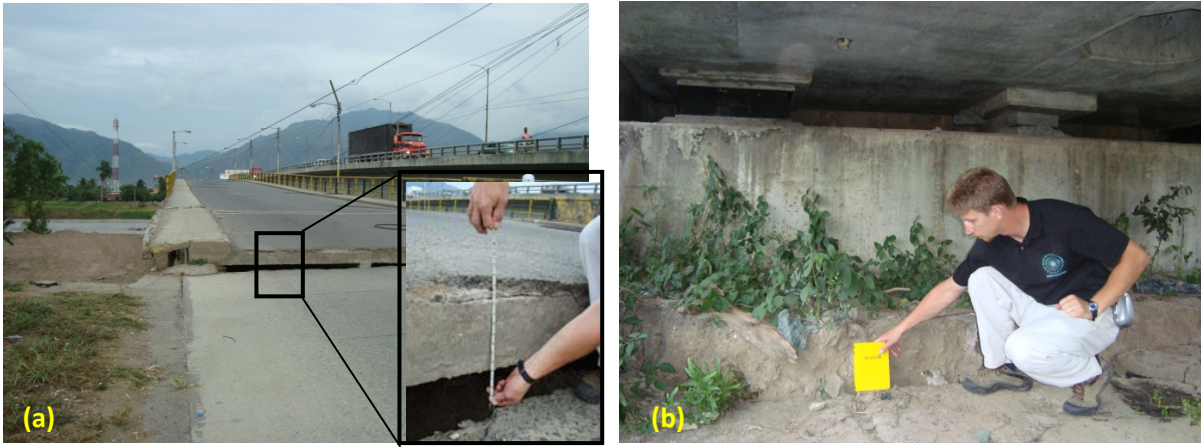
bank) was identified. Liquefaction sand boils and significant settlement of the banks and possible lateral spreading was evident on the river banks. In some locations cracks and settlement exceeding 250 mm was observed (See Figure 13).

Figure 13 – Settlement of ground around abutments due to liquefaction  
 (a) Old bridge westbound [06/19/2009, 6:36PM, N15.404409, W87.821095], and  
 (b) New bridge, eastbound [06/19/2009, 6:52PM, N15.40422, W87.821021].

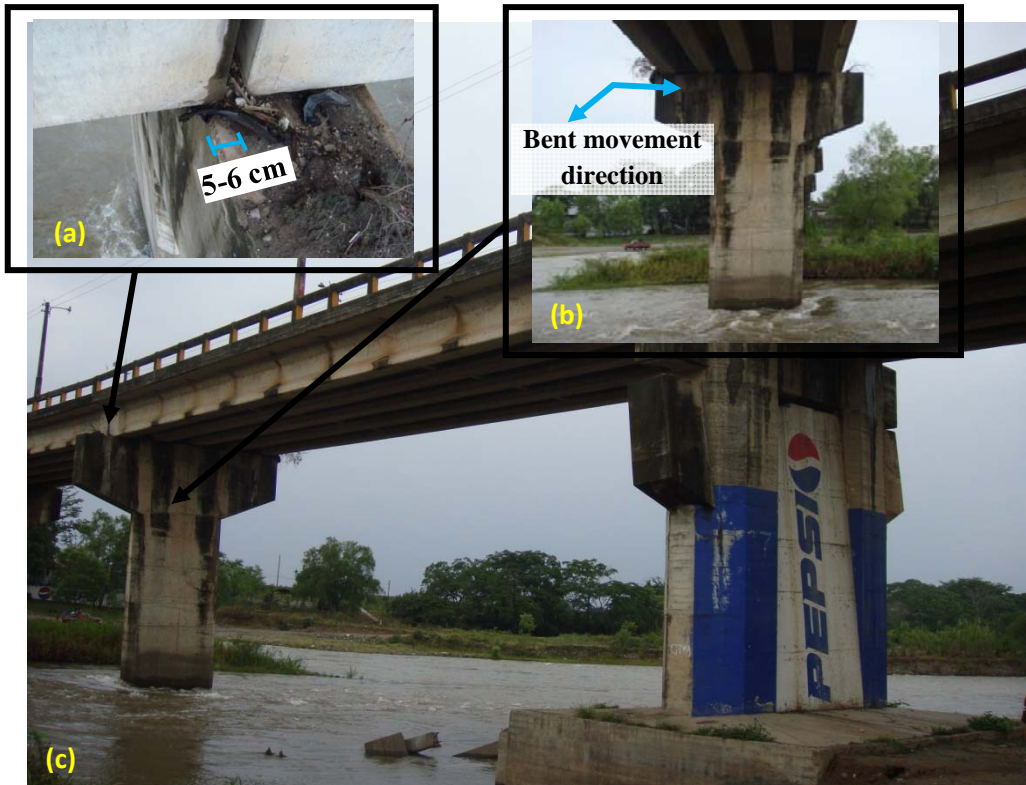
The other bridge that suffered damage during the seismic event was the bridge near Santa Rita over the Humuya River (Figure 14). The foundation support was already weakened due to scour, which historically has damaged the bridge and scour continues to aggravate the situation. The most common cause of bridge failure is structural instability and undermining caused by movement of column bent exaggerated by excessive scouring. Scour is the result of the erosive action of flowing water, excavating and carrying away material from the bed and banks of streams, and from around the piers and abutments of bridges.

This two-lane bridge consists of 8 spans of 5 simply supported reinforced concrete girders (1m x 0.6m x 30m) built in the 1970s. Two supports experienced significant movement and the third column bent was tilted and rotated causing settlement and a reduction in the bearing support of the girders. The fourth span had only about 5 to 6 cm of bearing on the third column bent as shown in Figure 14. The night of June 28<sup>th</sup> several spans collapsed as shown in Figure 15.

Figure 14 – Santa Rita Bridge over the Humuya River after the earthquake and before collapse  
 (a) [06/21/2009, 6:08PM, N15.191548, W87.82559],  
 (b) [06/21/2009, 5:43PM, N15.191017, W87.8922393],  
 (c) [06/21/2009, 5:40PM, N15.190907, W87.892658]

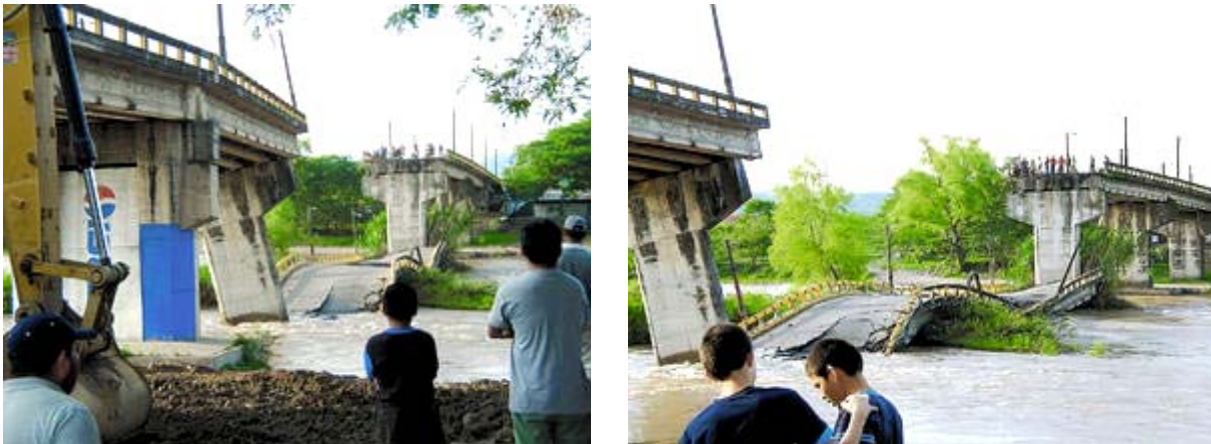
Figure 15 – Collapse of the 2 to 3 spans of the Sta. Rita Bridge over the Humuya River post-earthquake  
 [06/28/2009, N15.191019, W87.892095] (source: LaPrensa.hn).

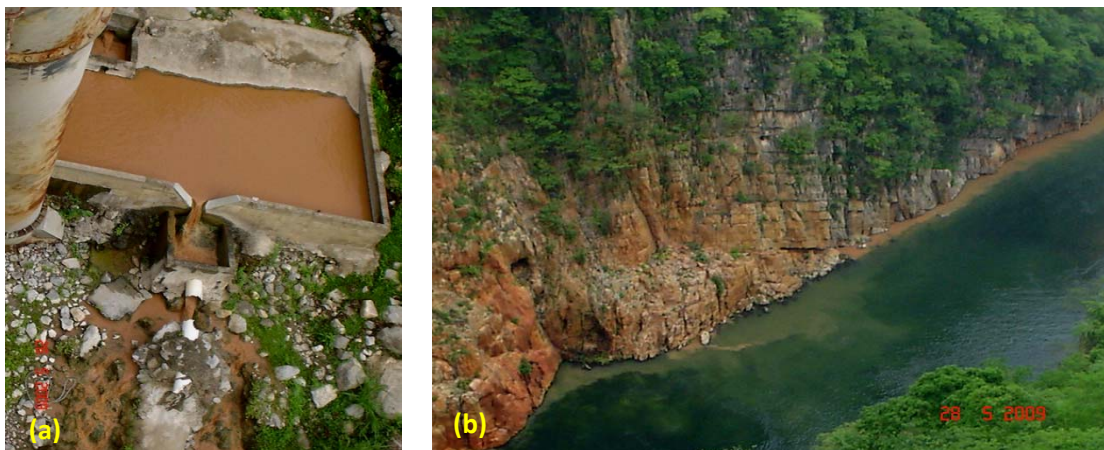
**Filtration Flow and Drainage:** The increments in the flow are not significant. The change in flow after the event was noteworthy, from about 138 lt./sec. to 167 lt./sec. Turbidity was detected in the downstream outflows shortly after the event (3 days), but none was observed during our visit. This is evidence of adjustments within the rock and soil that may promote continued filtration through the curtain.

Figure 16 – (a) Weir passing turbid water at base of dam [05/28/2009, N15.03096, W87.747885], and (b) reflected in downstream river [05/28/2009, N15.03096, W87.747885].

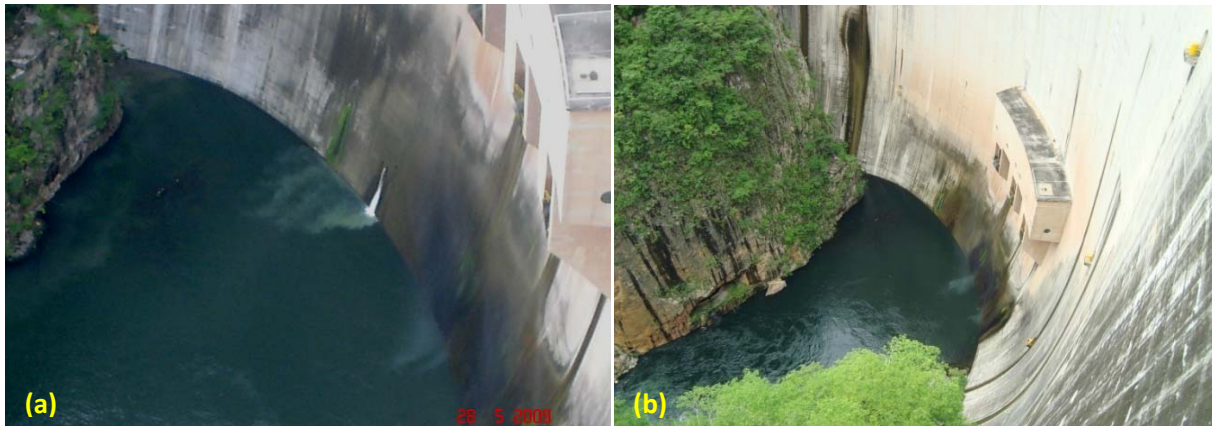
Figure 17 – (a) Turbid seepage at base of dam [05/28/2009, N15.03096, W87.747885], and (b) clear seepage at base of dam [06/21/2009, 11.55AM, 15.03096, -87.747885]

Even though the dam safety instrumentation measured the impact of the earthquake event on the dam, the structure is considered safe and continues to operate normally. The dam safety plan did not require any further action, as none of the thresholds were reached. However, a grouting plan programmed for the near future to seal the existing grout curtain is currently being re-assessed.
