Backanalysis of Deformations for Case Histories Involving Flow-Type Failures

Paper No. 6.14

SYNOPSIS: The results obtained from backanalyses of two case histories of failures of small earth dams resulting from liquefaction of foundation soils are presented. The analyses have been performed in order to evaluate the deformation parameters used in a finite difference model (developed by Woodward-Clyde Associates), specifically those relevant to the liquefied soil layer. For both case histories, the final deformed shape of the earth dam is known and serves as a basis for comparing the results from the numerical study, in terms of the deformation moduli employed.

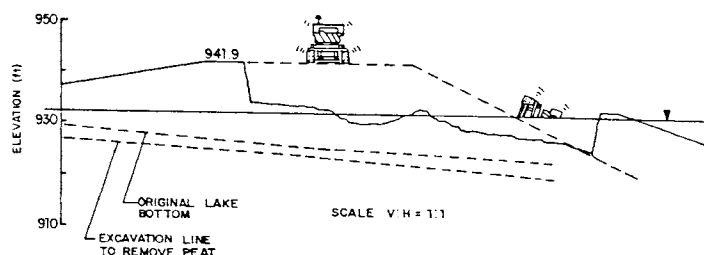
Fig. 3 Failed cross-section at Lake Ackerman (Hryciw et al. 1990)

No detailed information on the magnitude of the deformation of the embankment/slope is given in the paper. However, from Fig. 8 of the paper by Hryciw et al. (1990), at Station 871 + 00 the deformed embankment can be seen to have suffered a vertical displacement of about 10 ft (3.05 m) below the crest and is, on average, just above lake level. Lateral displacements are much more difficult to estimate from the information provided, but are roughly of the order of 40 to 50 ft (12 to 15 m).

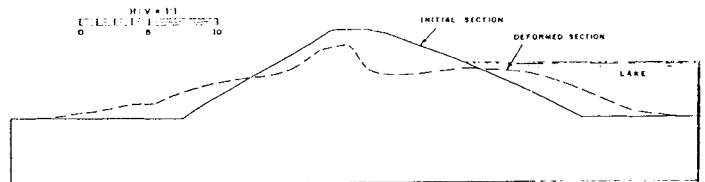
Fig. 4 Results of deformation analyses for La Marquesa dam

reflect possible upper and lower limit estimates for the post-seismic deformations, should the foundation soils liquefy as a result of ground shaking. The residual strength of the liquefied layer is also important in terms of controlling the mode of deformation. For these analyses, a residual strength of 1 t/m² was used for all the liquefied layers. This value is within the range determined by De Alba et al. (1986) based on stability calculations. The deformations at several locations on the dam are presented in Table 1. As can be seen the variation of the modulus number from 0.76 to 48 does not have a major effect on the final displacements. The general deformation pattern for the dam is shown in Fig. 4 where it can be seen to be in good agreement with the measured deformed section shown in Fig. 1.

Location on dam	(δ_v) _{max} (m)	(δ_h) _{max} (m)
D/S toe	1.0 to 1.3	2.3 to 2.7
D/S crest	1.5 to 1.7	2.4 to 2.7
U/S crest	0.6 to 1.1	3.2 to 3.7
U/S toe	0.4 to 0.7	3.2 to 3.7

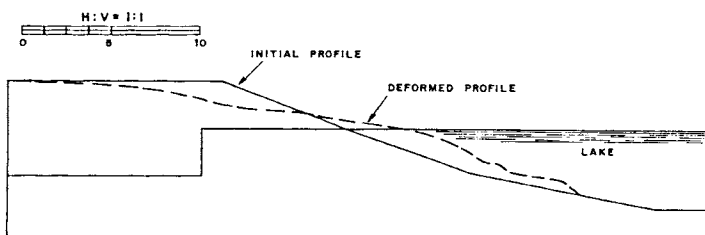
Fig. 5 Results from initial deformation analyses for Lake Ackerman embankment

The deformations in the area of the slope crest were compared with the values estimated from Fig. 8 of the paper by Hryciw et al. (1990) (Fig. 3 in this report). In terms of vertical movements, a range of values between 1.6 m and 2.0 m was obtained, while the horizontal displacements ranged between 2.6 m and 3.4 m. However, as indicated in Fig. 5, the deformations do not represent the profile shown in Fig. 3. Furthermore, even varying the values of the modulus parameters outside the range given above it was not possible to obtain a good representation of the field measured response. In an attempt to consider all possible factors, it was decided to consider the static loading imposed by the presence of the trucks performing the seismic refraction survey. A static distributed surface pressure of 8 t/m² over a 2.5 m width (to represent a 20 t truck) was considered at the top of the slope.
