## Case Histories of Widespread Liquefaction and Lateral Spread Induced by the 2007 Pisco, Peru Earthquake

## **CASE HISTORIES OF WIDESPREAD LIQUEFACTION AND LATERAL SPREAD INDUCED BY THE 2007 PISCO, PERU EARTHQUAKE**

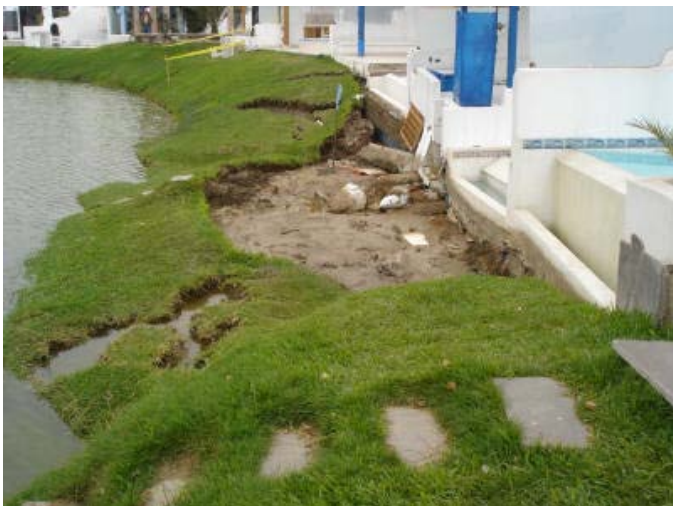
Las Lagunas is a beach housing complex 71 km south of Lima and approximately 51 km from the rupture plane. The area is located in a recent Holocene marine terrace deposit. The complex consists of one- or two-story houses constructed out of brick masonry confined by reinforced concrete columns and beams. Structural damage varied from none to severe and was closely correlated to the degree of foundation settlement and lateral displacement associated with soil liquefaction. Many of the houses are built around manmade freshwater lagoons that were formed by dredging sand and letting the water rise to the natural elevation of the ground water table. The banks of the lagoons were grass-covered slopes with an estimated slope of 1.5H to 1V. There was widespread evidence of lateral displacement of houses towards either the lagoons or the ocean, with displacements ranging from a few centimeters for some ocean-side houses to a case involving 3.9 m of movement towards an inland lagoon (Figure 4).

*Fig. 4. Lateral spread with a displacement of 3.9 m. The house located in front of this lateral spread suffered considerable damage due to differential settlements.*

Some houses also settled as much as 0.2 m. At least one lateral spread was also observed on the banks of a lagoon where there were no nearby buildings. Additionally, many houses did not show any evidence of movement and performed well in the earthquake, even when located near the open face of a lagoon. In the limited time of our visit, no clear pattern as to the spatial distribution of liquefaction damage within the subdivision could be deciphered. Sand ejecta was present at various places, mainly along cracks in the ground. The ejecta was gray, fine, uniform sand with some non-plastic silt.

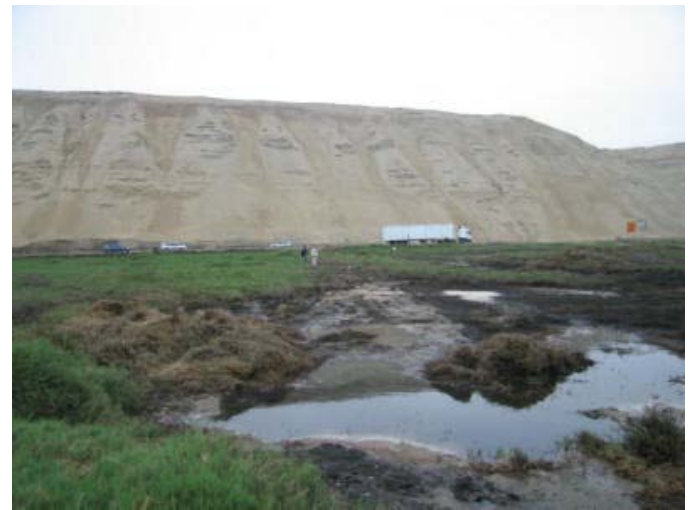
*Fig. 5. A view of the Pan American highway at the location of the 400 m long Jahuay slope failure. Marine terrace deposits are in the foreground and the Cañete Formation in the background.*

The slope failure was induced by liquefaction in the marine terrace deposits at the toe of the Cañete Formation. The shoulder and pavement from the northbound lane of traffic was lifted into a near-vertical face approximately 3 m high; this is thought to have occurred as a result of the failed slope material plowing under the highway embankment. Massive amounts of failed soil were slumped between the highway and the edge of the slope over the entire 400 m length of the failure. A local man reported that the highway south of the slope failure was recently repaired

Sand boils were found on both sides of the highway and a man who lived just south of the slide reported water and sand squirting out of the ground approximately 1 m high during the earthquake. A large sand boil feature on the southern end of the slope failure had shrinkage cracks in some of the perimeter material, indicating the presence of plastic fines. The fines were found only on a thin layer on top of the ejecta material. Laboratory tests conducted on the ejecta from this boil indicate it classifies as clayey sand containing approximately 43% fines (11% clay-size particles) with a PI of 8 and a LL of 25. However, until further investigations are conducted at the site it will remain unclear if the fine plastic material was part of the liquefied source layer or if it was mixed in with the liquefied material on its path to the surface. It should also be noted that a sand boil on the opposite side of the road classified as poorly graded sand with less than 3% non-plastic fines.

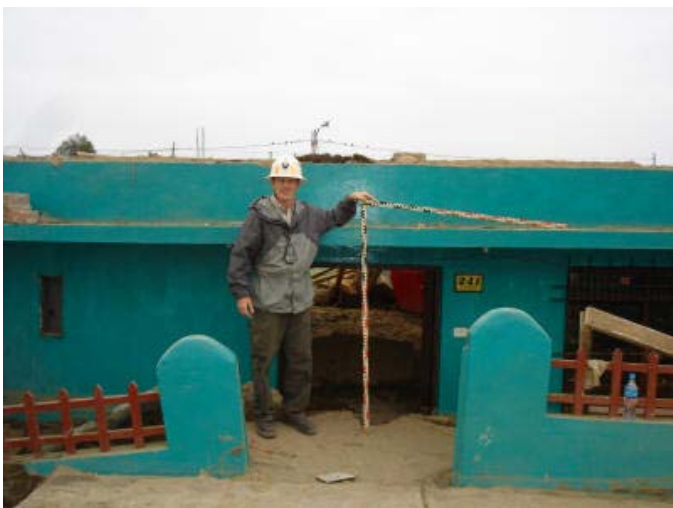
Liquefaction-induced foundation failures were documented in the northwest portion of Tambo de Mora approximately 0.5 km from the coastline and 38 km from the rupture plane. Tambo de Mora is located on Holocene alluvial and eolian deposits and has a shallow ground water table. While widespread evidence of soil liquefaction (minor settlement and sand ejecta) was present throughout much of the northwest portion of the city, particularly heavy damage (excessive settlement) was observed in one- to two-story buildings along a 300 m stretch of Alfonso Ugarte Street. Along this stretch of road, nearly every building settled substantially (0.3 m plus), with multiple buildings settling between 0.7 and 0.9 m (Figure 6).

*Fig. 6. Approximately 0.9 m of liquefaction-induced settlement at a one-story house in Tambo de Mora.*

Large quantities of ejecta was observed in cracks that had developed in the road and inside of buildings whose unreinforced slab-on-grade floors had been broken apart and heaved-up into their interiors. In most cases, ejecta was gray, non-plastic, poorly

graded sand to silty-sand. One exception was a plastic silt (LL = 48) found in the interior of a house. The depth to the water table along the road was measured at 0.3 m during our visit a week after the earthquake. However, locals reported that the water table existed at a depth between 0.5 to 1.0 m prior to the earthquake. These same residents reported water and sand shooting more than 1.0 m above the ground surface beginning with the second strong phase of the earthquake.

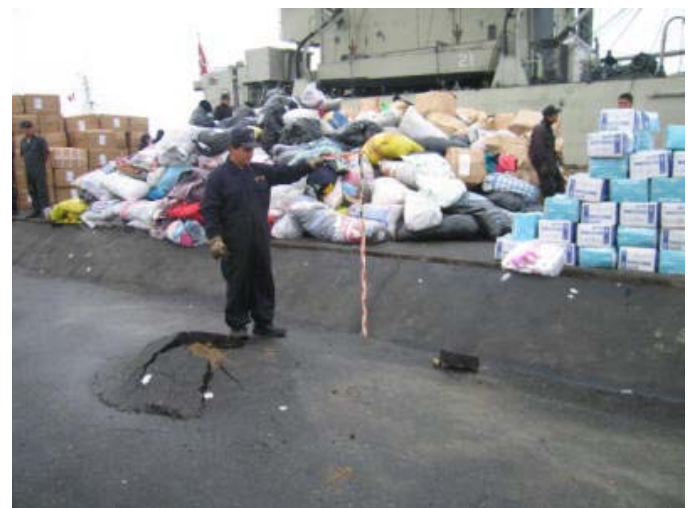
The General San Martin Port was inaugurated in 1970 and operates with ships as heavy as 25,000 tons of dead weight. It is located in Punta Pejerrey, Pisco Beach, approximately 30 km from the fault. The port is surrounded by granite porfids (intrusive rocks), which are part of the San Nicolas Batholite. The granite porfids have a fine to coarse matrix with colors ranging from pink to dark brownish red. Port facilities were constructed on reclaimed land. The wharf has a reinforced concrete deck that is supported by 780 circular steel pipe piles. The reclaimed land area of the port settled over the years resulting in differential movement between the pile-supported buildings and the surrounding soil. The typical solution to this problem was to place more fill to level the surrounding reclaimed ground surface. The earthquake induced liquefaction in the reclaimed land, as evidenced by sand boils and lateral spreading with significant cracks as wide as 0.25 m and vertical offsets as large as 0.8 m (Figure 7).

*Fig. 7. Vertical displacements as large as 0.8 m were observed between the pile-supported wharf and the reclaimed*

*backfill. The bulge appears to be a pile that was buried in the fill. Although the port was heavily damaged, it had enough functionality to receive relief for earthquake victims*

The pile-supported deck appeared slightly inclined seaward, and horizontal offsets in the deck joints were as large as 0.50 m. Ground cracking developed parallel to the deck on the reclaimed land area and was most severe near the waterfront. A pipeline that ran across the port inside of a concrete box was not damaged in the earthquake despite the fact that the surrounding ground settled substantially. It is presumed that the concrete box was supported on piles. No cracks were observed in native ground around the pier.

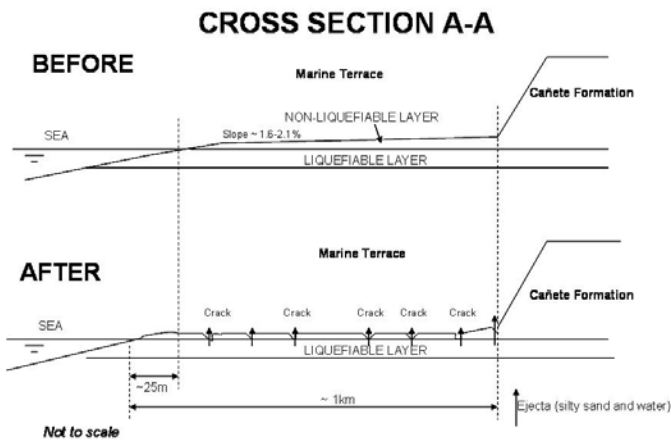
The eastern boundary of the lateral spread was defined by the interface between a Holocene marine terrace and the Pleistocene Cañete Formation (a conglomerate with weak- to medium-cemented sandstone, siltstone, and claystone). The southern boundary appeared to be defined by the interface of the marine terrace with a Holocene alluvial sand deposit. The northern boundary was not firmly established, but appeared to be influenced by the presence of man-made works at a bend in the Pan American highway. The lateral spread could have extended further to the north but it was not verified. The elevation of the Cañete Formation is approximately 10 to 20 m above the marine terrace. The near-surface marine terrace deposits appear to be

composed of an upper layer of non-liquefiable soil (weakly cemented sand), and a lower layer of liquefiable soil (silty sand). The thickness of the upper layer tapers from approximately 6 m on the east side to a thin veneer at the beach. The depth of the groundwater table was variable at the two locations where it was measured. Both measurements were made on the eastern side of the marine terrace near the Cañete Formation. In an existing well located approximately at the center (north-to-south) of the displaced area, the ground water was measured at 5.2 m deep, and in an open pit approximately 0.70 km north of this well, the ground water table was measured at 2.0 m deep. The westward slope of the marine terrace surface was approximately 1.6 to 2.1 %.

At present it is very difficult to estimate the total lateral displacement of the marine terrace because it occurred over such a massive area. However, local fishermen showed us traces on the beach of the sea level before and after the event, suggesting that the water line moved about 25 m westward. This measure is not an estimate of the horizontal displacement of the lateral spread, but it is believed that lateral spread contributed to this change in the landscape. A bulge along the beach was also observed, indicating that this could have contributed to the movement of the coastline. Figure 9 shows a sketch of the observed massive displacement of the marine terrace. This massive lateral spread could be as large or even larger than that reported along the Shinano river during the 1964 Niigata earthquake in Japan.

Fig. 9. Interpretative sketch of the massive lateral spread of the marine terrace at Canchamaná at Cross Section A-A from Figure 8.
