## Some Seismological Characteristics of Mw 6.5 Pishin-Ziarat October 29, 2008 Double Earthquake

Syed Kazim Mahdi  
WAPDA Directorate of Seismic Studies, Pakistan

## **SOME SEISMOLOGICAL CHARACTERISTICS OF Mw 6.5 PISHIN-ZIARAT OCTOBER 29, 2008 DOUBLE EARTHQUAKE**

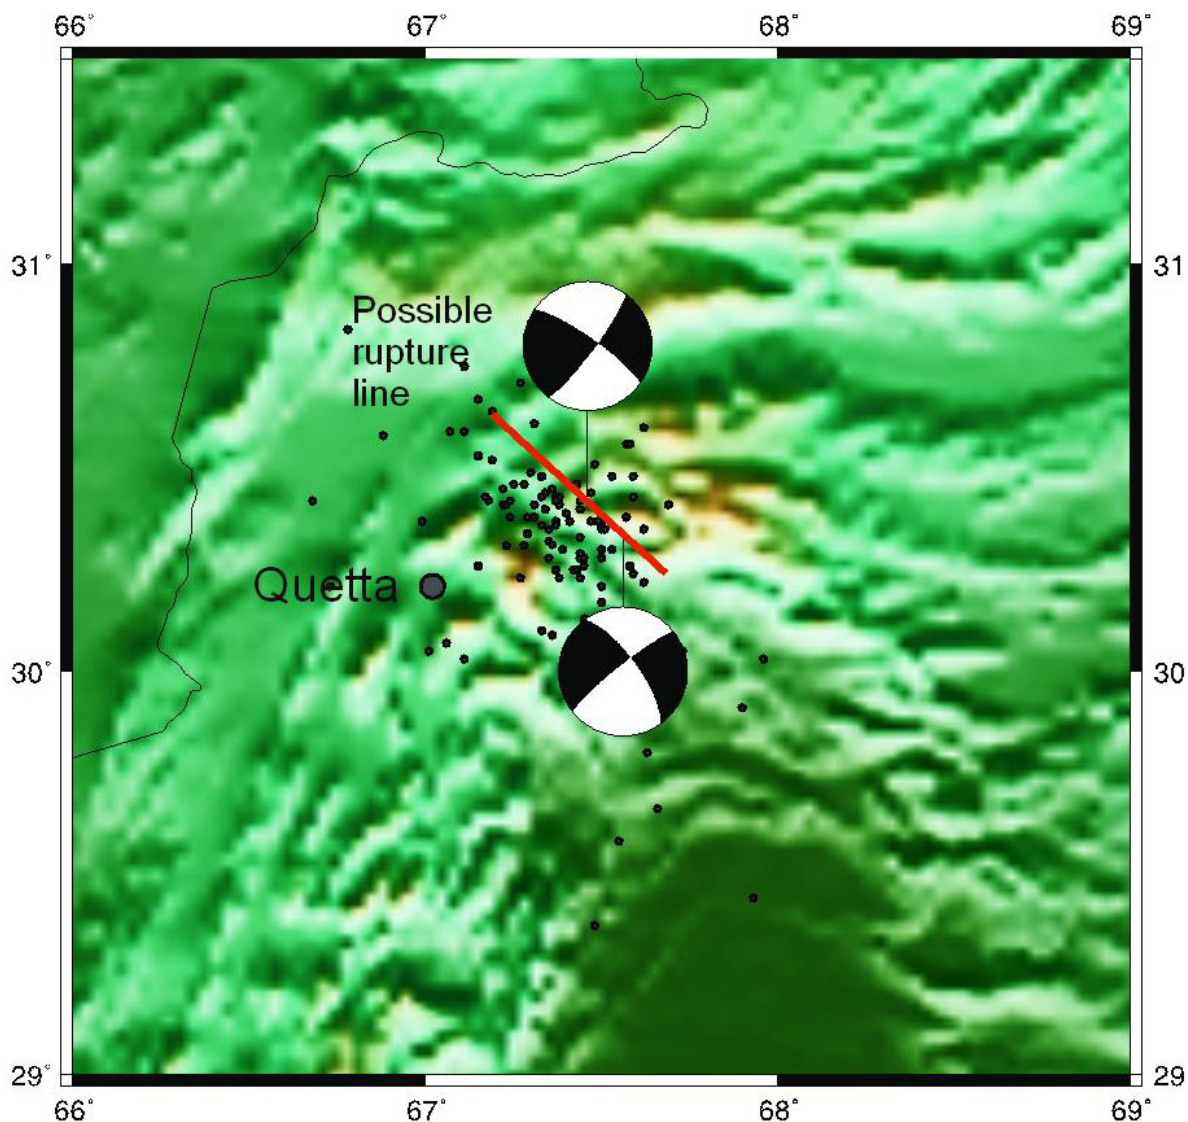
Figure - 1

**Focal mechanism of two Ziarat Earthquakes occurred on 29th Oct 2008.  
The fault line trend is SE-NW**

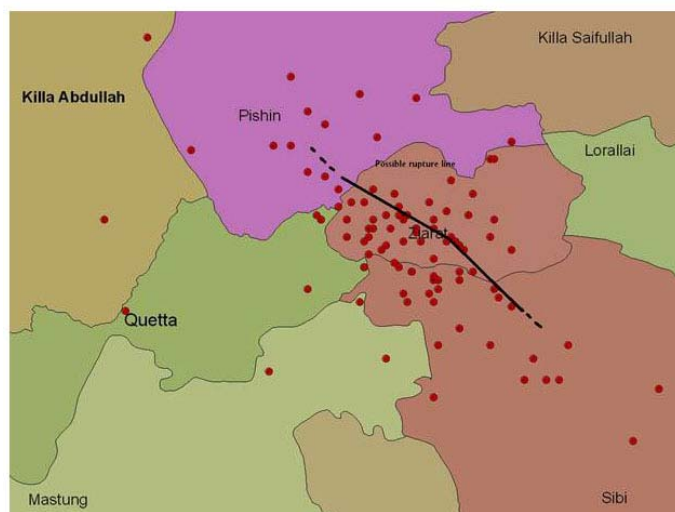
Figure-4

The analysis of aftershocks recorded by PMD Sesmic Monitoring Network. There is a possible rupture due to Ziarat Earthquakes occurred on 29th Oct 2008
