1991 - Second International Conference on
Recent Advances in Geotechnical Earthquake
Engineering & Soil Dynamics

Preliminary Report on the Geotechnical Aspects of the Philippine Earthquake of July 16, 1990

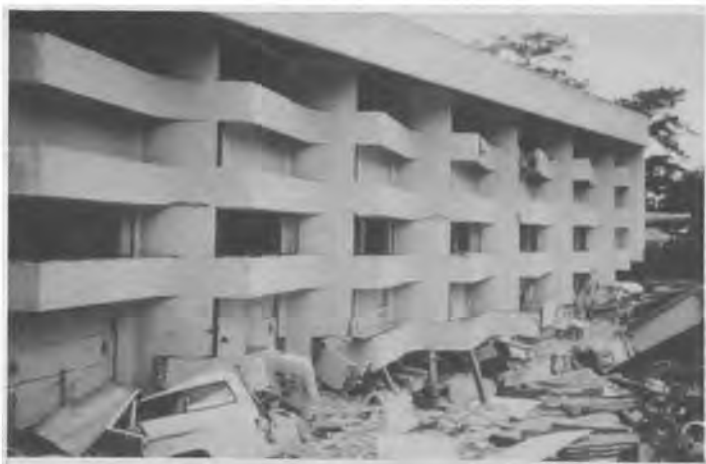
Photo 2 Soft first story failure of a building in Baguio

The damage associated with a combination of strong shaking and inadequate design of structure was observed mostly in Baguio and Agoo. Many multistory reinforced concrete-frame buildings collapsed, as a result of one of the following two failures: soft first story failure and multistory failure called pancake crush. Photos 2 and 3 show typical examples of these failures observed in Baguio city. Over 600 persons were killed or missing within the city as of July 29. It is interesting to note that only one old reinforced concrete building collapsed in Cabanatuan city near the epicenter.

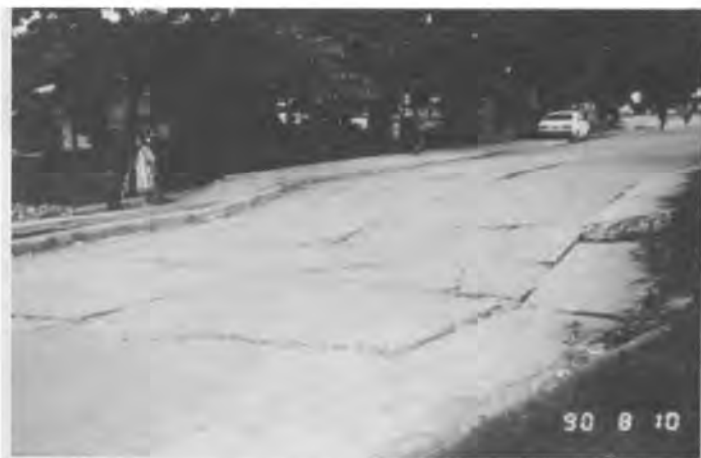
Digdig Fault. The July 16 earthquake occurred along the Philippine Fault zone including Digdig Fault, with its epicenter being near Cabanatuan city at a depth of about 25 km, as shown in Fig. 2. Also shown in the figure is the trace of a 110 km surface faulting resulting from this event. The fault showed a left lateral movement up to 6 m. Photo 1 shows the surface faulting observed in a small town called Rizal about 30 km north of Cabanatuan. Although structures on the fault collapsed due to differential lateral movement of footings, no apparent damage was observed in nearby structures which were not on the fault.

Photo 1 Surface faulting near Rizal

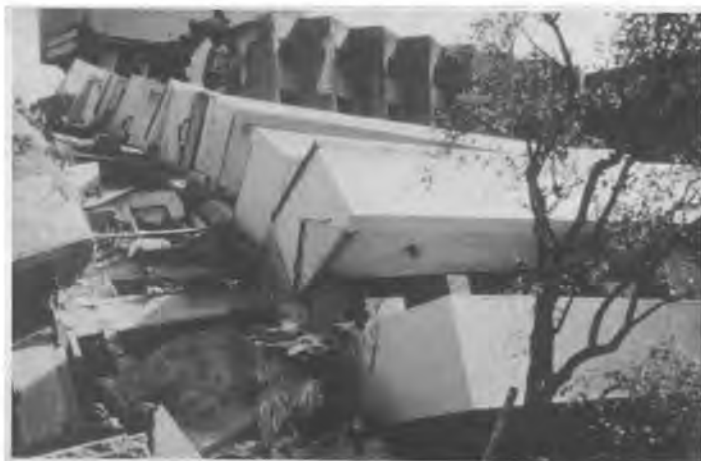
Photo 3 Pancake crush of a building in Baguio

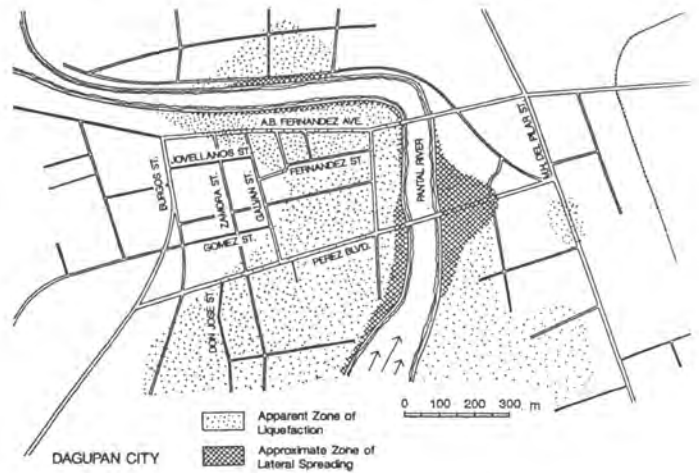
Fig. 3 shows a map of downtown Dagupan which is bisected by the Pantal River. The figure indicates the approximate zone in which buildings and houses were severely damaged as a result of bearing failure due to liquefaction of its foundation soil. The zoning was made based on quick inspection during our site visit. Most of the commercial buildings concentrated in the area from Burgos Ave. to M. H. Del Pilar St. and from A. B. Fernandez Ave. to Perez Blvd.

Also shown in the figure is the area which is considered to have slid toward the river, due to liquefaction of underlying soils. By and large, ground sliding or lateral spreading occurred on both sides of the river shown in the map, making structural damage within the area much worse. The slide which occurred on the right side of the river extended 150 m wide by 300 m long, causing extensive damage to over ten reinforced

Fig. 3 Map of downtown Dagupan

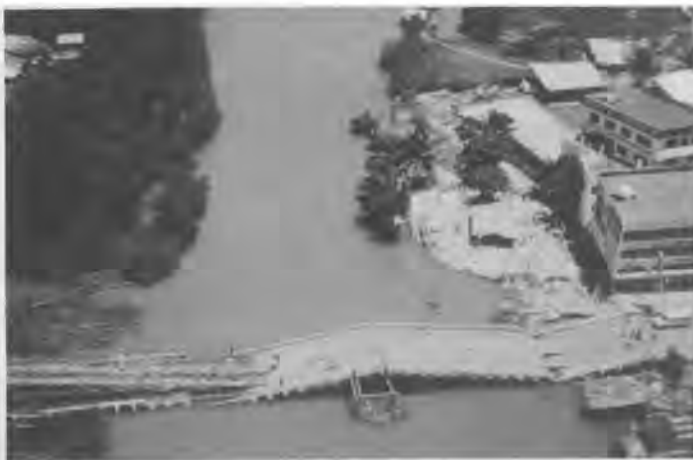
The bridge on Perez Blvd., called the Magsaysay Bridge, which has seven spans collapsed due to lateral movement and bearing failure of its piers. Photo 4 shows the collapsed bridge and the river which has been narrowed due to lateral spreading of both side of the river. The lateral displacement on the left side of the river appears significantly larger than that on the right side. Thus, at least 5 piers from the left side tilted toward the right. Many wooden houses near the river were found to be submerged. The bridge on A. B. Fernandez Ave. appeared to be unaffected.

Photo 4 Collapsed bridge and narrowed river

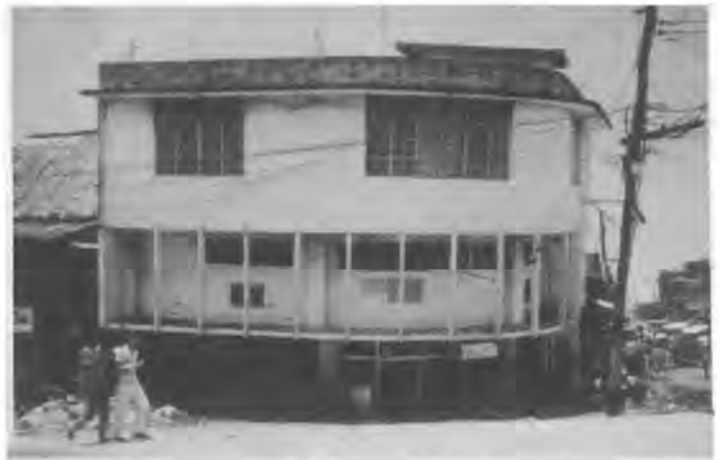
Over 80% buildings in the left side of the river suffered extensive damage, with buildings on and in the west of Galvan St. from Jovellaros St. to Gomez St. remaining intact. Much of the buildings on Perez Blvd. (Photo 5) and some buildings on Fernandez St. (Photo 6) settled and tilted considerably, whereas settlement and tilting of the buildings on A. B. Fernandez Ave. appeared generally smaller. The damage to super-

Photo 5 Bearing failure of three-storied building in Perez Blvd.

Relatively new buildings that have continuous foundations or mat foundations appear to have settled or tilted with their superstructures remaining intact or with little damage, as shown in Photos 5 to 7.

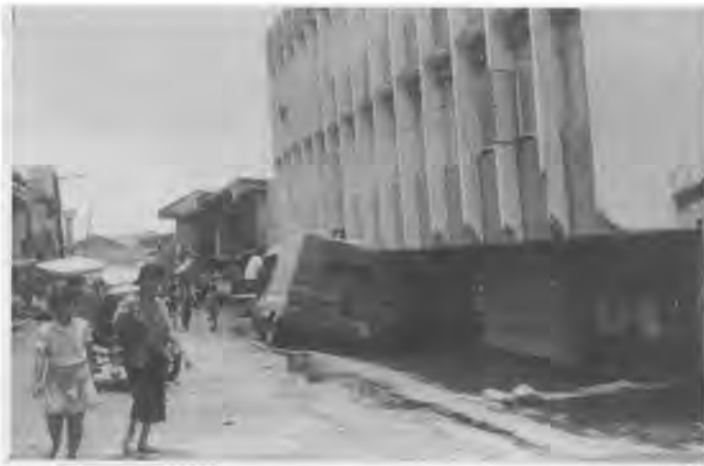
Photo 6 Damage in Fernandez St. - building is supported by a trapped van

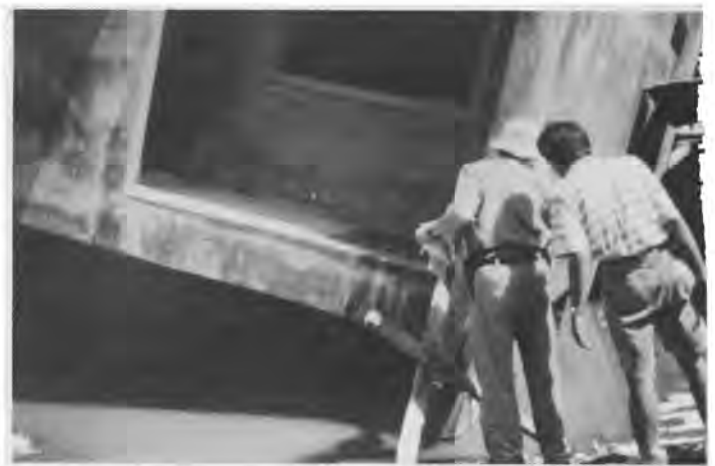
Photo 7 Three-storied building settled by 2 meters

Several multistory reinforced concrete buildings distributed within wooden houses in the south of Perez Blvd. suffered extensive settlement and tilting (Photo 7). Wooden houses in this area were also badly damaged. The ground surface along Don Jose St. settled by about 50 cm.

cent buildings on one or both sides, and in buildings surrounded by light weight structures. The building shown in Photo 7 is the one that settled most in the city. It was in fact surrounded by wooden houses, and settled by about 2 meters and tilted by 17 degrees.

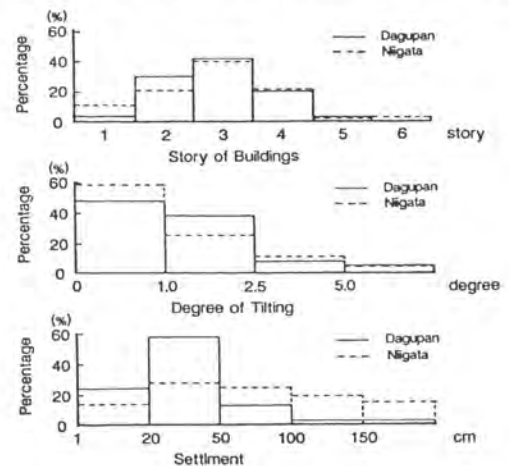
Fig. 4 summarizes damage statistics of some 120 RC buildings made by our team in the affected region. Over 90 % buildings were sampled from A. B. Fernandez Ave. and Perez Blvd. Most of the buildings are two to four storied with shallow footings and without pile foundations. It appeared that very few buildings have pile foundations and that no consideration was made in the foundation design to mitigate liquefaction hazards.

Also shown in the figure in dotted line are similar data for the damaged buildings in Niigata city after the 1964 Niigata earthquake. The figure indicates that over a half of the buildings tilted by more than 1 degree. The average settlement is found to be on the order of 50 cm which is considerably smaller than that observed in Niigata.

Fig. 4 Damage statistics of RC buildings in Dagupan compared with those in Niigata

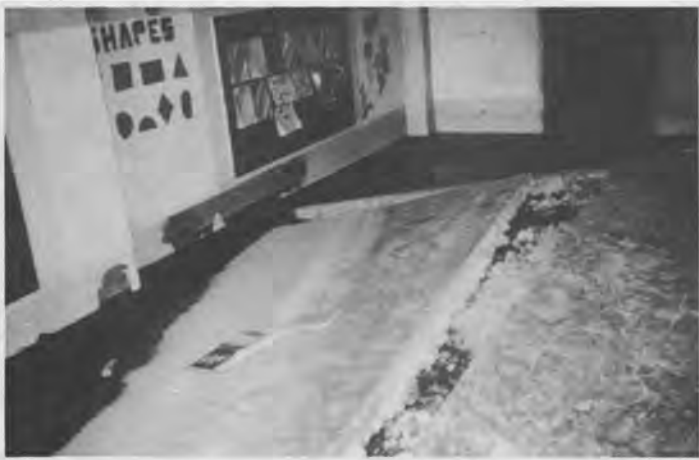
Photo 8 Heaved slab due to bearing failure of footings

On the contrary, extensive damage to first floor slab and superstructure was apparent in many buildings that have individual shallow footings without tie beams or, if any, with beams of low rigidity. Photo 8 shows unreinforced slab which was heaved and broken due to foundation settlement and sand intrusion of a three-storyed school. Photo 9 shows shear failure of exterior columns in a three-storyed store, possibly caused by lateral movement of footings. No apparent damage was observed in interior columns. It appears that bearing failure and resulting settlement of the building pushed both foundation soil and exterior column footings outward. Photo 10 shows a two-storyed building that suffered serious damage to its entire superstructure due to differential settlement. These types of failure were particularly noted in many old buildings in A. B. Fernandez Ave.

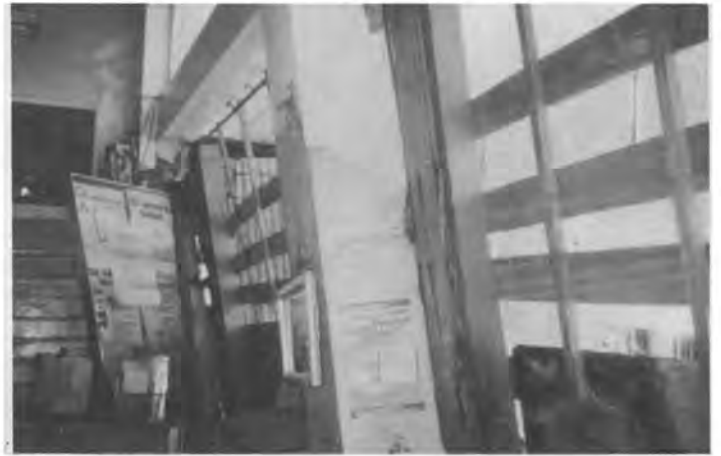
Photo 9 Inclined columns due to lateral movement of footings

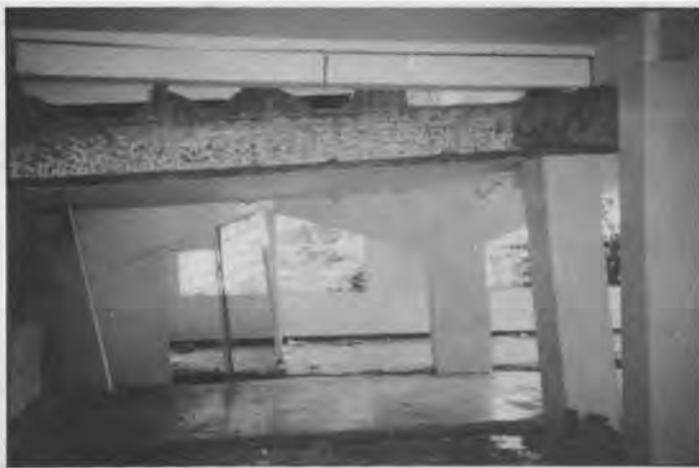
Photo 10 Significant differential settlement in two-storyed school

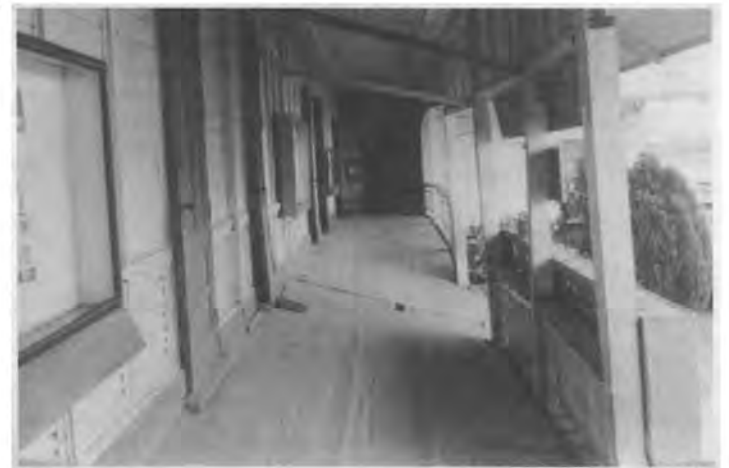
Photo 11 Differential settlement due to partial bearing failure

Photo 11 shows inclined corridor of a two-story wooden frame school which suffered significant differential settlement. Photo 12 shows a typical damage observed in the sliding area in which a wooden house was destroyed due to differential lateral movement of its foundation soil toward the river. Many wooden structures in the sliding area were submerged due to lateral spreading and subsidence of foundation soil.

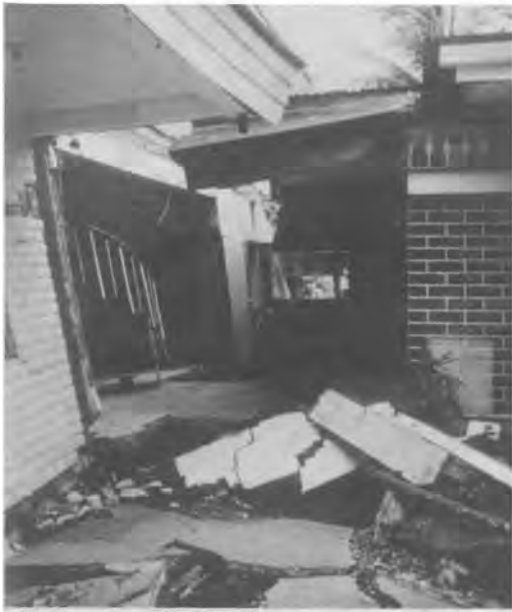
Photo 12 Damage to house in sliding area

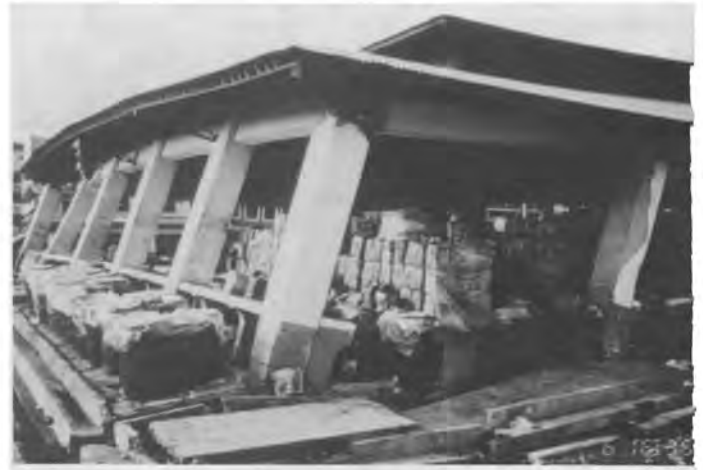
Lateral spreading may also cause considerable damage to superstructure of reinforced concrete buildings. Photo 13 shows a warehouse which suffered differential lateral movement of footings. It was elongated by about 2 meters in the direction perpendicular to the river.

Photo 13 Warehouse in sliding area

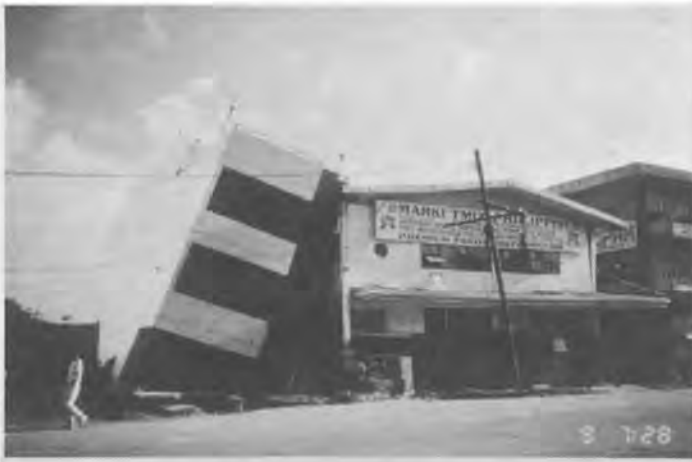
Damage induced by structure-to-structure interaction was also evident in many places. For example, settlement and tilting of heavy concrete buildings affected damage patterns of adjacent structures of lighter weight. Photo 14 shows damage of a structure caused by the overlying building. Photo 15 shows differential settlement and associate damage of a light-weight structure, induced primarily by a larger settlement of the adjacent structures of heavier weight.

Photo 14 Damage to structure caused by overlying building

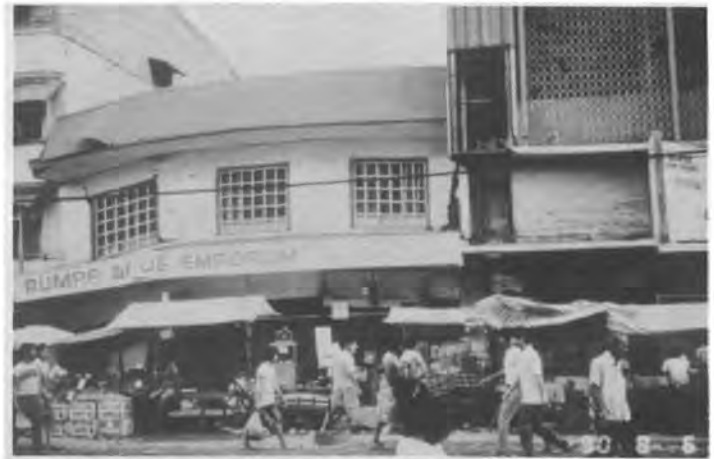
Photo 15 Damage to light-weight structure sandwiched in between heavier buildings

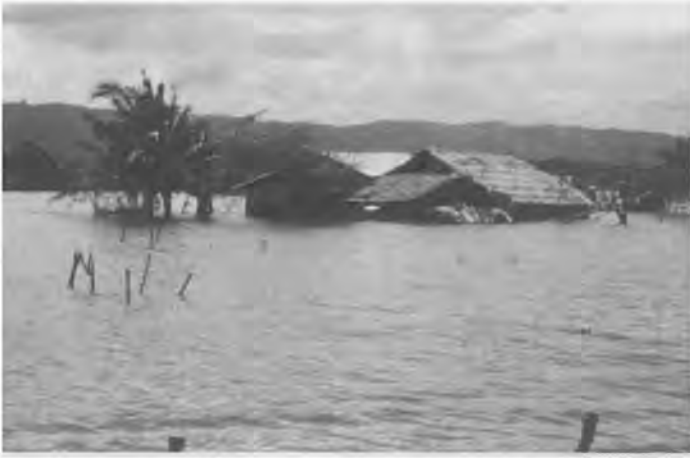
Photo 16 Homes submerged below sea level in Alaska, Aringay

Photo 16 shows submerged homes in a village called Alaska, Aringay. Sandbars and levees enclosing fish ponds sank or slumped on the order of 1 meter due to soil liquefaction, making some 260 homes submerged below sea level. The affected area in the village extends about 1 km inland from the original seashore and stretches about 4 km along the coast. The total area submerged below sea level is at least 50 ha.

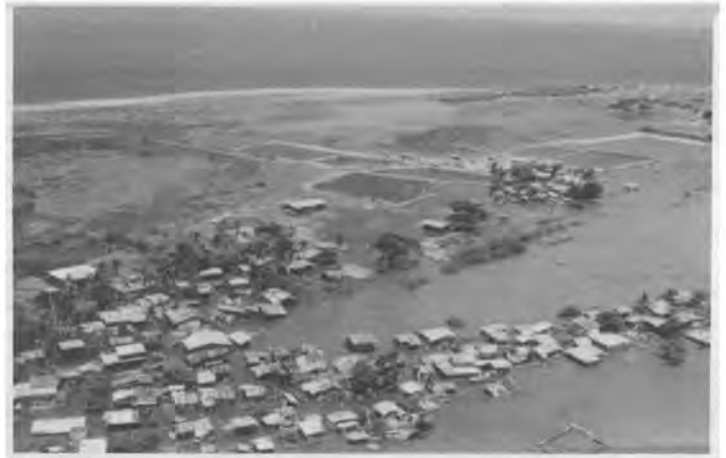
Photo 17 Aerial view of a village submerged below sea level

A similar ground subsidence was also observed in a small village on a sandbar in the south of Agoon. Photo 17 shows an aerial view of the village. Most of the homes in the village are now below sea level.

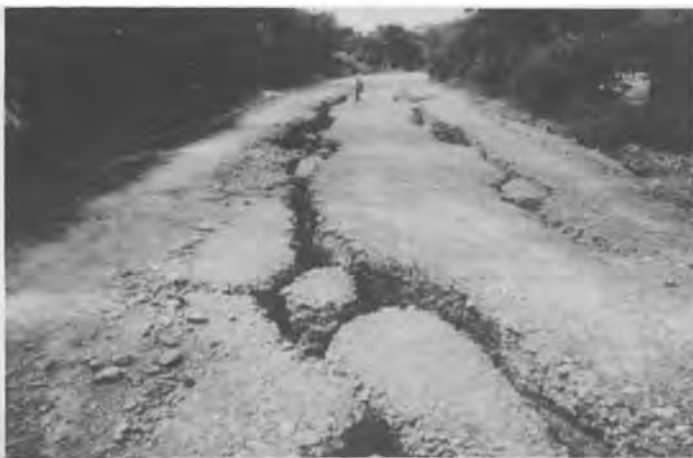
Liquefaction also occurred in many alluvial sandy deposits in the sparsely populated epicentral region and the middle of the Central Plains, causing lateral spreading, and failure of embankments and roads. Photo 18 shows large ground fissures occurred along unpaved road crossing riceland near Rizal. Numerous large sand boils observed on riceland indicated that the liquefaction of underlying soil is the primary cause of the failure. Photo 19 shows damaged road near Rizal due to slope failure associated with soil liquefaction. Liquefaction induced damage of many houses was also reported in Gerona north of Tarlac.

Photo 18 Large fissures near Rizal

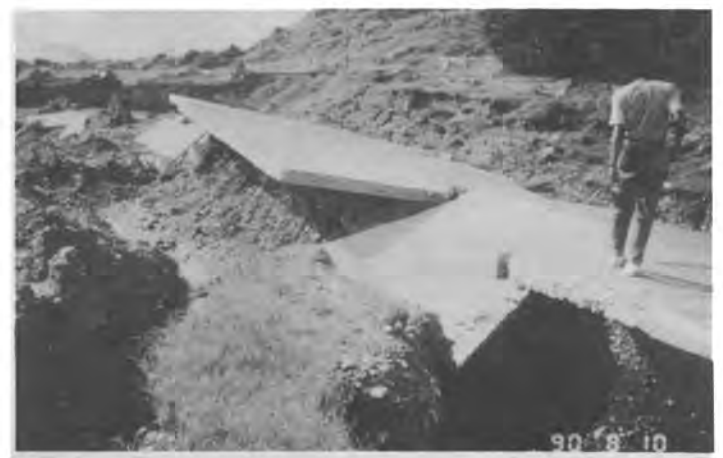
Photo 19 Damage to road near Rizal

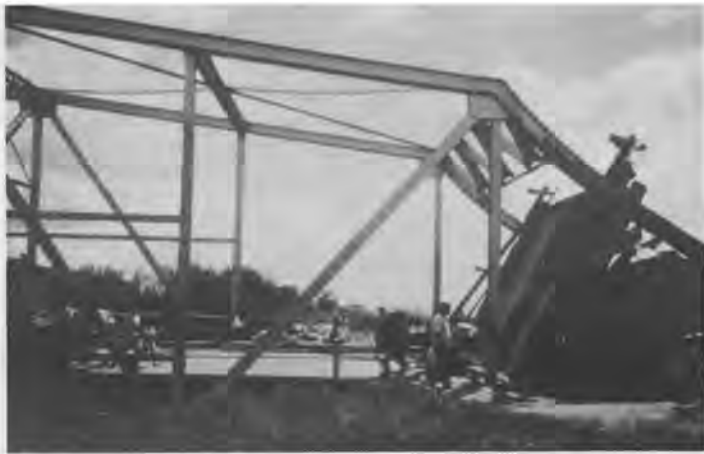
Many bridges collapsed as a result of lateral spreading due to soil liquefaction. Photo 20 shows a collapse portion of the Carmen Bridge which crosses the Agno River in the north of Tarlac and connects Rosales to Villasis. This has thirteen 48 meter span trusses. Several piers on the Rosales side settled, tilted by up to 26 degrees, and possibly moved toward the

Photo 20 Carmen Bridge destroyed by lateral spreading due to soil liquefaction

center of the river due to liquefaction and associated lateral spreading. As a result, first six span trusses from Rosales were destroyed or badly damaged, causing cut-off of the main root from Manila to the Northern Luzon. No structural damage was observed in the rest part of the bridge, except breaks in pin joints on the first piers from Villasis. Sand volcanoes were seen in the damaged area.

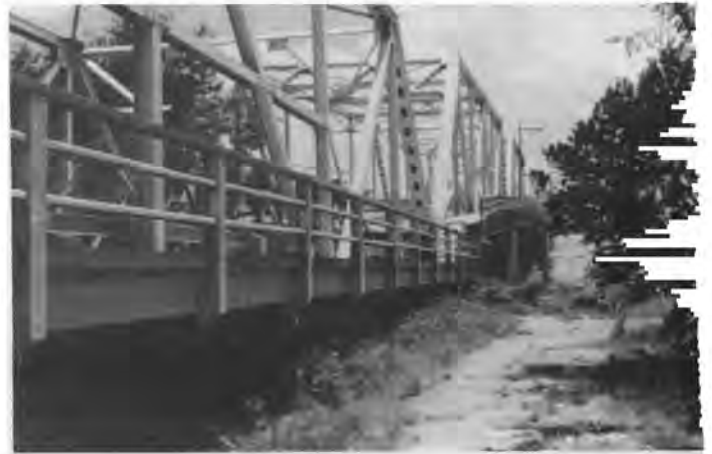
Photo 21 Damage to Carvo Bridge and lateral spreading of its foundation soil

Similar lateral movement of pier also damaged the Carvo Bridge in the north of Tarlac, as shown in Photo 21. It has four 42 meter span trusses connecting Bautista and Bayambang. The first pier from Bautista moved toward the river by about 1 meter, causing a fall of the truss. Ground fissures occurred parallel to the river near the damaged pier.
