The Performance of Hillside Fills During the Northridge Earthquake

Paper No. 14.05

SYNOPSIS: Many hillside fills located in the Santa Monica, Santa Susana, and San Gabriel Mountains were damaged during the 1994 Northridge Earthquake. While no deaths have been attributed to fill movement, on the order of tens of millions of dollars in property damage was caused by fill movements which typically involved less than about 7.5cm (3 inches) of localized displacement. Some of the damage was induced by permanent deformations of underlying native materials, but most appears to have resulted from ground failure or ground shaking phenomena associated directly with the fill materials. These phenomena include cyclic compaction, lurching, and amplification of shaking within the fills. This paper presents a preliminary summary of the typical distress to fills caused by the Northridge Earthquake, and discusses the probable mechanisms of failure.

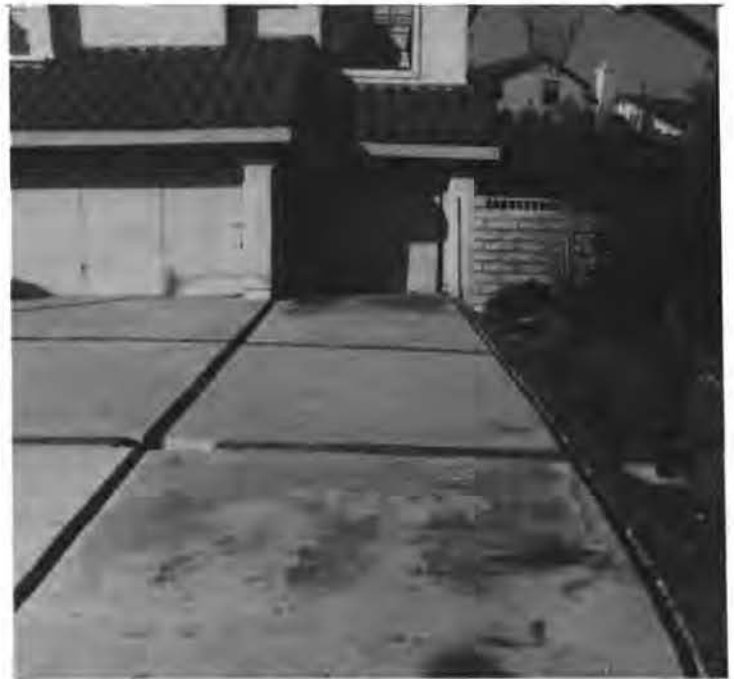
Cracks at the cut/fill contacts: Ground cracks commonly occurred at the cut/fill contact, or above the closest bench to the cut/fill contact (Figure 5). These cracks were typically less than 7.5cm (3 inches) wide, and usually had less than 1.3cm (1/2 inch) of vertical movement, although there were

Figure 5: Typical crack at the cut/fill contact. The top of slope is visible on the right side of the photograph.

cases where the differential movement across cracks was on the order of 2.5cm (1 inch). Even in these cases, differential vertical movement was normally less than the horizontal movement. Where there was differential vertical movement across the crack, the fill moved down relative to the cut, except in one unusual case, where the fill apparently moved up about 2.5cm (1 inch) relative to bedrock cut. Where investigated with trenches or down-hole logging in borings, these cracks became thinner with depth, and could only be traced to a depth of 1 to 2m (3 to 6 feet) below the surface. The cracks did not appear to be related to any detectable localized shear movement through or along the base of the fill. There was severe damage to buildings, pools, or pavements spanning across the cut/fill contacts.

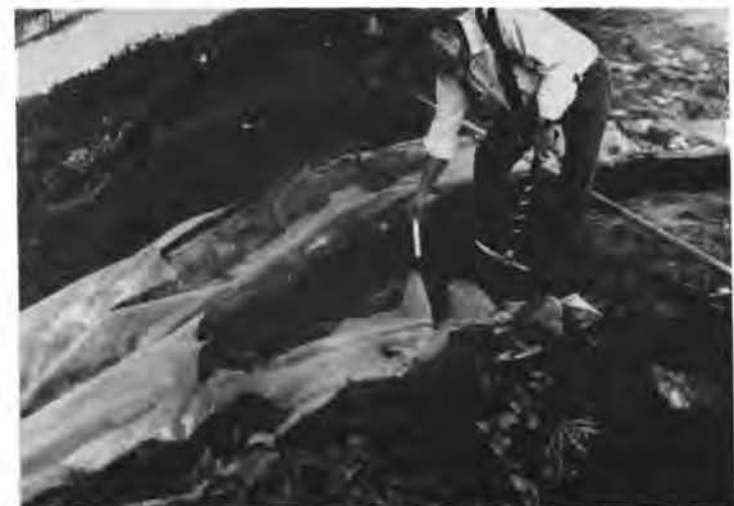
Figure 6: Typical down drain uplift, at one-third of the slope height up from the base of the fill (see also Figure 4).

Face of fill slope distress: Distress on fill slope faces was generally observed in terrace or down drains. The typical locations of terrace and down drains on the slope face are illustrated in Figure 2. Terrace drains generally had irregularly spaced cracks oriented perpendicular to the slope contours. Typical crack widths were 1.2mm (0.05 inches), widening to 2.5mm (0.1 inches) on the downslope side, with no vertical differential movement or shear across the crack (except at the sides of fills near the cut/fill contacts). In deeper fills, down drains, which collect water from terrace drains, were locally uplifted as much as 30cm (1 foot) relative to adjacent terraces (Figures 4 and 6). The uplift typically occurred at one-third of the slope height up from the base of the fill. Other than distressed terrace and down drains, fill slope face deformations were generally only observed as ground cracks along the sides of the fill, oriented in the downslope direction, parallel to the fill/native material contact. The observed movements in the terrace and down drains indicate bulging of the fill near the center of the fill (in plan), and bulging with possible shortening of the fill surface near the base of the slope (in profile), respectively. To date, consultant and agency investigations have focused on the flatter portions of fills that support structures, and few subsurface investigations have been performed on slope faces to investigate the causes of these bulging features.

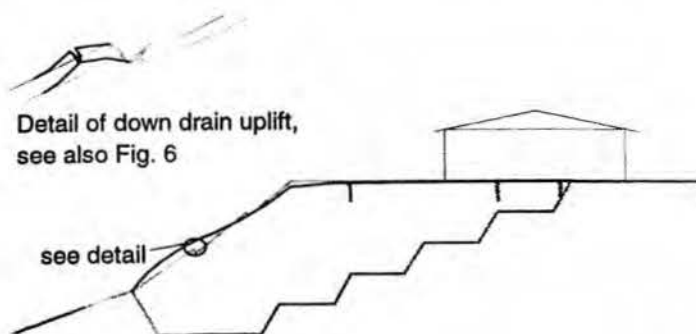
The characteristics of the fill distress induced by the earthquake in each of these regions are fairly similar, and are illustrated in Figure 4. The distress features can be broken down into several categories, including cracks at the cut/fill

contact, cracks in the fill pad parallel to the top of slope, deformations on the face of the slope, differential settlements in the fill, separations between foundations and adjacent soils, and cracks in cut areas. Typical observations of these distress modes follow:

Fig. 4: Schematic showing typical damage to fill slope

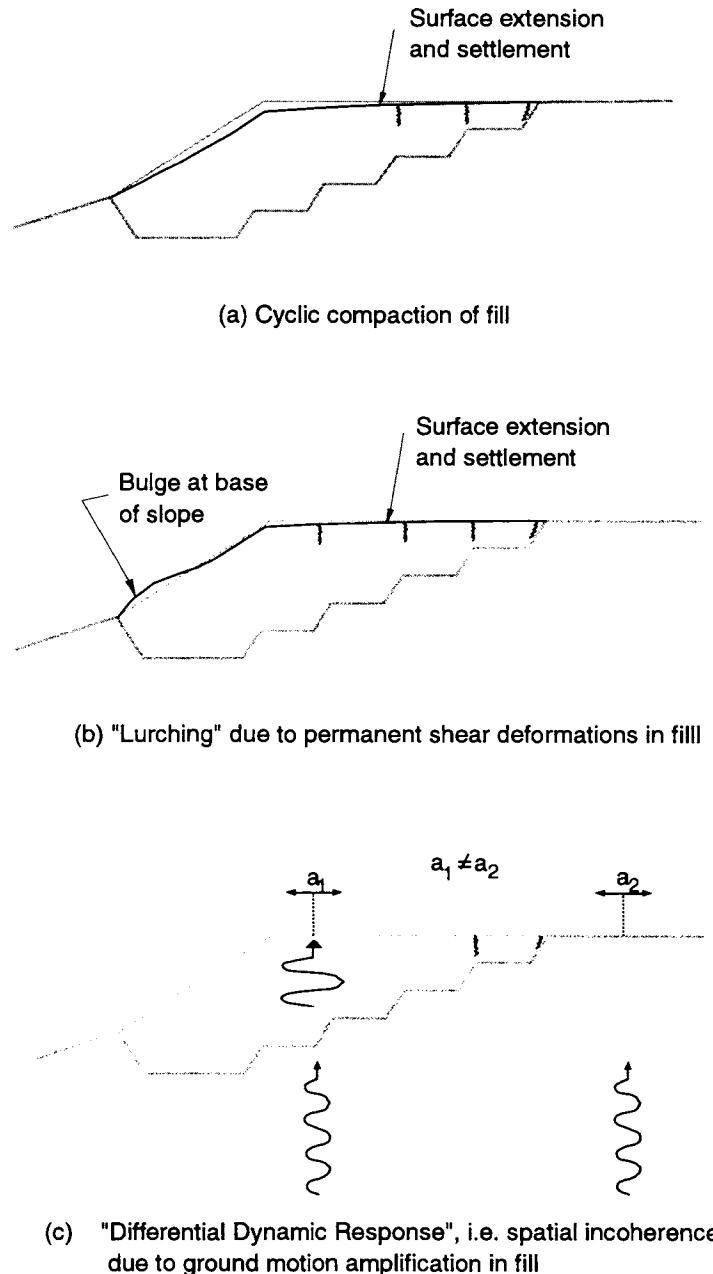
2. **"Lurching" deformations of fill soils:** Permanent shear deformations (without shear failure) are likely to have occurred over the depth of the fill sections in many of the fills investigated. These lurching effects would tend to induce deviatoric downslope "slumping" of the fills (Figure 7b), leading to crest settlements and associated toe/face bulging, as was commonly observed. However, this mechanism cannot explain shortening of the lower portions of the fill slope face.

3. **Differential Dynamic Response:** Differential ground shaking levels may have occurred between the cut and fill portions of the building pads (Figure 7c). The differential shaking intensities would have resulted from a combination of topographic/geometric amplification (Ashford and Sitar, 1994), and amplification of ground motions in the fills due to impedance contrasts between the fills and underlying stiffer native soils or rock. These amplification effects would tend to produce spatially incoherent ground motions between the fill and cut portions of building pads, with greater shaking intensities typically occurring in the fill. This spatial incoherence could potentially induce some minor lateral cracking of the fill surface, but does not explain differential settlement of the fill surface, or fill toe/face bulging or shortening.

Fig. 7: Schematic illustrations of fill deformation mechanisms
