## Change of Waterline and Water Depth at Izmit Bay Due to 1999 Kocaeli Earthquake in Turkey

# CHANGE OF WATERLINE AND WATER DEPTH AT IZMIT BAY DUE TO 1999 KOCAELI EARTHQUAKE IN TURKEY

## ABSTRACT

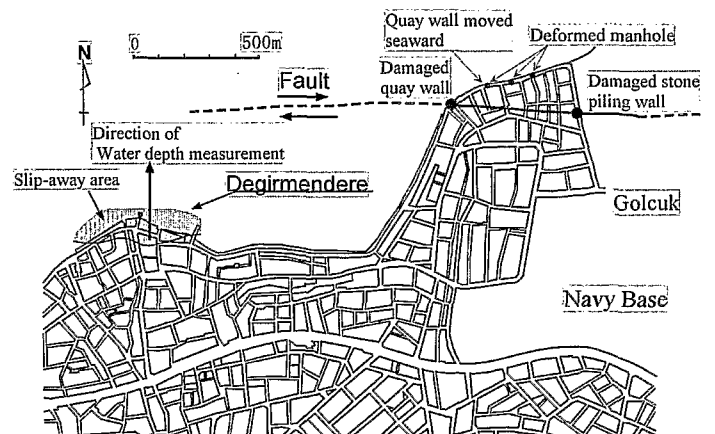
Locations of fault line and land submergence in the city of Degirmendere that is located west of Gölcük City are shown in Figure 2. The fault was observed on ground in the east of downtown Gölcük, whose traveling direction is also roughly shown in Figure 2. Two typical damages to waterfront area were observed. The stone-piling wall was just located on and was damaged with a horizontal relative displacement in 1.5m of west-east direction and 4.3m of north-south direction. Quay wall along the coast was moved seaward, and damaged due to ground gaps by the fault.

Fig. 2. Location of the damaged and slip away area in Degirmendere

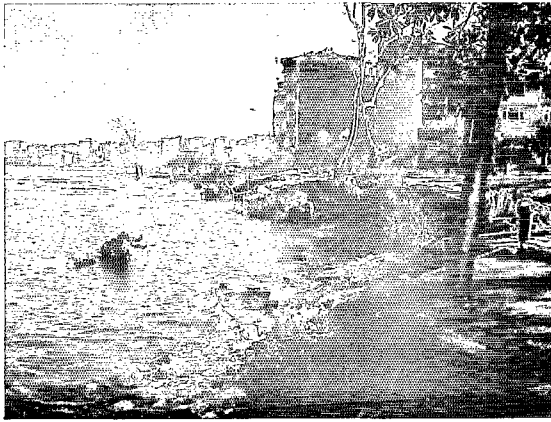
Photo 1. Slip away area in Degirmendere

In the west of the downtown, the coastal land with about 300m long and 100m wide was chopped away into the sea including all buildings on the ground just after earthquake as shown in photo 1. From the observation of outcrop and inclination of riverbed, this area was not reclaimed land but alluvial deposit, which includes many gravels with about 10mm diameter. The buildings near the boundary between flowed out areas were damaged and tilted toward the sea. The evidence of soil liquefaction could not be observed at the back ground of slipped-away area.

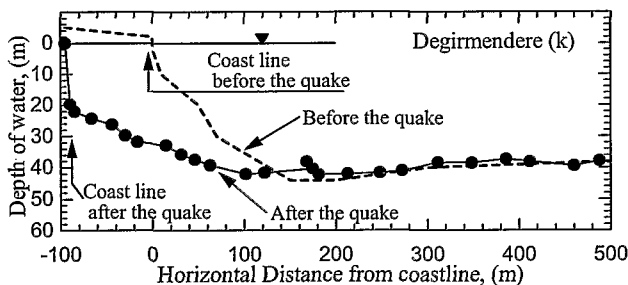
Fig. 4. Result of Measurement of water depth (Degirmendere)

demonstrated in Figure 4, together with the water depth prior to the earthquake. That was read off from the published marine chart showing contour lines of equal water depth. It can be seen that the shape of the seabed had changed drastically after the earthquake as compared to that prior to the earthquake. Amount of change of water depth reached about 20m in depth near the shore. This indicates that a landslide must have taken place under the sea. The distribution of collapse converged within 150m offshore from the coast. The fault is considered to run east to west at a location about 500m off the coast as estimated from the fault line extension in Figure 2. The obvious change of water depth can be measured at this terrain. Considering that the change of seabed in several tens meters caused by the collapse of alluvial deposit, but not the transform fault.

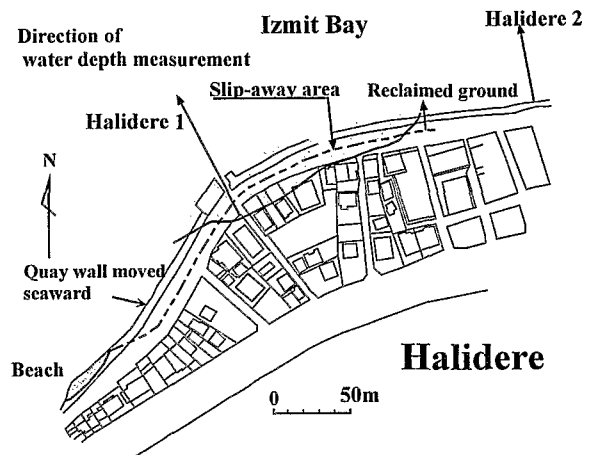
Figure 5 shows location of land submergence in Halidere located on west of Degirmendere City. Part of nose of alluvial cone, about 200-250m long and 20m wide, was slipped away into the sea. According as slipped away area is mainly reclaimed land and the gradient of back ground is relatively small, collapse of reclaimed land seemed to affect to natural ground. Similar measurements of water depth were carried out in two cross sections in Halidere as indicated in Figure 5. The section 1 passed through the mouth of a small river across the

Fig. 5. Location of the damaged and slip-away area in Halidere

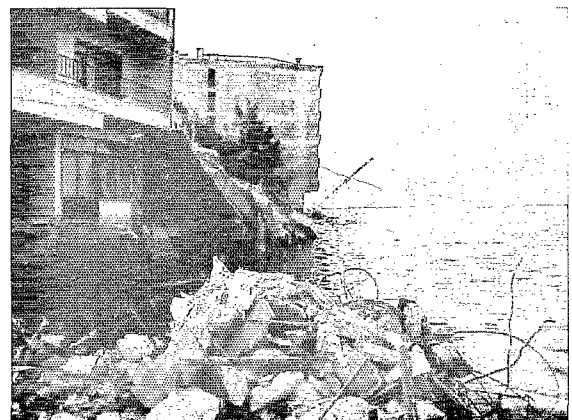
Photo 2. Slip away area in Halidere

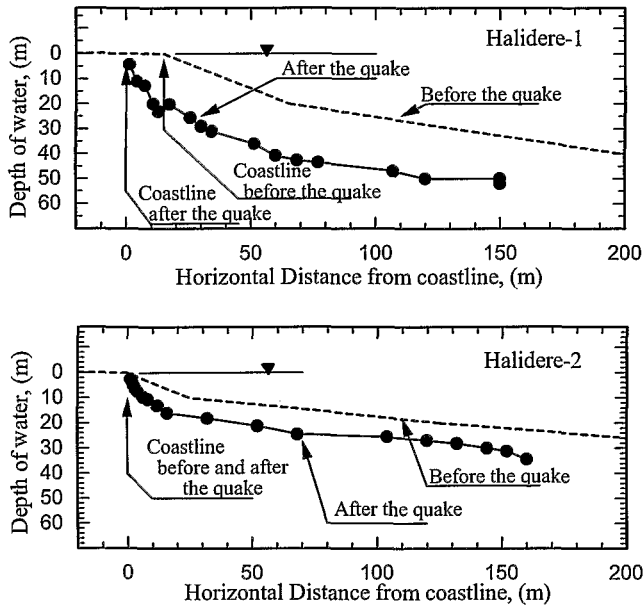
Fig. 6. Result of Measurement of water depth (Halidere)

In the Halidere 2 cross section, the depth of submarine slide is inferred to be about 10m on the average, whereas the slide in Halidere 1 cross section involved the soil movement to a depth of about 20m. From these observations, it may be noted that the removal of a huge mass soils from the coastal land was caused by a large-scale submarine slide where the sliding plane was as deep as 20m beneath the original sea bottom.

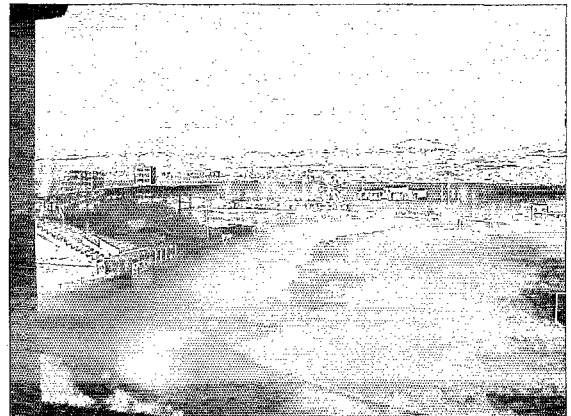
1.5-2.0m as also indicated in Figure 7. The triangular area northeast of the fault subsided with a gradual tilt toward the sea with the northern tip submerged into the sea. The submerged area is also shown in Figure 7 and Photo3. It would appear likely that the terrain about 1 km by 1 km area has moved as a whole towards the sea with lower relief. And the amusement facilities such as swimming pool and Ferris wheel in the park were submerged accompanied with the ground subsidence. Because walls, electric poles and woods in the submerged area were standing straightly after the earthquake, it would appear that the land was subsided maintaining the level of the land. Furthermore, the ground subsidence was gradually increased even after several months.

Photo 3. Submerged area in Golcuk

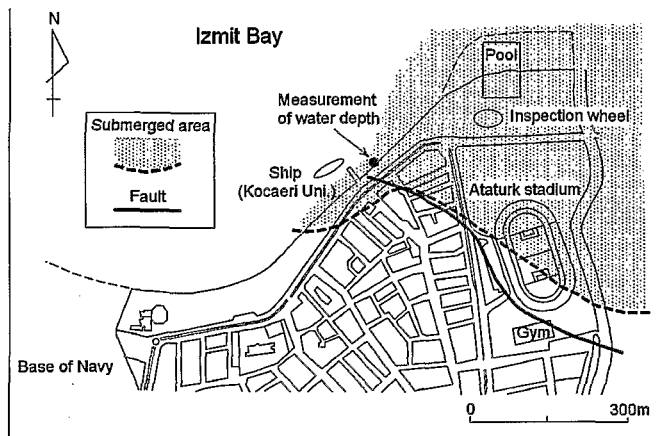
Figure 7 shows a schematic map of Kavakli district in Gölcük City. Traces of the fault was observed on the ground at several sites in this district, whose direction is roughly shown in the same figure. The fault line passed through the road along the west of football stadium. The vertical offset amounted to about

Fig. 7. Location of the fault and the submerged area

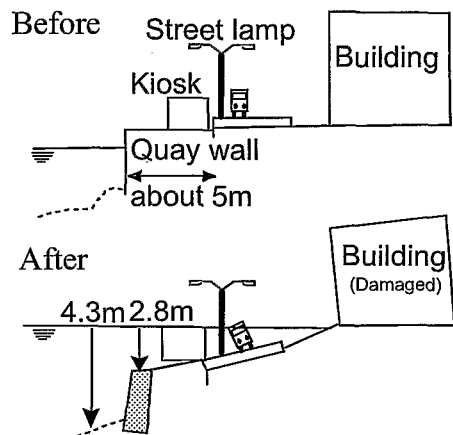
Simplified measurement of water depth was carried out at the site on Figure 7 by using plumb-bob. Figure 8 shows the schematic drawing of the change of waterfront before and after the earthquake in Gölcük. The promenade along the coast has gone under the water, and vertical displacement of the top of quay wall amounted to 2.8m. It is confirmed that the signboard of kiosk which could be seen on the water level just after the earthquake, it disappeared under the water after several months. Several cracks with sand boil could also be observed along the coast road near the submerged area. It is undeniable possibility that soil liquefaction was partly occurred and induces to the ground movement towards the sea.

Fig. 8. Schematic Drawing of change of water depth

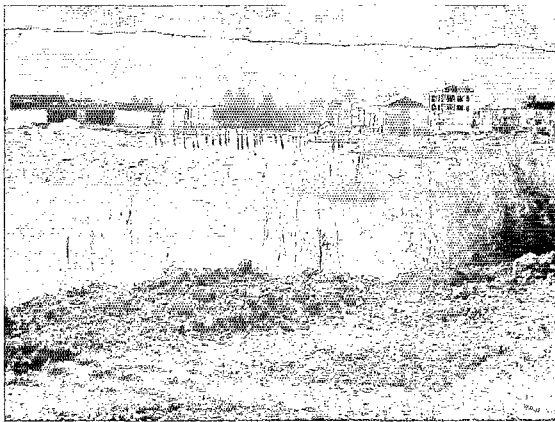
Photo 4. Submerged area in Kawakli

There was a Ford Gölcük automotive factory south east of Kavakli district and the fault reached to at least this factory and submerged area was spread far east from here as shown in Photo 4. Several damages such as cut-off of the buried pipes under the road and heavy destruction of the mosque standing on the fault due to the ground deformation directory induced by the fault movement were found.

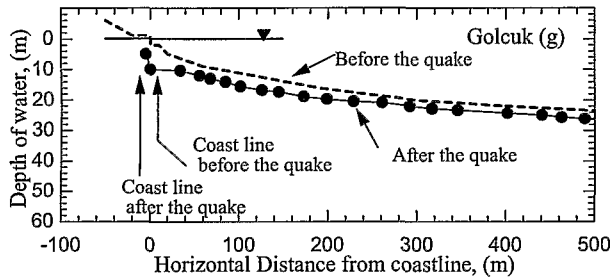
Fig. 9. Result of Measurement of water depth (Golcuk)

Measurement of water depth was carried out along the cross section toward offshore in this district. Although water depth becomes steep just in front of the shoreline, it may be seen to subside beneath except these as shown in Figure 9. Amount of the change of water depth was only 3m-4m. Shape of the seabed after the earthquake could not be seen like submarine slide, and inclination of seabed toward offshore keep tendency before the earthquake. The cause of which the coastland disappeared and the seabed settled down after the earthquake is different from the cause in another sites mentioned previously.

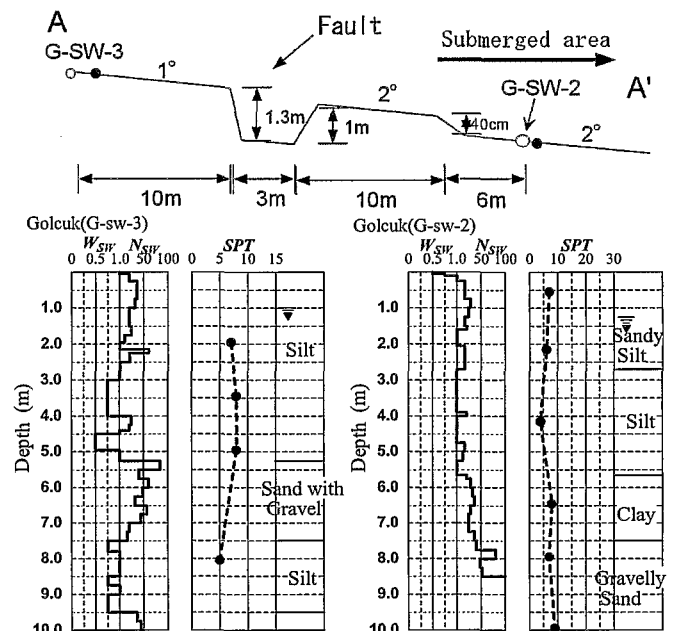
Fig. 11. Result of in-situ tests and Soil Profile in Yenikoy

Swedish cone penetration (Swedish Sounding) test and standard penetration test (SPT) were conducted for soil survey in order to clarify the cause of land loss along two sites stepped over the fault. The schematic drawings of the site and the sounding log from the tests are shown in Figure 11. Loose silt was deposited up to 10m in depth from the surface, and gravely sand was interstratified between silty layers. There is no significant difference soil profile between upper and lower sites. Therefore, the change of soil profile does not seem to cause to the subsidence, but fault movement caused to it directly. The existence of the soil layer indicates the possibility of the occurrence of soil liquefaction during the earthquake. It is however not sufficient to consider only volumetric change in sand layer due to soil liquefaction in order to explain the observed subsidence. Considering to the amount of subsidence from the water depth measurement, it seem to be that compressive volume change was taken place due to development of pore water pressure in silty layers during the earthquake. It is no doubt that the slip plane with soil liquefaction in interstratified sand layer, promoted the ground deformation.

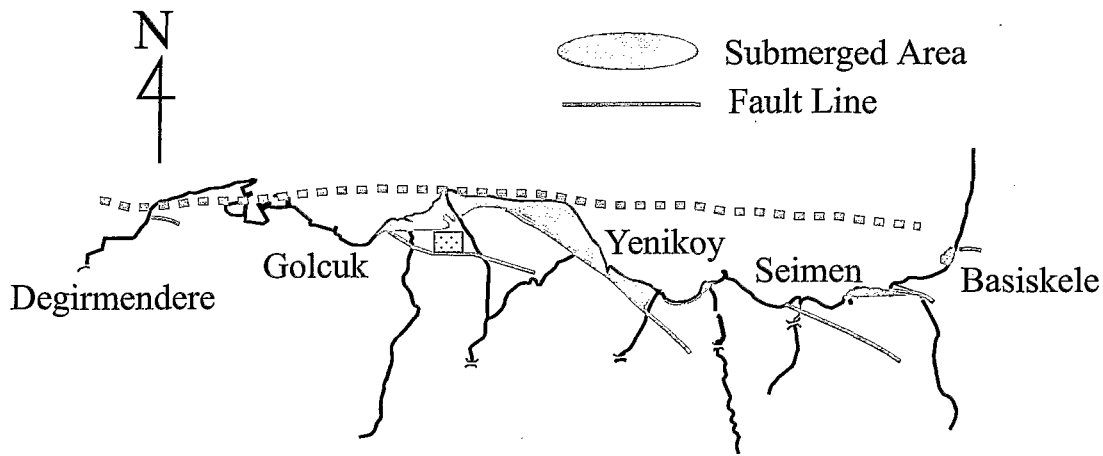
Fig.12. Location of submerged area of the south of Izmit Bay

The schematic drawing of the submerged area during Kocaeli Earthquake, which was inspected in this survey, is shown in Figure 12. It can be seen that large-scale submergence and subsidence were occurred in many places. From this figure, the terrain, which was surrounded between main- and sub-fault, was mainly subsided. Especially, submerged area concentrate to the coastland around river mouse and/or top of triangular of alluvial cone.
