LIQUEFACTION AND GROUND FAILURES DURING THE 1998 ADANA (TURKEY) EARTHQUAKE AND LAB MODEL SIMULATIONS

Korhan Adalier

ABSTRACT

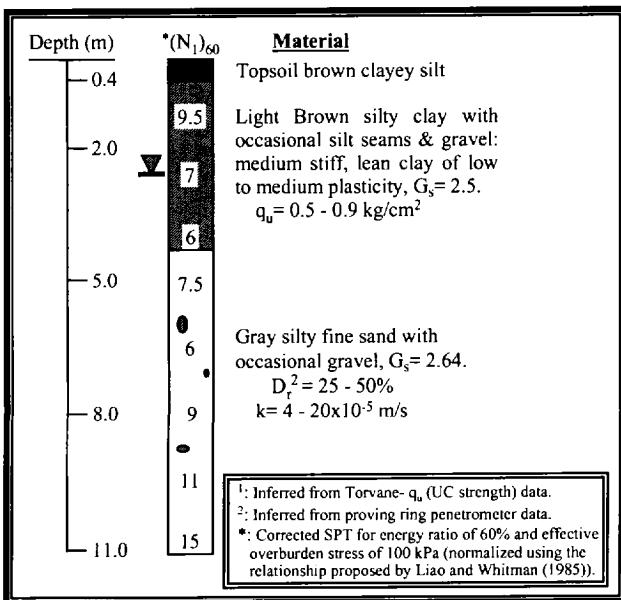
Fig. 3 A typical soil profile near Abdioglu.

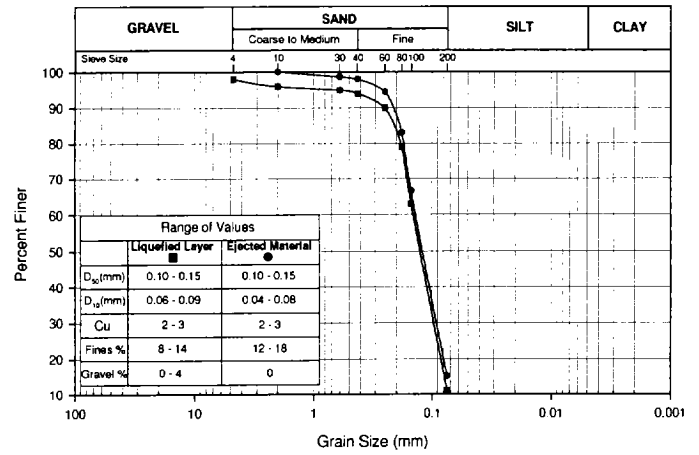
Fig. 4 Grain size distribution of liquefied layer and ejected material.

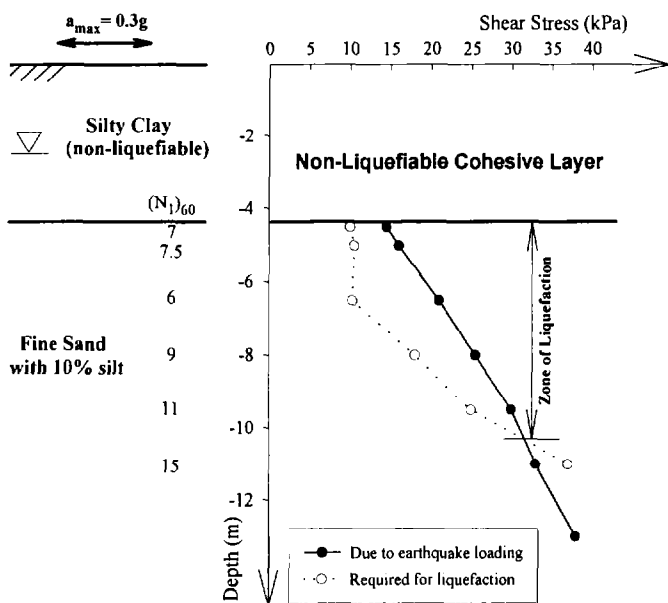
Where a_{max} is the peak ground acceleration, g is the gravitational acceleration, σ_v is the total overburden stress, r_d is a stress reduction coefficient that relates the behavior of a deformable soil mass to that of rigid mass. Within a close proximity of the epicenter and the fault line, this site is estimated to have experienced peak ground acceleration (a_{max}) of about $0.3g$. This estimate is based on the: ground motion record (Fig. 2) at Ceyhan Station (which sits on similar soil formation not far from the fault) and the effects of ground shaking on structures and their contents located in the area. The reduction factor r_d was approximated using the Japanese practice where $r_d = 1 - 0.015z$ (where z = depth in meters). The cyclic shear strength was estimated based on SPT-N values as suggested by Seed et al. (1985). Figure 5 shows the variation of the earthquake induced cyclic shear stress and the cyclic shear strength with depth. Based on this analysis, liquefaction did occur in at least the upper 10 m within the underlying sand stratum (ele. -4.5 to 10 m). The conditions of this example are representative of those in the Abdioglu area and many other areas along the Ceyhan River. The extensive liquefaction predicted in this example is consistent with what was actually observed in the 1998 earthquake.

Fig. 5 Evaluation of liquefaction potential at Abdioglu.

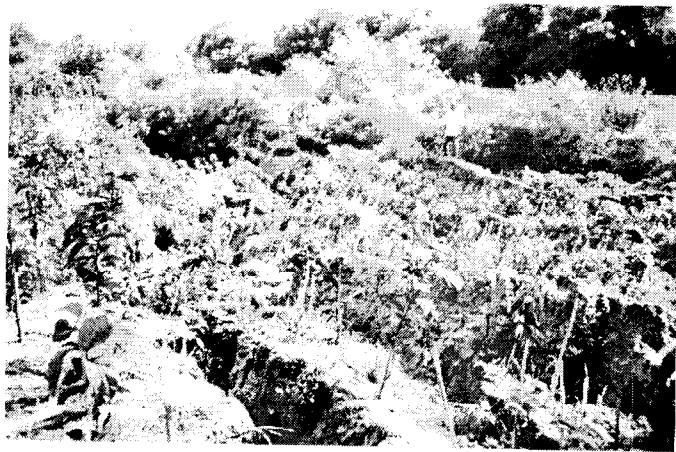
Fracturing induced by ground oscillations and lateral spreading was widespread. Numerous slope failures or collapses along the Ceyhan River were observed. Large volumes of soil both settled vertically (up to 4 m) and moved laterally (up to 10 m) towards the river (Fig. 6), apparently due to the flow of the liquefied silty sand

sublayer (i.e., lateral spreading). Almost all the slides in the area were initiated within the underlying loose sand layer at depths varying from 3 to 8 m. In many locations, long fissures in the ground parallel to the river channel were observed as far as 300 m inland, indicating lateral spreading of the ground toward the river. Lateral spreading due to mildly sloping ground remote from free faces (e.g., incised channels) or known areas of cut and fill were also observed at several isolated sites, but to a much lesser extent. Permanent ground deformations were predominantly extensional although at several inland sites failure by compression was observed.

Fig. 6 Lateral spreading along Ceyhan River near Abdioglu.

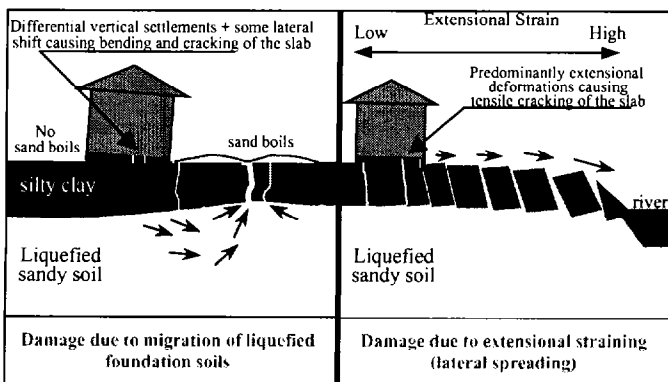
Sand boiling by itself caused minor structural damage in a few cases, but only when it led to localized differential settlements in foundation soils (e.g., due to sediment migration, Fig. 7). In some cases, sand boils emerged at the periphery of buildings or were forced through exceptionally thin unreinforced concrete floors of the houses and literally filled them with fine sand and water. The worst cases of lateral spreading (which involved not only large horizontal displacements but large vertical settlements as well) and slope failures were concentrated on the banks of the Ceyhan River. Since most of the riversides in the earthquake-affected area were used for plantation alone, damage to man-made structures from these types of ground failures was rather limited. At areas away from incised river channels (or any other free face) and any slope, where the principal effect of the liquefaction was vertical ground settlements, surprisingly little damage to man-made structures was observed. However, at areas not far from river channels or sloping ground, where liquefaction generated lateral ground displacements, foundation performance was typically poor. Tension cracks associated with lateral spreading and uneven subsidence displaced and fractured the foundations of several homes (Fig. 7), ruptured sewers, water pipelines and irrigation canals, and damaged small concrete bridges and pavements. In the vast majority of these cases, it was clearly observed that the specific locations of these types of damage closely matched the zones of ground failure, suggesting that ground failure rather than ground shaking was the dominant cause.

The number of observations was rather limited due to sparse development in the affected area and did not permit a quantitative analysis of ground failure structure interaction. However, it was noticeable that the buildings (mostly 1-2 story houses) with strong continuous mat foundations or thick strong base slabs performed significantly better in areas subjected to minor to moderate effects of liquefaction, such as lateral spreading, sand boils, and ground subsidence. Where foundation or base elements were weak and not well tied together, differential ground displacements broke base slabs and pulled apart structures, mainly fracturing the walls. However, no total collapse case related to liquefaction induced hazards were observed, as only minor to moderate effects of liquefaction were observed in developed areas.

Fig. 7 Some liquefaction-induced structural damage mechanisms observed after 1998 Adana earthquake.

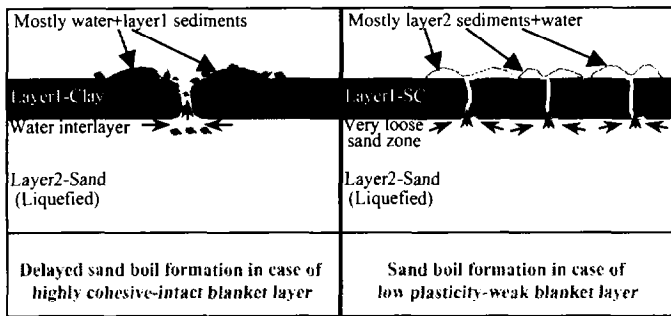
- i) Water gap or a very loose zone of soil develops at the interface between the sand (layer 2) and relatively impervious clay/silt layer (layer 1) as the liquefied sand reconsolidates. This accumulated water eventually escapes to the surface in the form of a sand boil (Fig. 9). Such loose zones in a soil domain with an initial static driving shear stress may lead to instabilities (e.g., slope failures and lateral spreading) as were observed during the 1998 Adana earthquake among others.

- iii) Highly plastic-cohesive and intact blanket layer is conducive to large and delayed (as cohesion inhibits the cavity formation) sand boils. Lesser amount of liquefied sediments is carried to the surface in delayed sand boils (as more pure water is available) as compared to sand boils that occur during or right after shaking (see Fig. 9).

Fig. 9 The two main sand boil mechanisms observed in the model tests.
