DAMAGE FROM COLLAPSED BACKFILL ROCK AND SOILS BEHIND RETAINING WALLS CAUSED BY EARTHQUAKE SHAKING

Chester A. Carville, P.E.
Carville Engineering & Construction
Cardiff-by-the-Sea, CA 92007

ABSTRACT

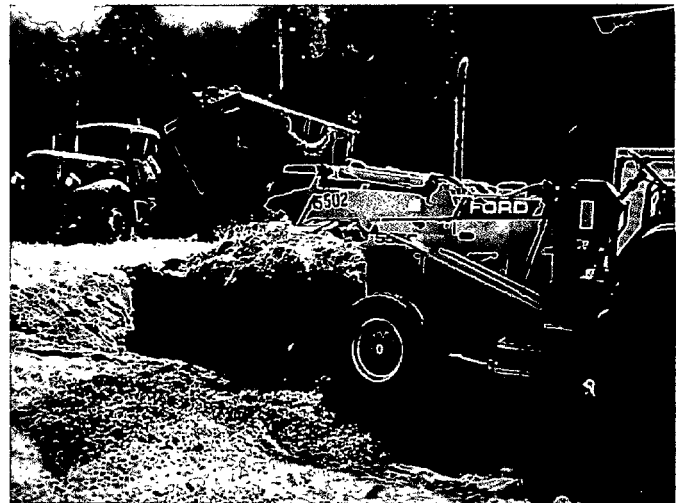
Fig. 2 – Crushed Rock Dumped into Test Trench

Crushed rock was then dumped directly on the pipe from a height of up to ten feet with a half yard bucket and brought to a

level of three to four foot above the pipe. A 10 ton tractor was then used to compact the gravel at the three to four foot level and to bring the gravel up to the six to seven foot level (Fig. 2).

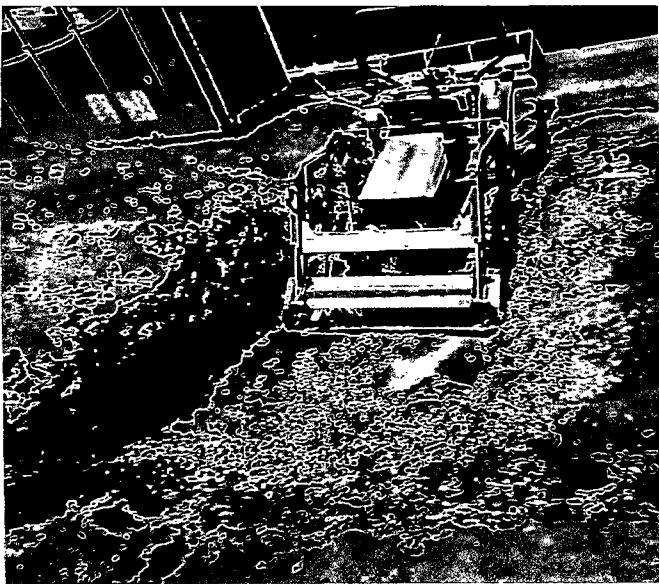
Fig. 3 – Removal of Gravel by 3 Ton Tractor

The gravel backfill was left for over one week, and saturated with water. The gravel was then removed with the 10 ton tractor down to the two to three foot level above the PVC pipe and down to the one to two foot level above the PVC pipe with a 3 ton tractor. (Fig. 3). At all time the right set of wheels of the two tractors were running directly over the drain pipe and the buckets were fully loaded with gravel. The PVC pipe was then carefully removed and examined for cracking or crushing. No visible damage could be found to either of the two drain pipes, in two separate tests.
